Practitioner Case History

Field Experience

Distribution: Engineer: <u>DLH</u> Engr. Ingr.: <u>JAB</u>		Northwest Airlines ENGINEERING AUTHORIZATION National Airlines, Inc. Engineering Dept.		E.A. Number 32-197865	Rev B
Name of Component/Title Left Hand Elevator, Upper Skin		Orig. Issue Date 02 Feb 04	Last Rev. Date 02 Mar 04		
NWA Ship & Serial No. - 58486 -		Type A320	Hours 34,678	Cycles 15,143	Mfg. ATA Code 55-20-01
Mfg. PIN D552 80001 004 51		Classification <input checked="" type="checkbox"/> Major <input type="checkbox"/> Recurrence <input type="checkbox"/> Vice		Prepared By / Date Dan Hitchcock / 02 Feb 04	
Approval No. 0121 (CG 1421)		Approval Date 02 Feb 04		Approved By / Date Brian Holasek / 02 Feb 04	
NWA Stock No. 32-5520-4-0001		NWA DSR SFAR 36		Aircraft Zone 33C	
Weight & Balance Change Weight: <u>NA</u> <u>NA</u> <u>NA</u>		Approval of AIRCRAFT DEPT <u>NA</u>		Rev Info See Sheet 3

Description of Problem:
 During accomplishment of Airbus Service Bulletin A320-55-1024 [Ref (A)] through inspection at MUP and per Refs (C), (D), & (F) multiple locations with evidence of water ingestion were found on the upper surface of the LH Elevator. The elevator skin panels are made

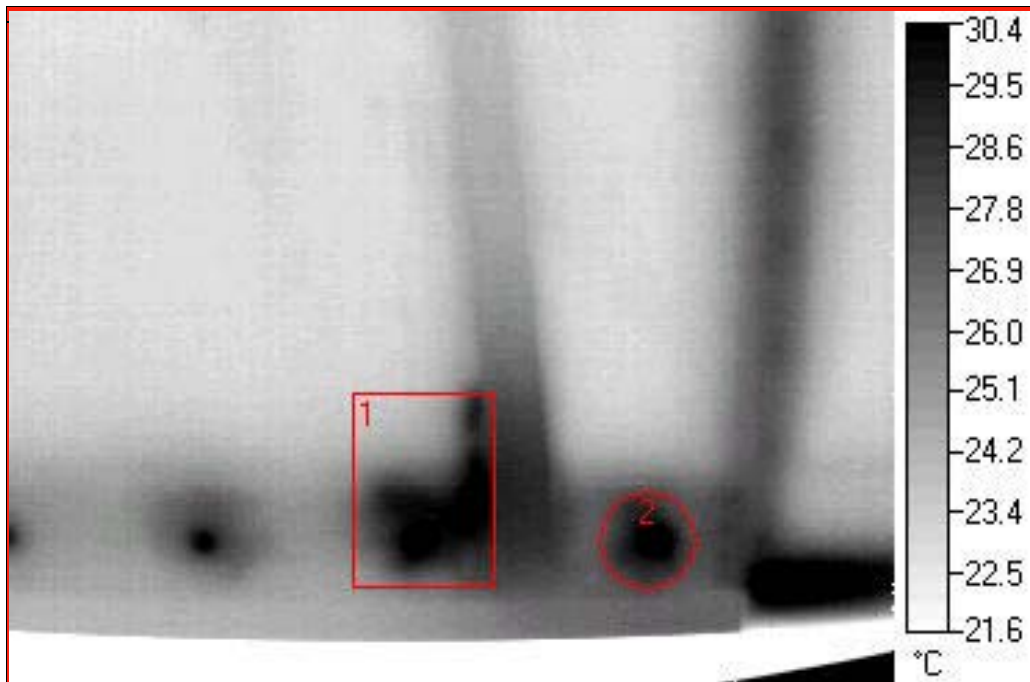
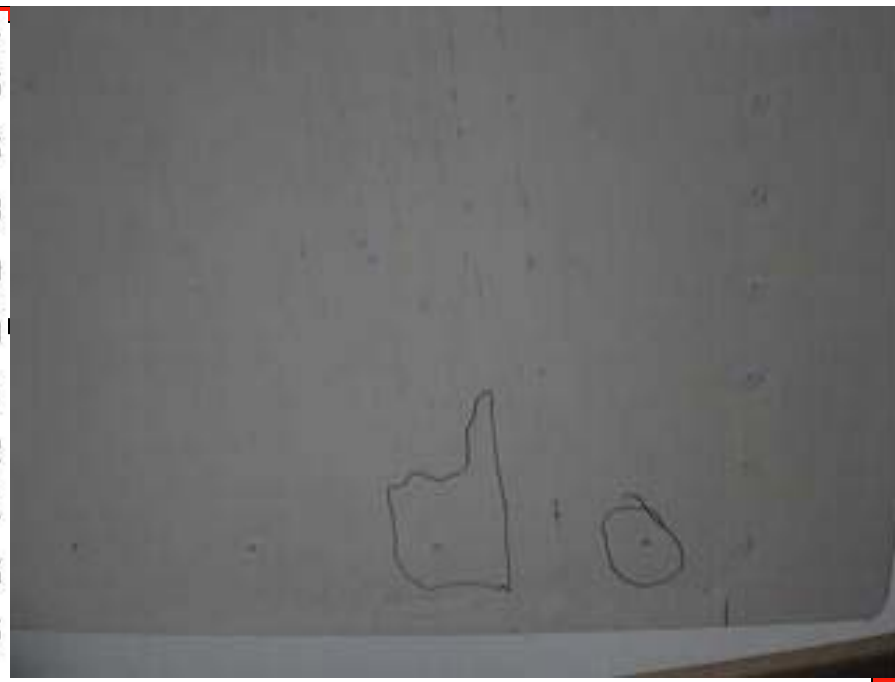
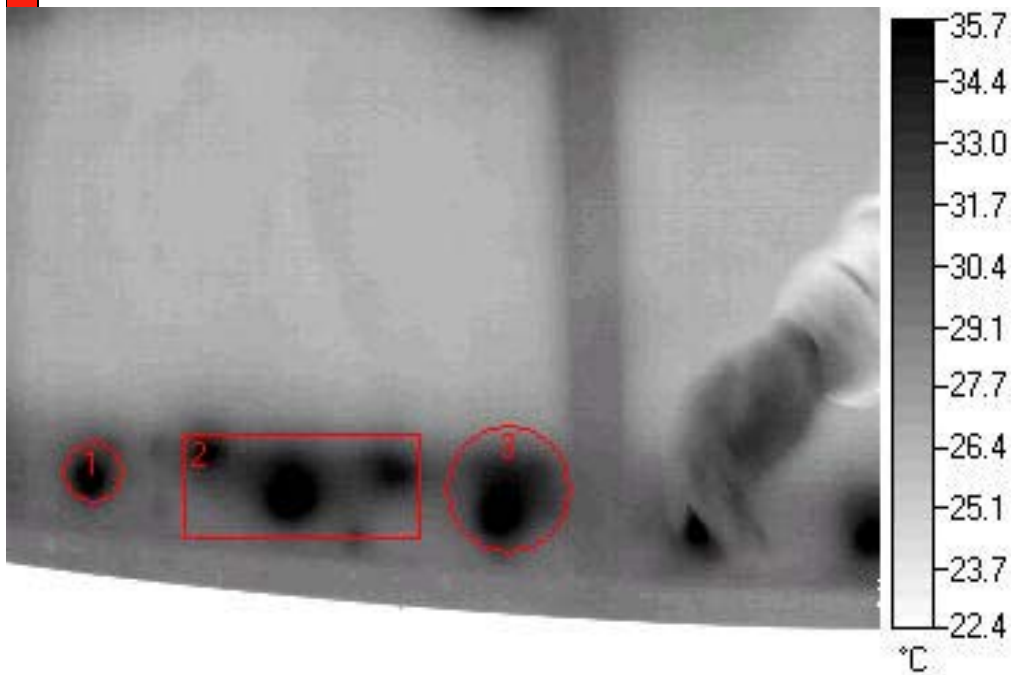
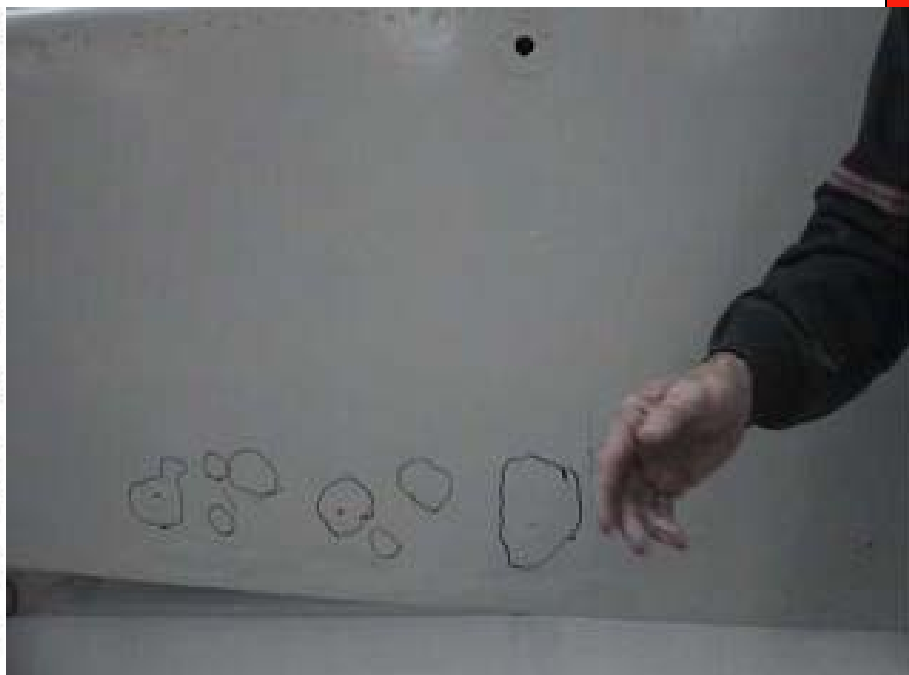
- Majority of moisture ingressions indications located around skin discontinuities
 - Trailing edge inserts
 - Holes in skin provide possible moisture ingression path
 - Electrical conductivity straps
 - Embedded in OML surface possibly distorting fiber alignment

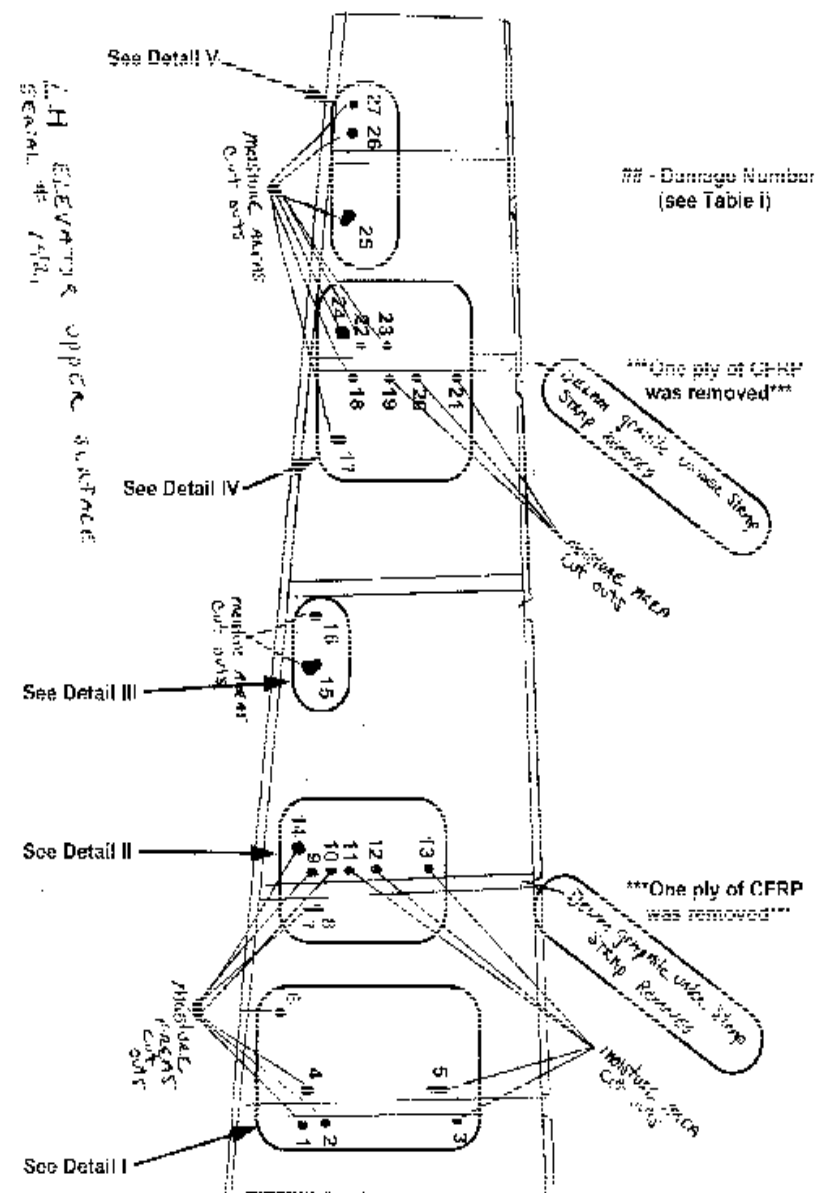
Figure 1

Damage Number	Damage Size
1	0.5" x 0.5"
2	0.5" x 0.5"
3	0.5" x 0.5"
4	0.5" x 0.5"
5	0.5" x 1.625"
6	1.0" x 1.0"
7/8	0.5" x 2.0"
9	0.5" x 0.5"
10	0.5" x 0.5"
11	0.5" x 0.5"
12	0.5" x 0.5"
13	0.5" x 0.5"
14	1.0" x 1.0"
15	2.5" x 3.5"
16	1.0" x 1.0"
17	1.0" x 1.625"
18	0.5" x 0.5"
19	0.5" x 0.5"
20	0.5" x 0.5"
21	0.5" x 0.5"
22	0.5" x 0.5"
23	0.5" x 0.5"
24	1.0" x 1.0"
25	3" x 2.5"
26	1.0" x 1.0"
27	0.5" x 0.5"

1. Gain access as required.
2. Repair each damage in group of damage as follows:
 - a) Damage #1 & #2: Perform a combined cosmetic repair according to A320 SRM 55-21-11 (C1) Figure 204 (sheet 2) and Figure 205 (sheet 4).

- b) Damage #3: Perform a cosmetic repair according to A320 SRM 55-21-11 (C1) Figure 204 (sheet 2).
 - c) Damage #4: Perform a cosmetic repair according to A320 SRM 55-21-11 (C1) Figure 204 (sheet 2).

- d) Damage #5: Perform a cosmetic repair according to A320 SRM 55-21-11 (C1) Figure 204 (sheet 2).
 - e) Damage #6: Perform a cosmetic repair according to A320 SRM 55-21-11 (C1) Figure 204 (sheet 2).

- g) Damage #15 & #17: Perform a combined cosmetic repair according to A320 SRM 55-21-11 (C1) Figure 204 (sheet 2) and Figure 205 (sheet 4).
 - h) Damage #17: Perform a cosmetic repair according to A320 SRM 55-21-11 (C1) Figure 204 (sheet 2).

- j) Damage #25: Perform a cosmetic repair according to A320 SRM 55-21-11 (C1) Figure 204 (sheet 2).
 - k) Damage #26 & #27: Perform a combined cosmetic repair according to A320 SRM 55-21-11 (C1) Figure 204 (sheet 2) and Figure 205 (sheet 4).

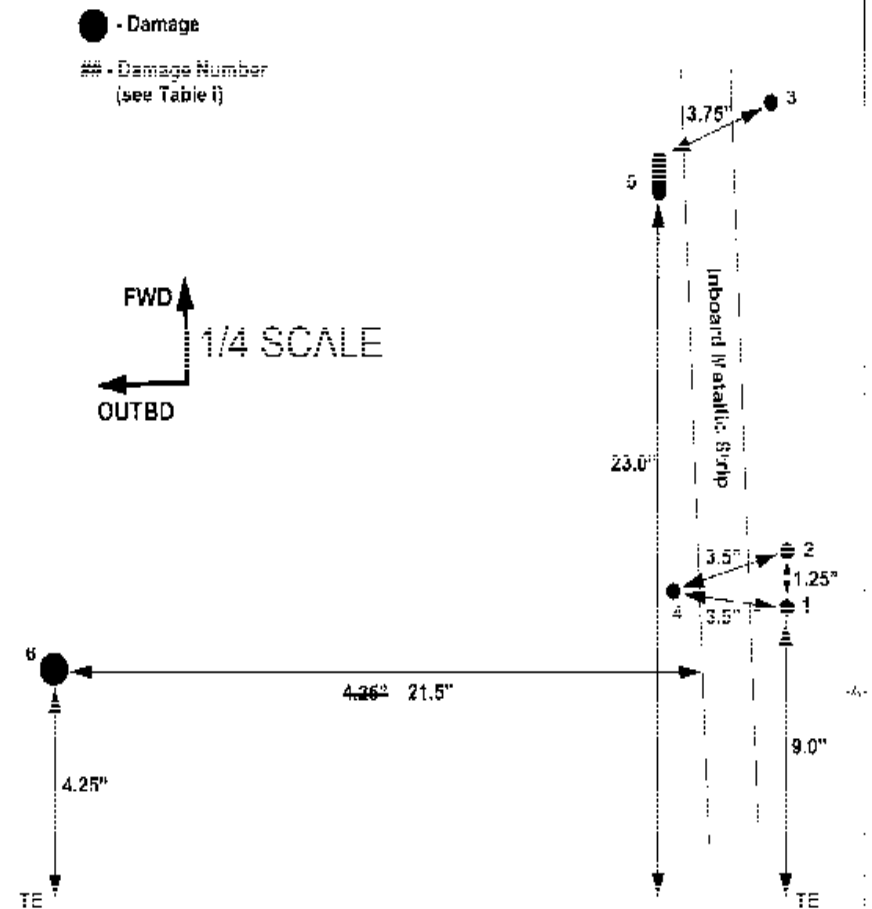
Figure 1
Detail I

- c) Detail I also has a mistake. Damage 6 of this area is being 7.1" westward from the metallic strip (vs. 4.25"). It is still 4.25" forward of the trailing edge. This information will also be corrected in the new revision of this EA.

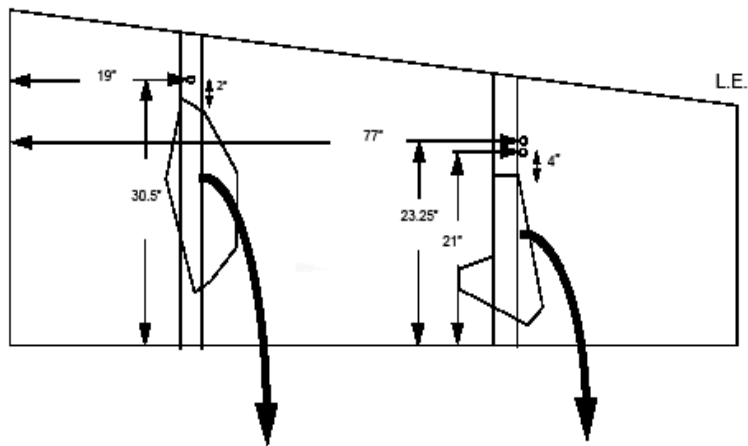
SEE DETAIL A

SEE DETAIL B

AREA OF DETAIL A 63 sqin

AREA OF DETAIL B 40 sqin
