# Rudder structural investigations

Relevant to rudders CFRP rudder PN A55471500 series

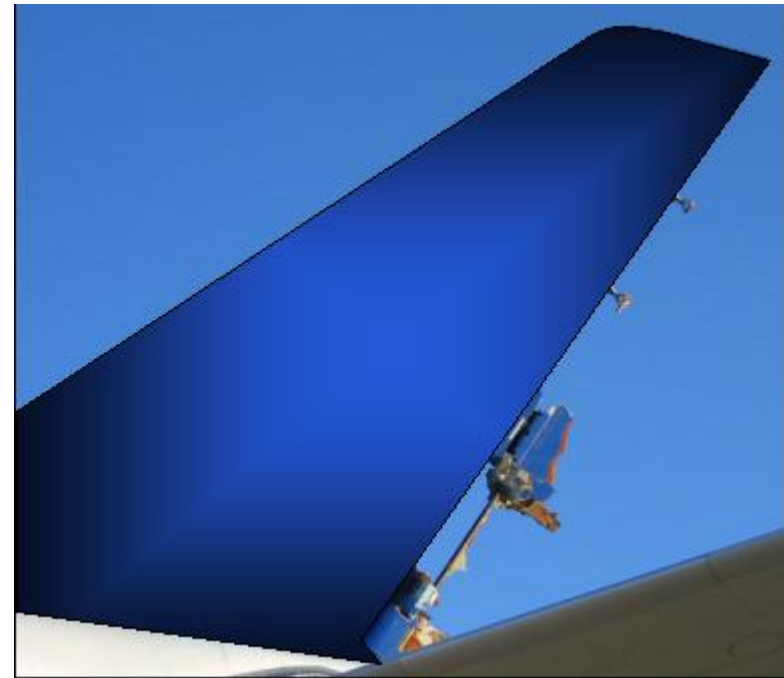
- March 2005
- Normal flight until the aircraft reached FL350
- Sudden vibrations and loud noise
- The aircraft entered a Dutch roll that decreased and eventually ceased when descending
- On ground, major part of the rudder had departed the aircraft

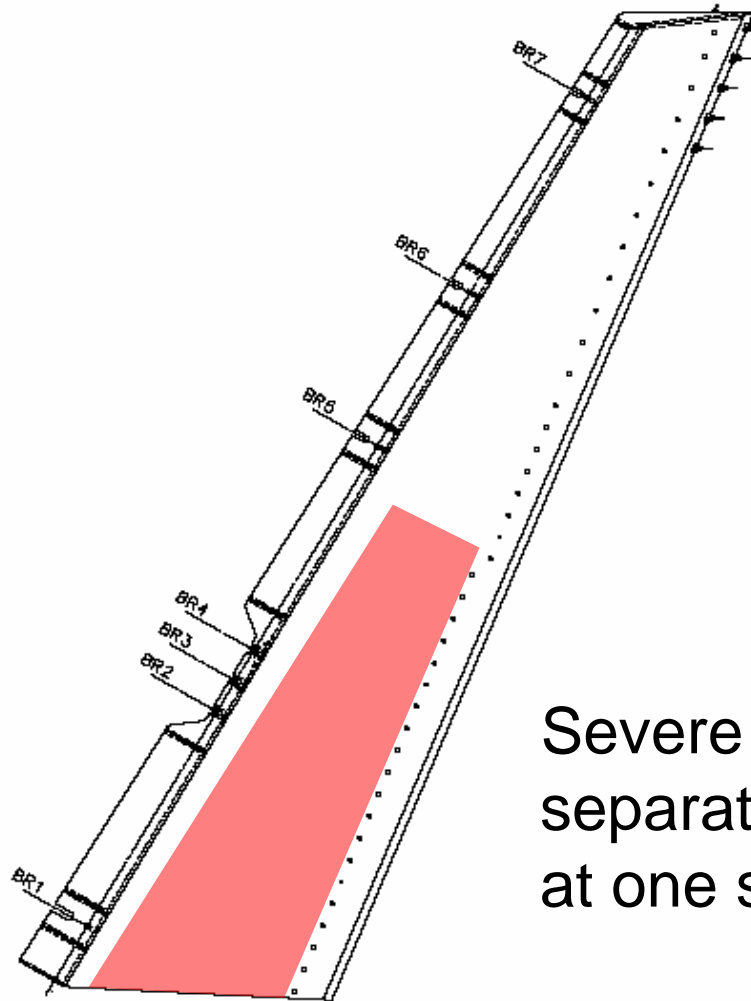
- Flight data recordings evidenced a dynamic event prior to rudder separation
- It appeared to be a “flutter like” phenomenon
- However, **aircraft is flutter free**
- The rudder would not enter into flutter without a severe pre-damage condition

Severe face sheet separation from core at one side panel

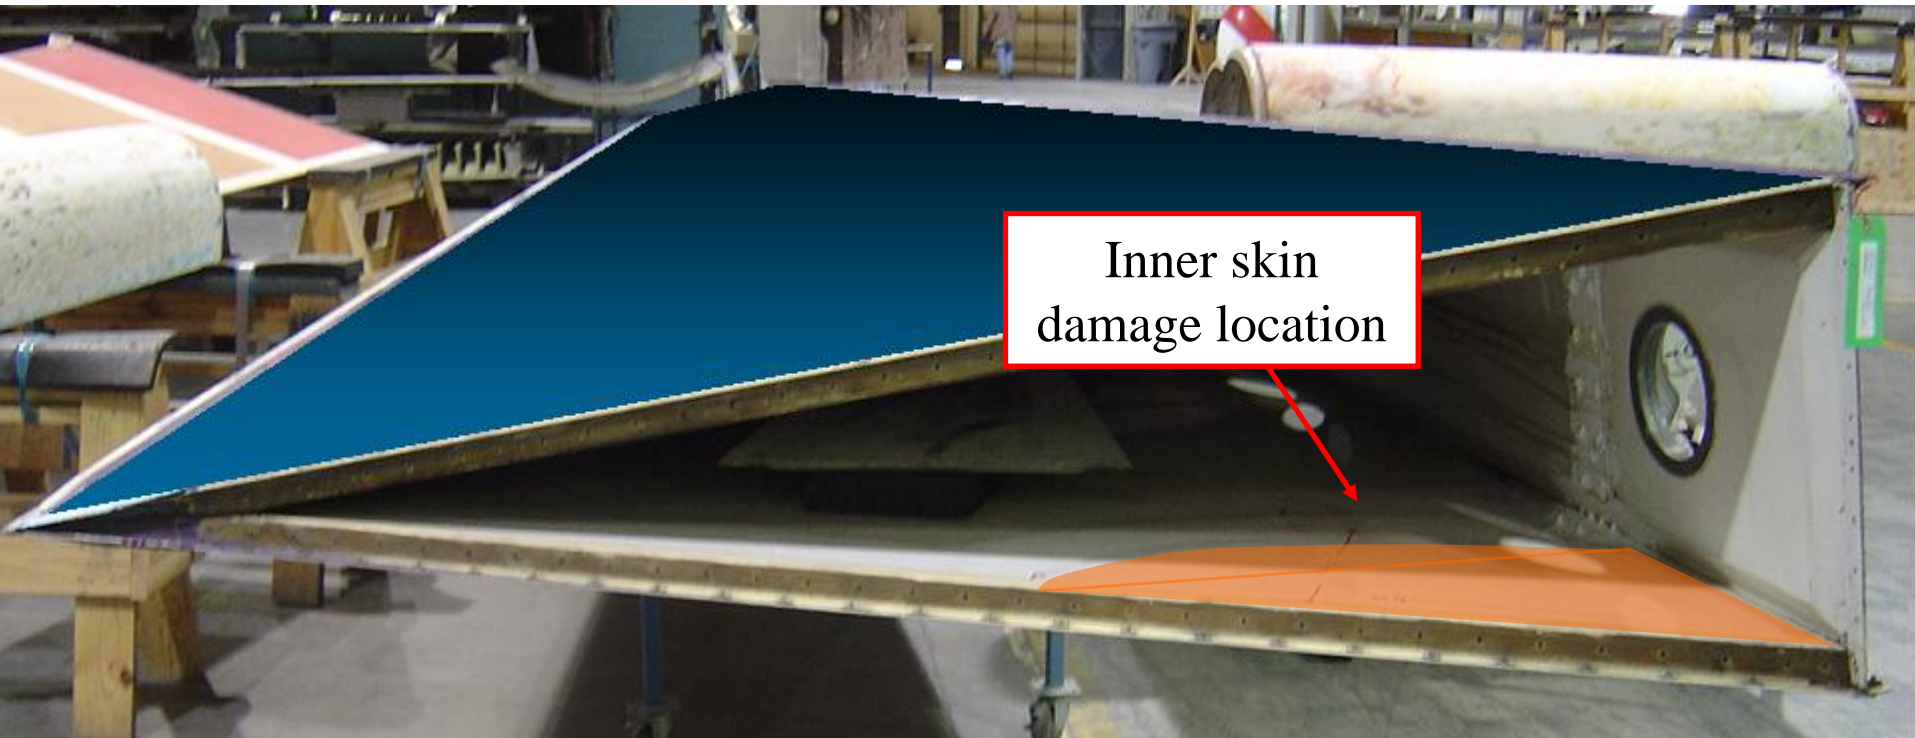
- December 2005
- Lower rib was removed for maintenance
- Inner skin to core disbond was detected

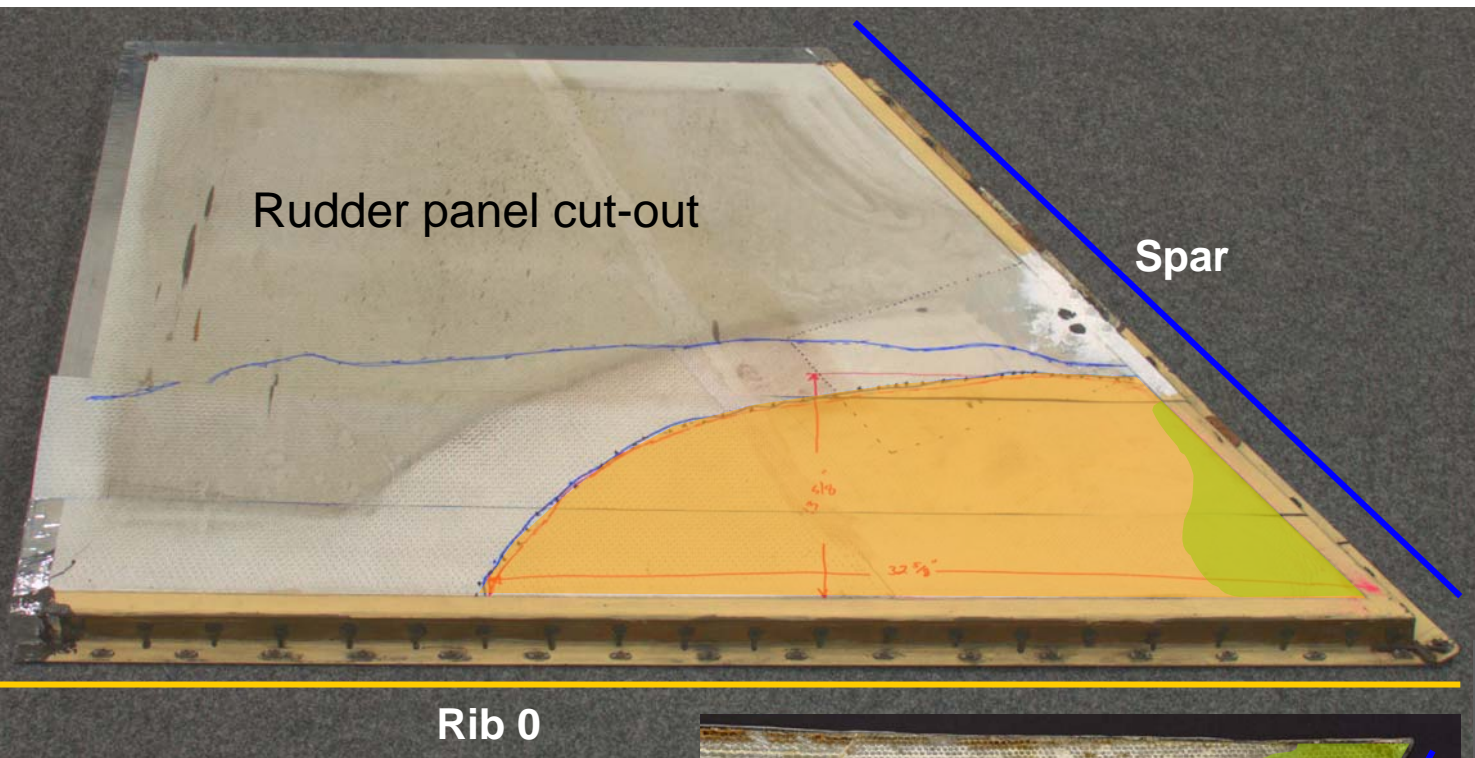
## Hydraulic fluid contamination at inner face

Inner skin flipped after removal

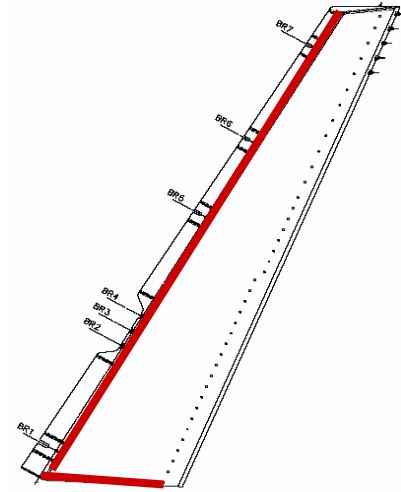
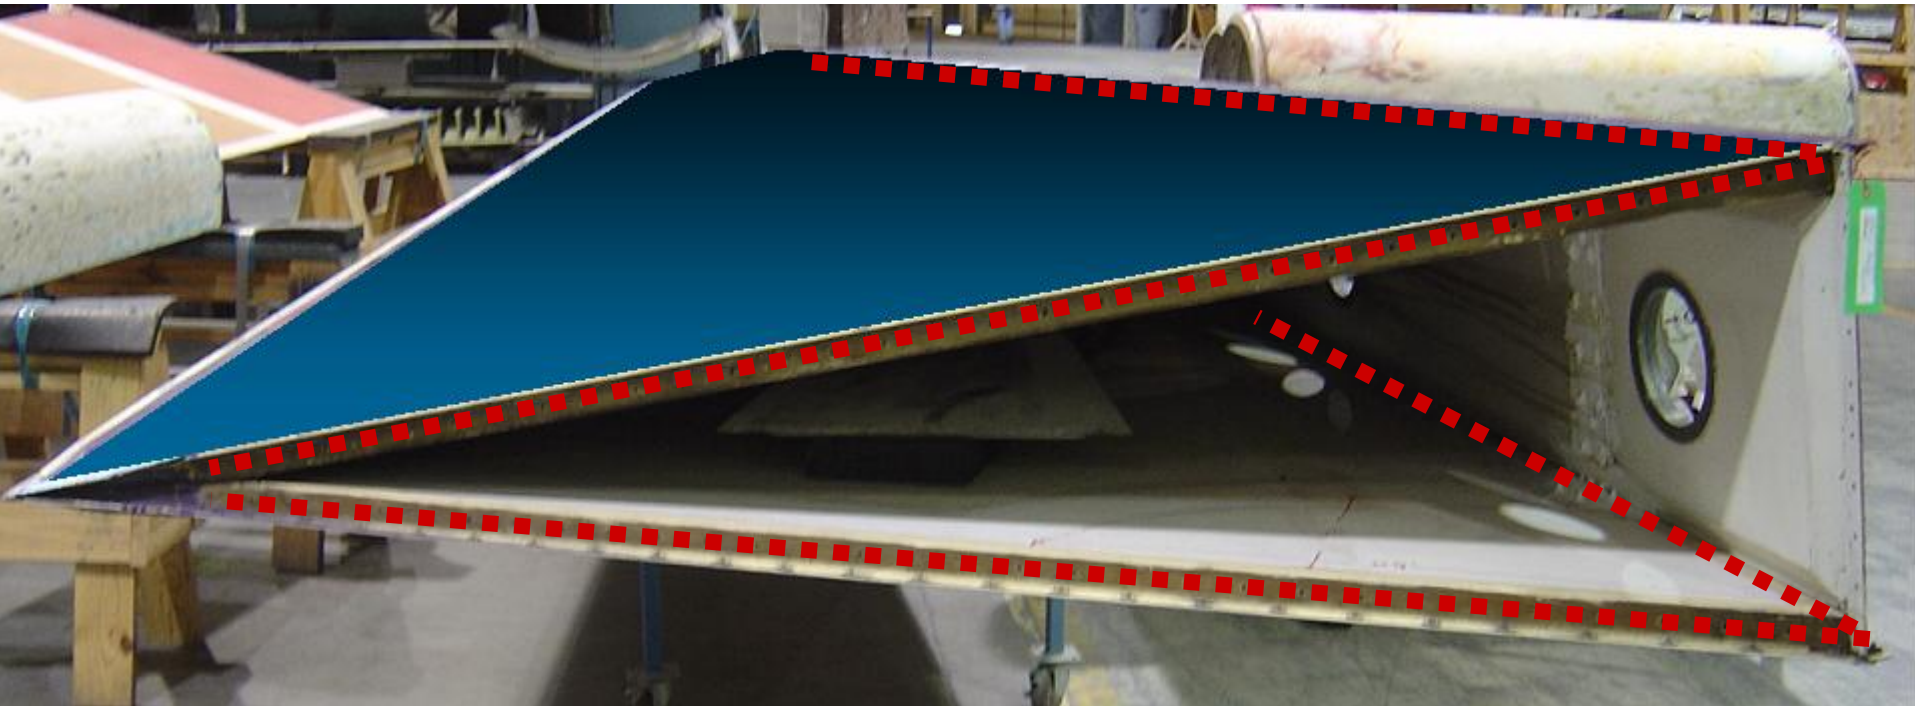
- Z-profile is fitted on panel edges
  - ▶ at connection to the spar
  - ▶ at connection to the rib 0

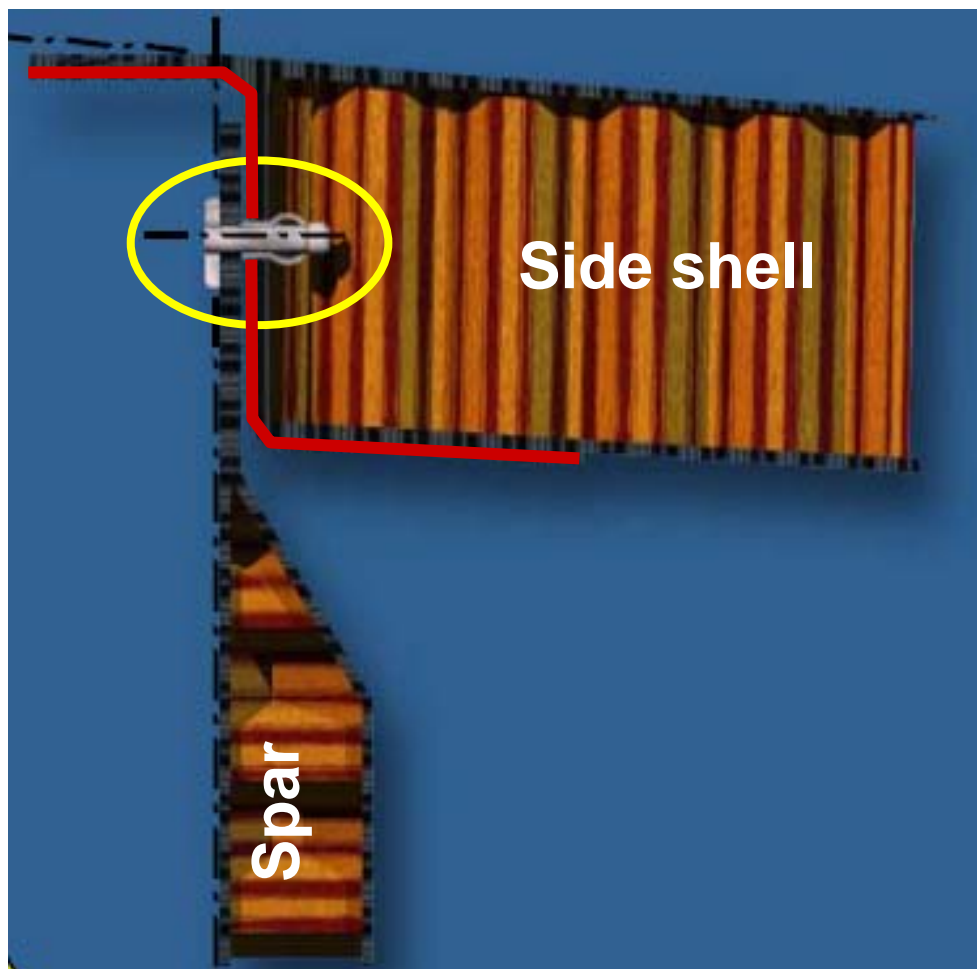
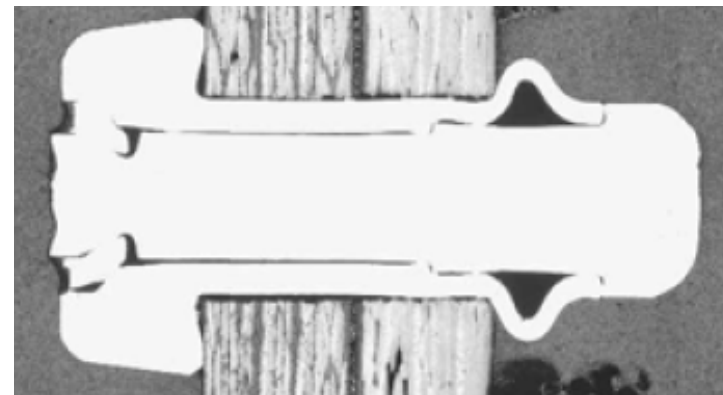
- Blind rivets used for spar to shell connection
- Hydraulic fluid had penetrated past some rivets

Section cut of blind rivet

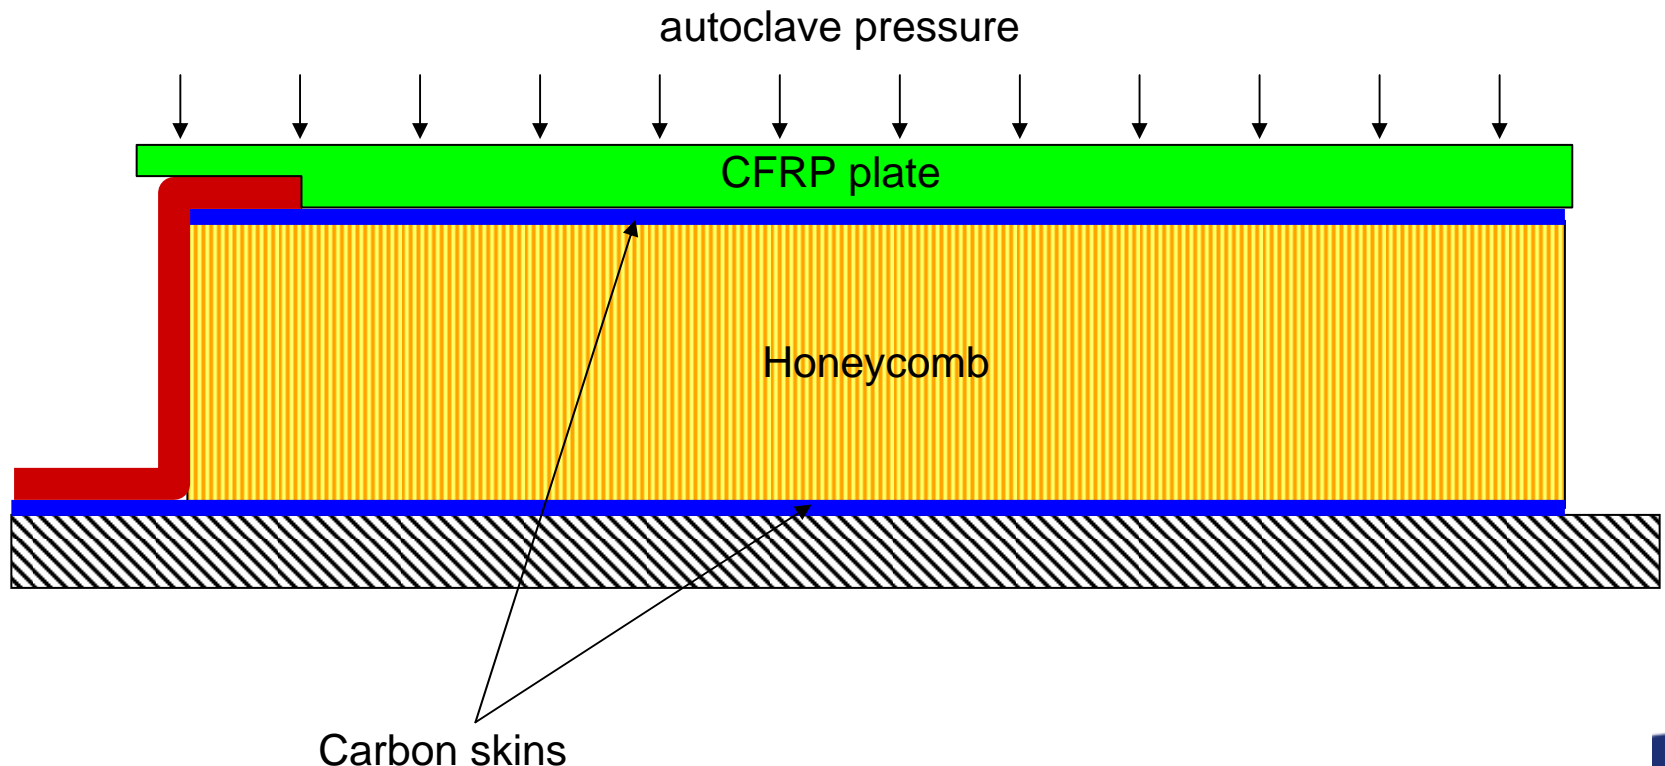
- CFRP plate is designed to compensate for Z-profile thickness
  - ▶ No gap between plate and inner skin

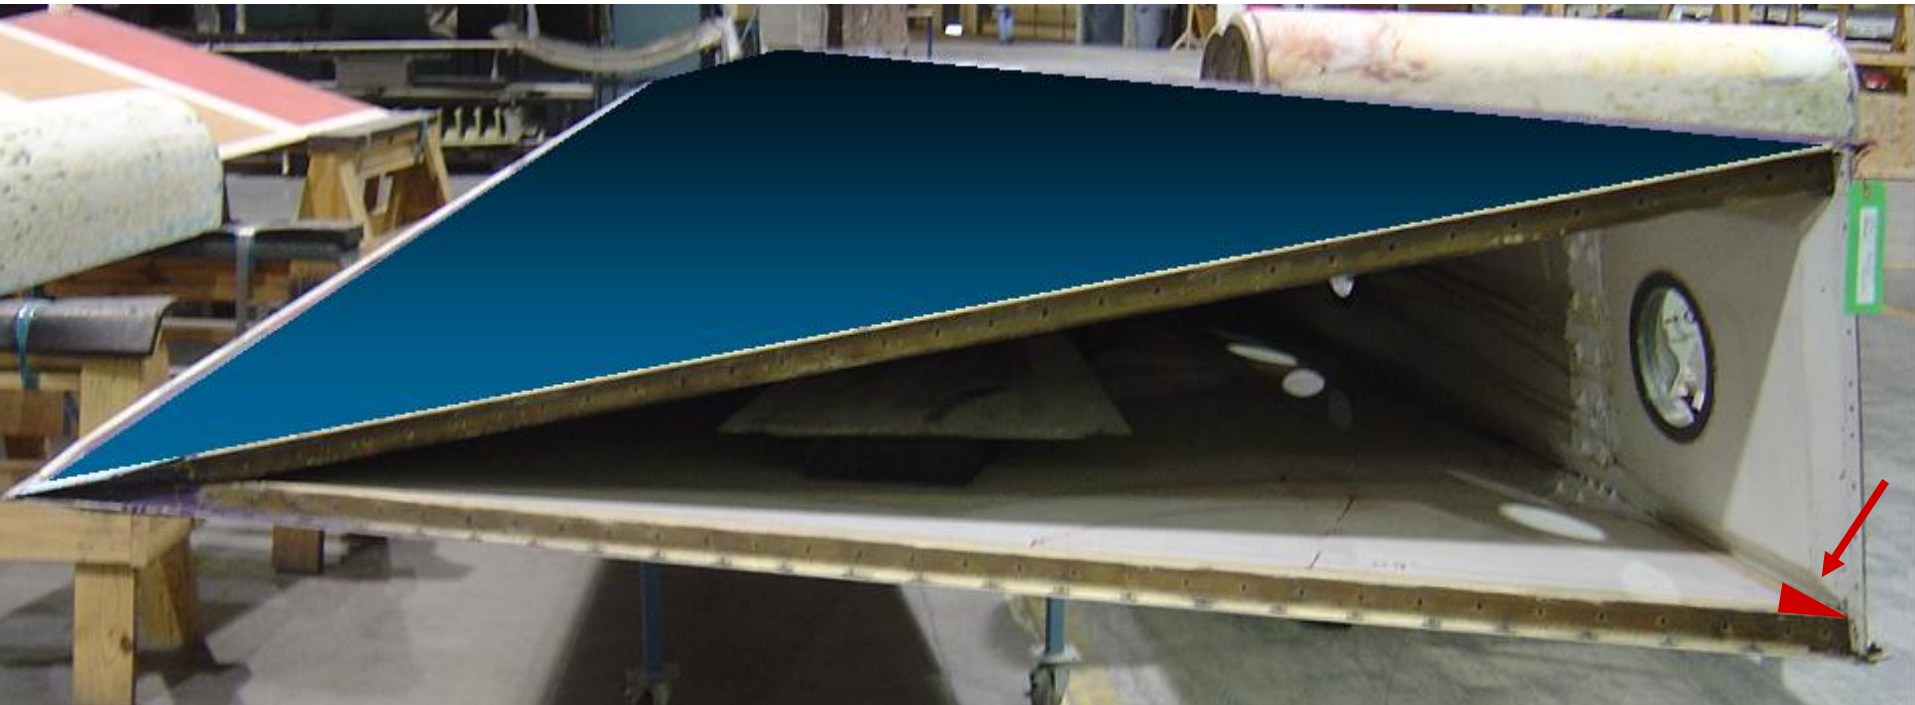
- Tolerances review has indicated that CFRP plate cut-out did not totally compensate higher tolerance Z-profile thickness
- In addition, CFRP plate did not compensate over-thickness at Z-profiles junction, where additional carbon plies are fitted

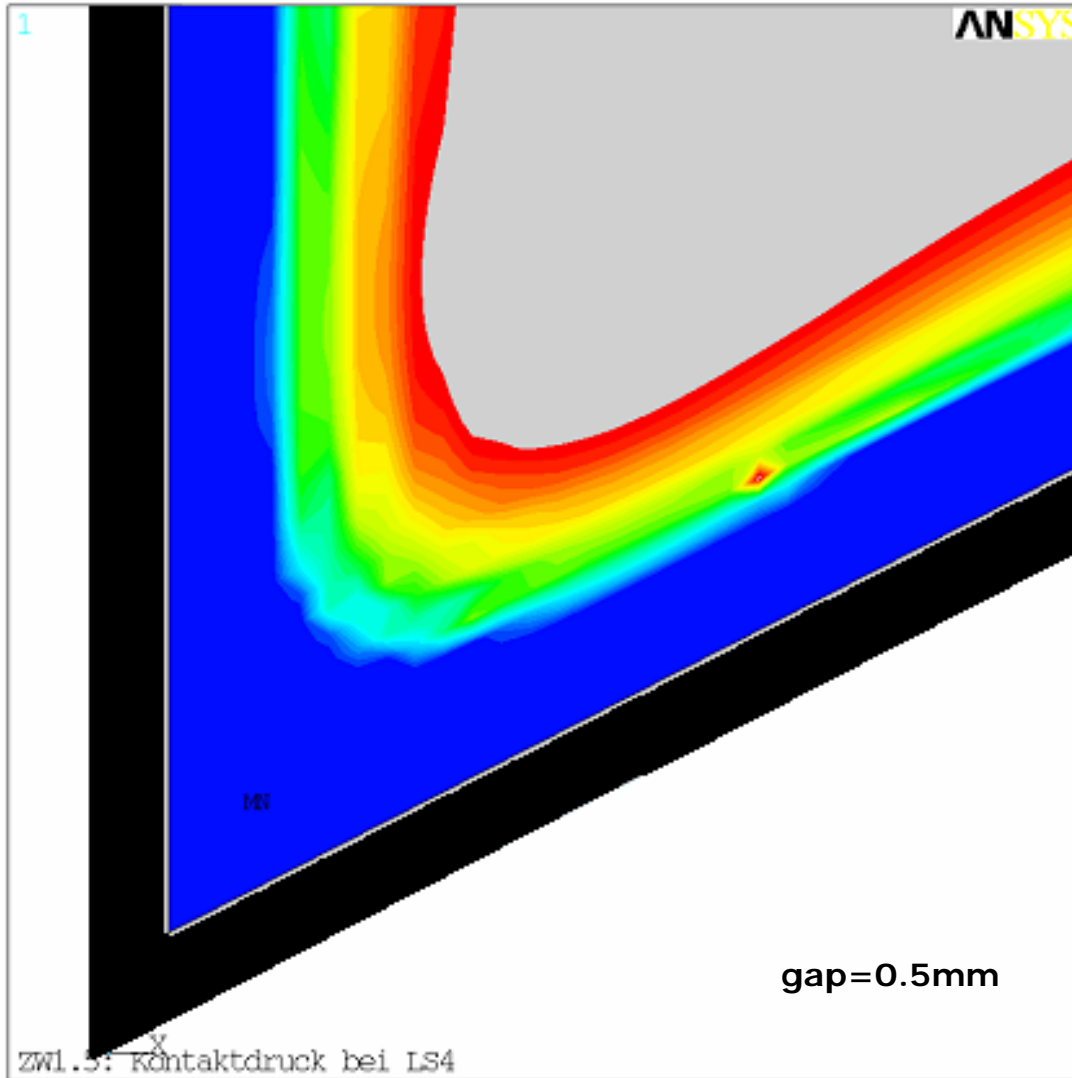
Blue area  
=  
zero pressure

Red area  
=  
nominal pressure

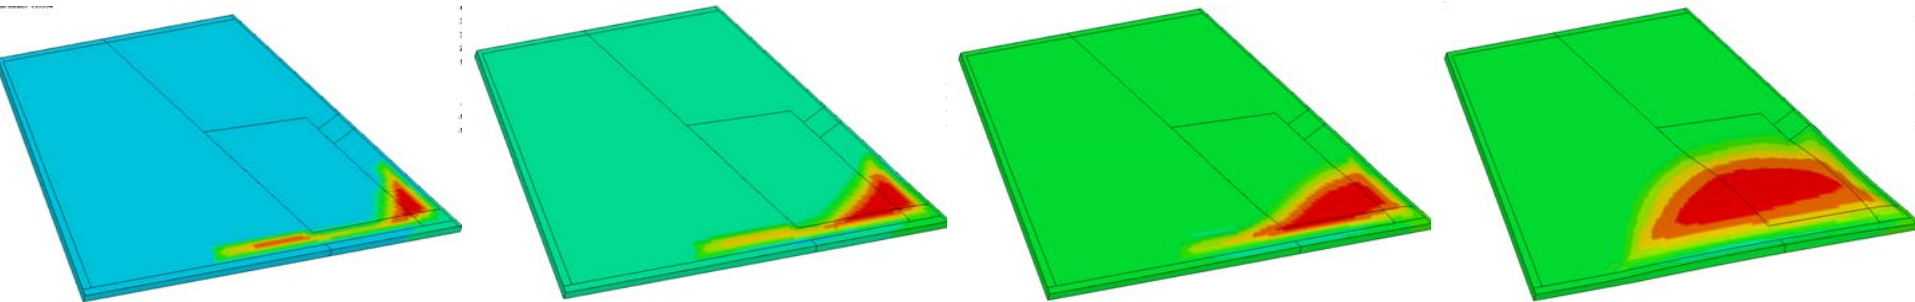
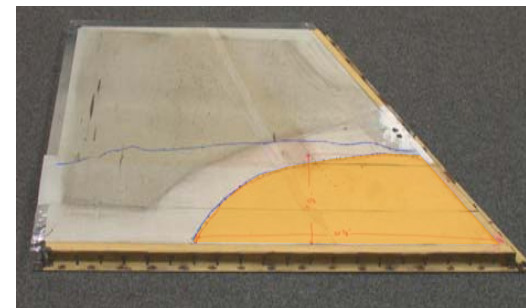
- Rudder damage was accurately reproduced making the hypotheses of an initial disbond :
  - ▶ at the additional carbon plies area
  - ▶ along the lower spar and front rib 0 Z-profile

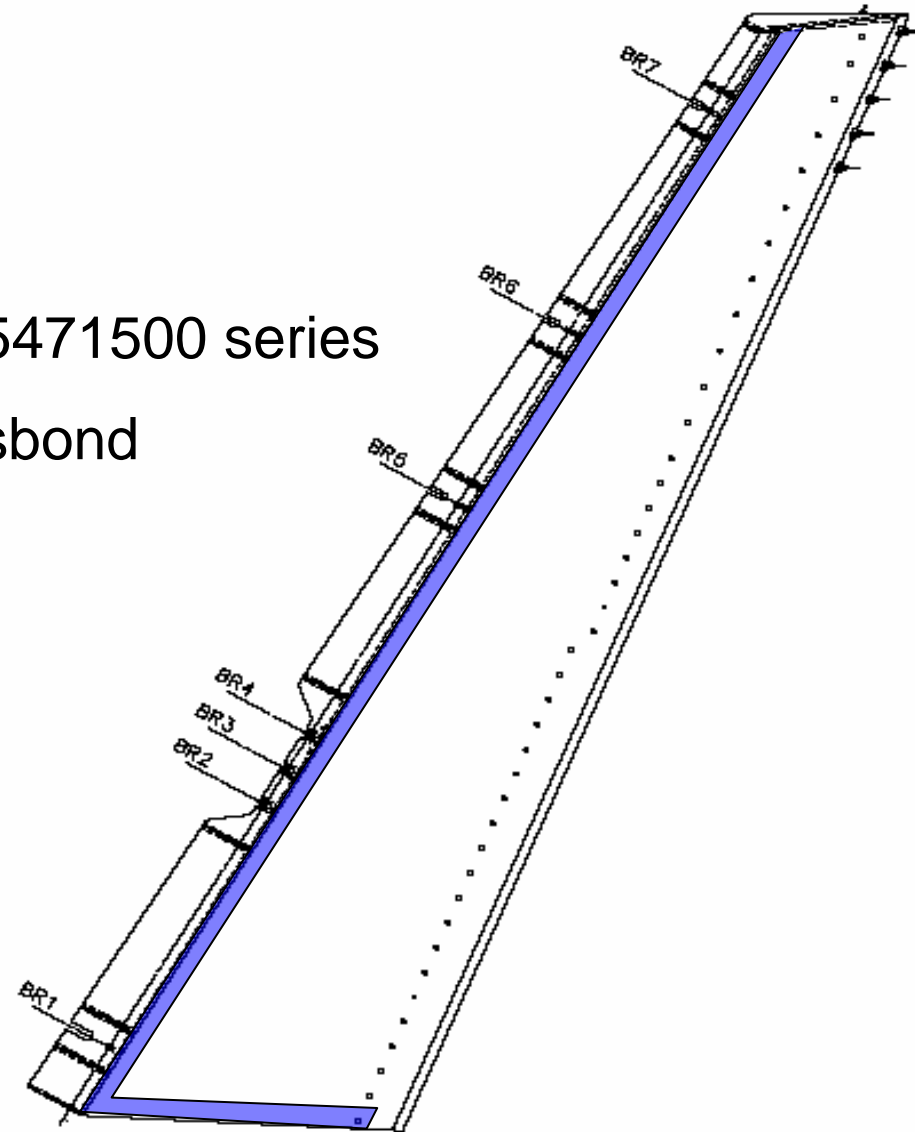
- Inspection of rudders
  - ▶ Rudders CFRP rudder PN A55471500 series
  - ▶ Repetitive inspection for no disbond initiation adjacent to Z-profile
  - ▶ To be launched in mid-2007

- UT at first
- Damage confirmation involves thermography or X-ray
  - ▶ To identify nature and actual size of indication
  - ▶ To exclude spurious findings from indications  
(e.g. filler, repairs etc)
- Grace period for repair function of severity
- No damage allowed in the long term
- All repairs upon Airbus instructions
