Overview of Structural Behavior and Occupant Responses from a Crash Test of a Composite Airplane

Lisa E. Jones and Huey D. Carden
NASA Langley Research Center

**General, Corporate and Regional
Aviation Meeting and Exposition
Wichita, Kansas
May 3-5, 1995**

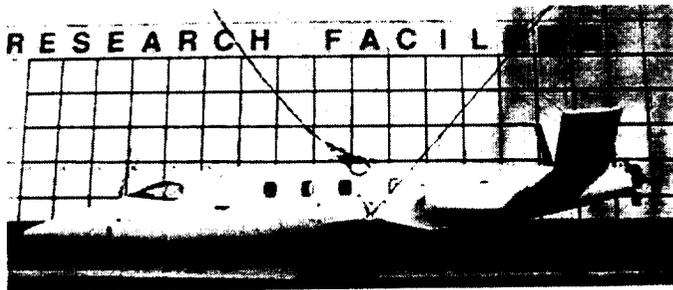
Figure 3. The test specimen.

The fuselages acquired by NASA Langley Research Center were non-flying, ground test structures. Avionics, seats, engines, propellers, tails, and landing gear were not included. Consequently, a plywood dash board was constructed in the cockpit, seats were installed, weights were added to simulate the engines masses and propeller, and a tail was added to the test vehicle. Landing gear, without hydraulic systems or operating linkages, were installed for ease of handling as well as for ballast weight. The fuel cells were filled with water to simulate the fuel mass. Interior and exterior surfaces of the airplane were painted to enhance photographic contrast. A plywood bulkhead wall was installed in front of the most rearward pair of seats to accommodate the installation of the airbag experiment. A photograph of the test aircraft is shown in Figure 3. The final ballasted weight of the test vehicle was 6989 lbs.

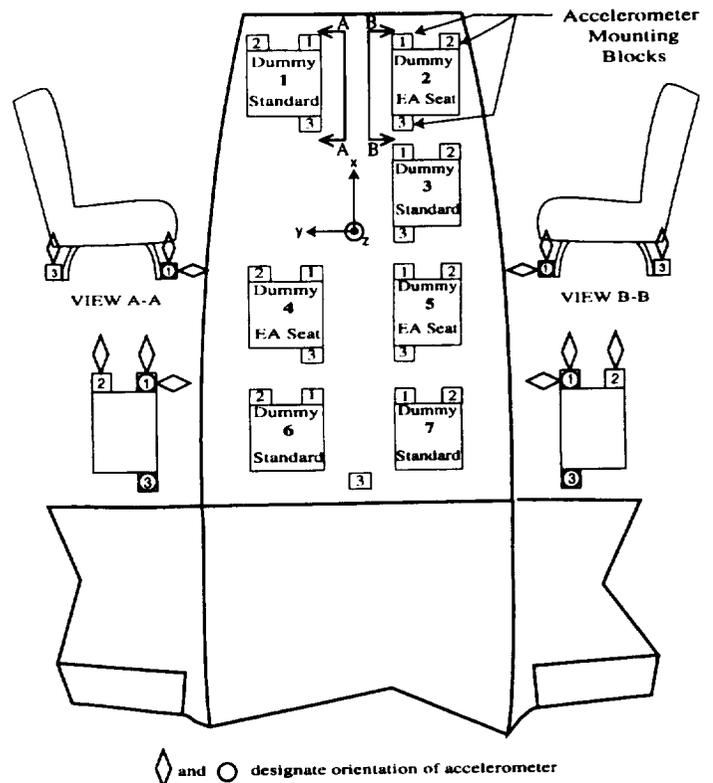
Figure 4. Seating and instrumentation.

(a) Schematic of seat locations and onboard accelerometer locations and orientations.

The seating layout is shown in Figure 4(a). Unlike the original design (Reference 3), all seats were forward facing. Only seven seats were installed to provide room for onboard instrumentation and easier access. Note that each seat is numbered and henceforth the occupants will be referred to by the seat number assigned. For example, the pilot position is the number 1 occupant seat, copilot position is the number 2 occupant seat, and so on. Seats 1, 3, 6 and 7 were standard 9 g aircraft seats equipped with a lap belt only. Seat 2 was an energy absorbing seat that is currently installed in aircraft that fly into unprepared landing strips. The front legs of this seat are bent into an "S" shape and the back legs are slanted rearward to provide improved energy absorption due to bending. Seat 2 was equipped with a lap belt and shoulder harness. Photographs of a standard seat and certified seat are shown in Figure 4(b). Seats 4 and 5 were seats provided by a university and are being developed through a grant with the Federal Aviation Administration (FAA). Seats 4 and 5 are designed to satisfy a proposed FAA dynamic crash test requirement. The seats were equipped with lap belts and shoulder harnesses and the design incorporates energy absorbing devices in the cushion and the chair legs. Additional information on the designs of seats 4 and 5 is given in Reference 4.

The reference orientation axes and aircraft seat-rail mounted accelerometer locations are shown in Figure 4. X is defined as the longitudinal direction, Y is the lateral direction, and Z is the vertical axis. In addition to the accelerometers mounted on the aircraft, occupants 1,2,4,5,6 and 7 (50 percentile Hybrid II anthropomorphic dummies) were equipped with a lumbar load cell and accelerometers in the head, chest, and pelvis. The orientations of the instrumentation are given in the dummy's body-axis system

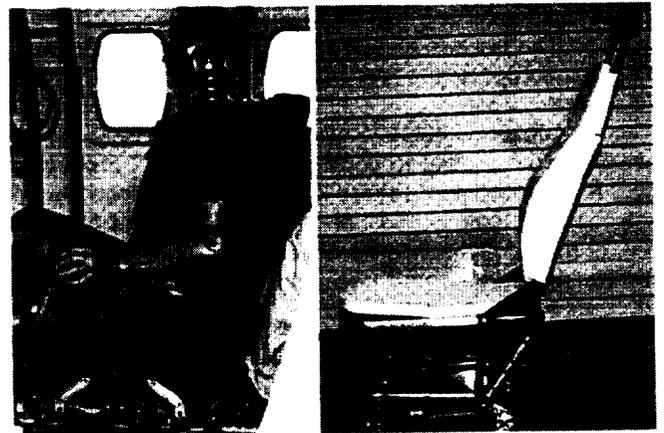
Figure 4. Concluded.

(b) Standard aircraft seat (left) and certified energy absorbing seat (right).

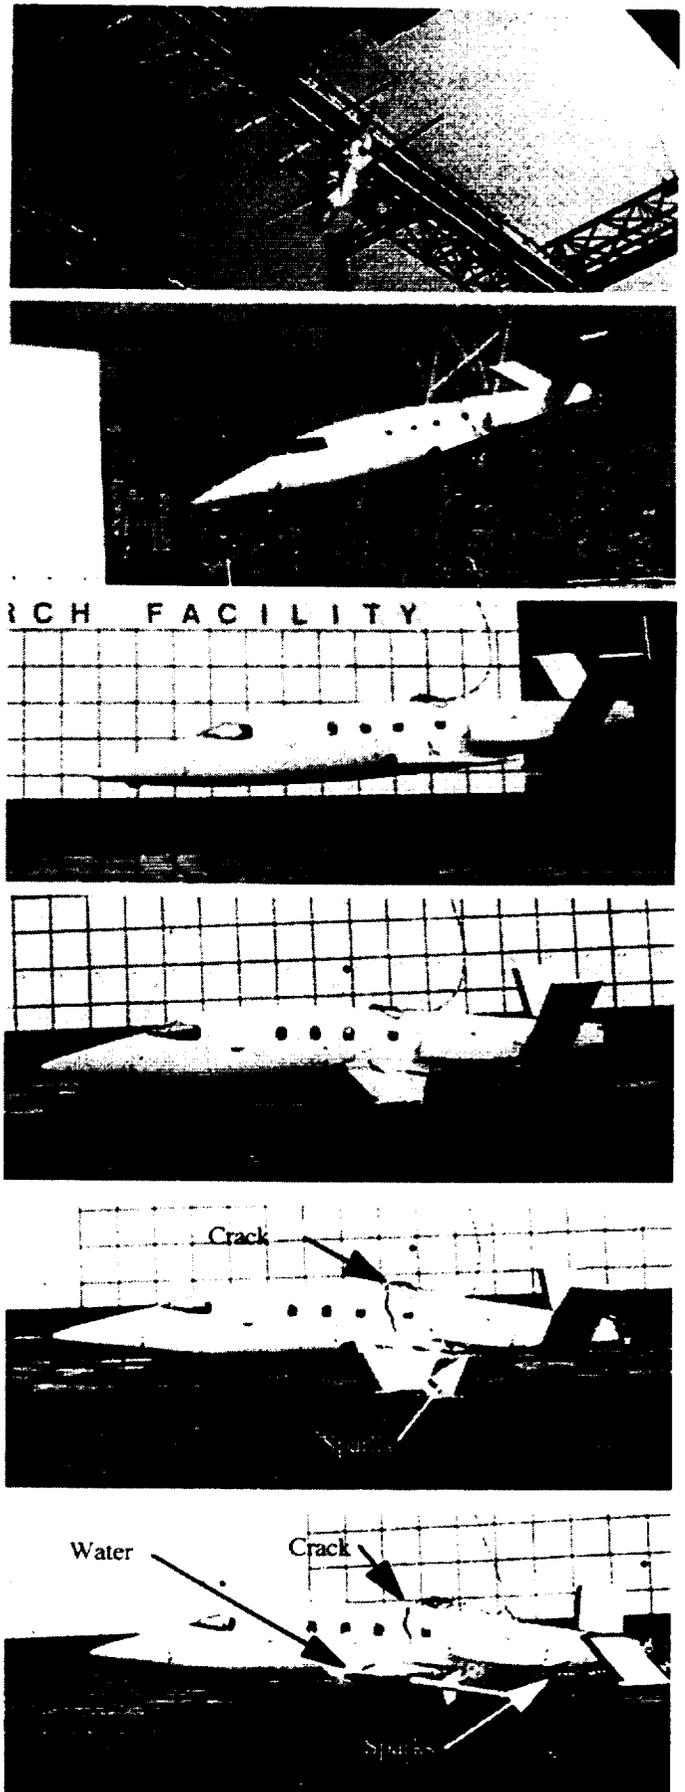
Figure 5. Crash sequence photographs.

A series of photographs illustrating the crash sequence is shown in Figure 5. The photographs show the motion from the pull-back position through the slide-out after impact. In the last two photographs, a crack is visible running

from the crown of the fuselage down to the wing. Sparks created by metal bolts contacting the concrete impact surface are noticeable just rearward of the wing. The bolts were used to secure a panel and were not added by NASA. Water-simulating fuel leaked from the wing after impact.

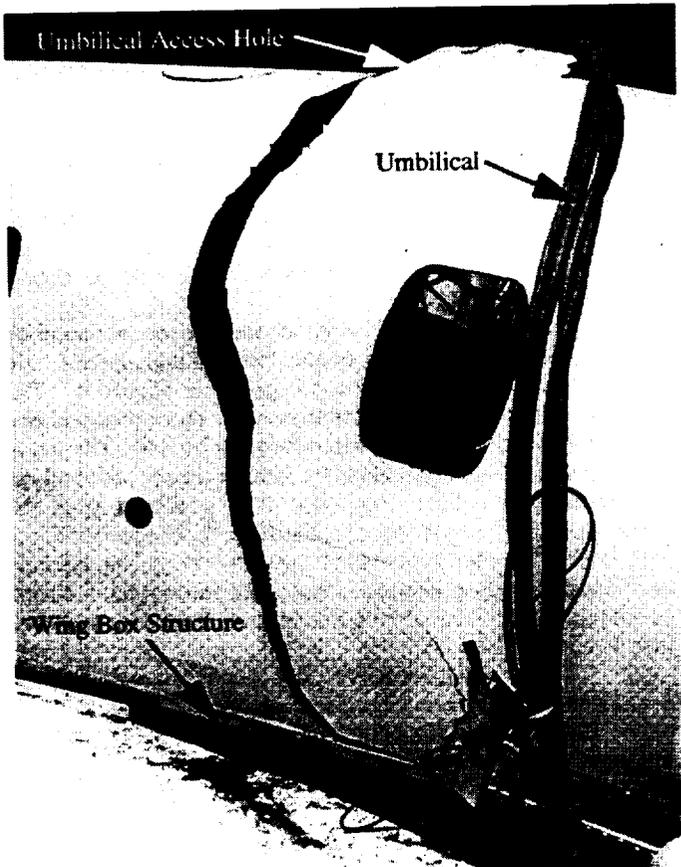
Figure 6. Photographs of exterior damage.

(a) Crack that initiated at the umbilical access hole.

VISUAL ASSESSMENT OF STRUCTURAL DAMAGE - Post-test detail photographs of the exterior and interior damage are shown in Figures 6 and 7. The circumferential crack running from the crown of the fuselage to the wing is shown in Figure 6(a). Examination of the high speed film confirms that the crack initiated at the umbilical access hole that was cut in the crown of the fuselage. A photograph of cracks around a window is shown in Figure 6(b). Note that three of the cracks originated at the corners of the window perhaps due to the stress concentrations at these locations. Similarly, cracks originating at the corners of the door opening were found. A photograph of the damage that occurred on the underside of the wing is shown in Figure 6(c). The water leakage that was shown in the crash sequence photographs was due to this damage.

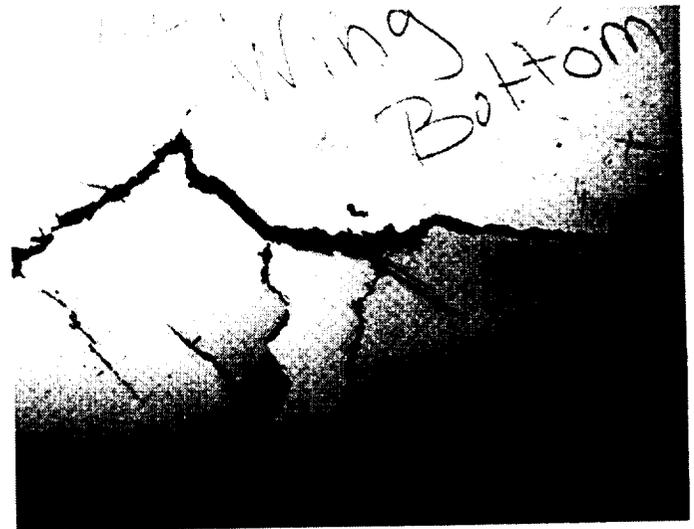
Figure 6. Concluded.

(c) Damage to bottom of left wing.

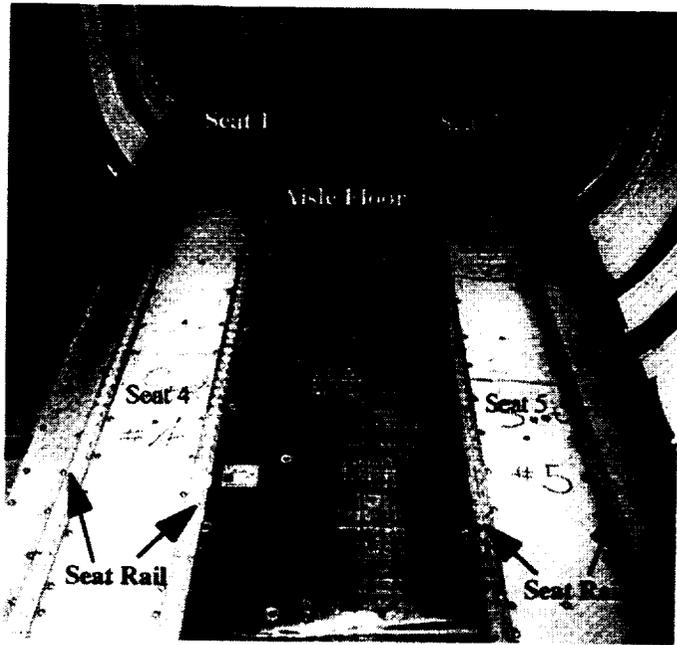
Figure 7. Post-test interior photographs.

(a) Interior with seats removed.

A post-test photograph of the interior of the aircraft with the seats removed is shown in Figure 7(a). Very little damage to the metal floor, seat rail track, or aisle floor covering is noticeable and the cabin volume was maintained. A photograph of the interior after all of the floor material was removed is shown in Figure 7(b). The frames failed along the center line of the aircraft and the same type of frame damage was found along the length of the aircraft. Details of this damage are shown in Figure 7(c). The frames appear to have failed in a brittle manner with little or no crushing or energy absorption. This failure is typical of the carbon fibre reinforced skin frame construction (Reference 5) used for the test vehicle.

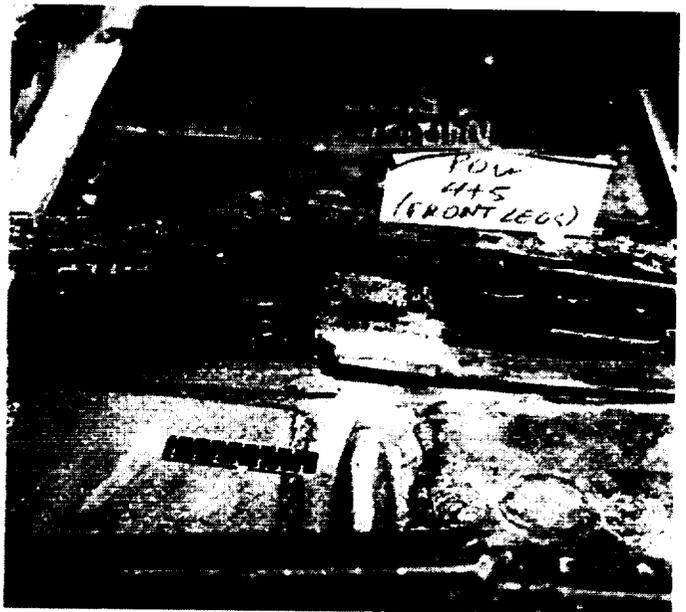
Figure 7. Concluded.

(c) Details of frame damage.

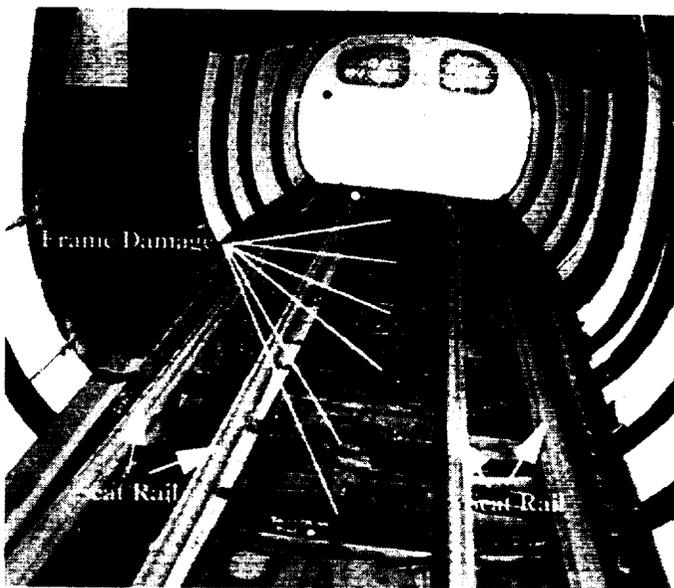
Figure 7. Continued.

(b) Interior with floor removed.

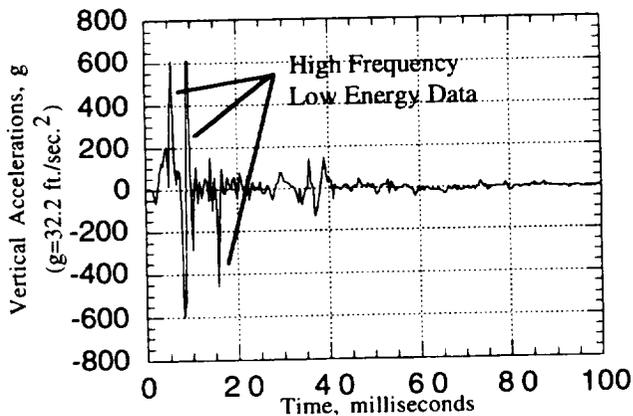
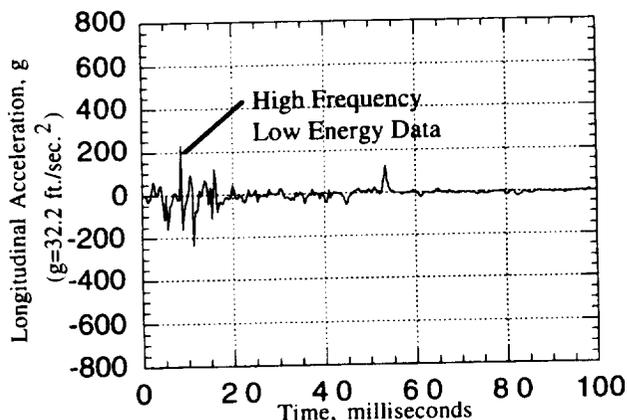
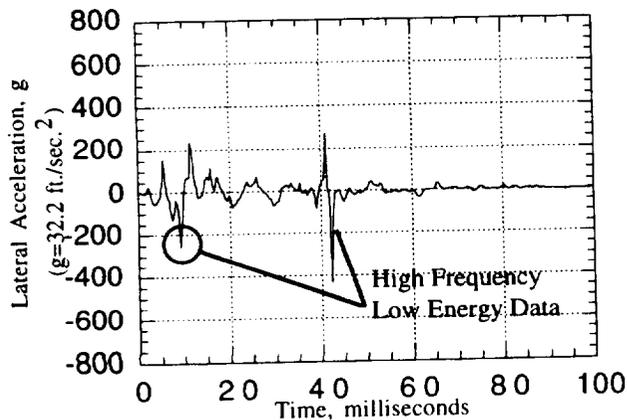
Figure 8. Typical seat rail accelerations.

(a) Vertical seat rail acceleration.

(b) Longitudinal seat rail acceleration.

(c) Lateral seat rail acceleration.

CRASH PULSES - The data presented in this section are typical of the data acquired throughout the aircraft. The high g, high frequency data spikes associated with local structural responses are low energy and considered insignificant when compared with the overall response. Examples of these high frequency signals are noted in Figure 8.

Data were recorded from accelerometers mounted on the seat rail. Typical plots of the longitudinal, lateral, and vertical seat rail accelerations are given in Figure 8. The vertical accelerations were more than twice those recorded in a similar test of an all-metallic aircraft (Reference 6). The initial vertical pulse lasted approximately seven milliseconds and the maximum acceleration exceeded 200 g where g is the acceleration due to gravity (32.2 ft./sec.²). The longitudinal and lateral accelerations were not as severe as vertical accelerations. For example, the longitudinal and lateral accelerations did exceed -50 g but the time durations were less than 3 milliseconds.

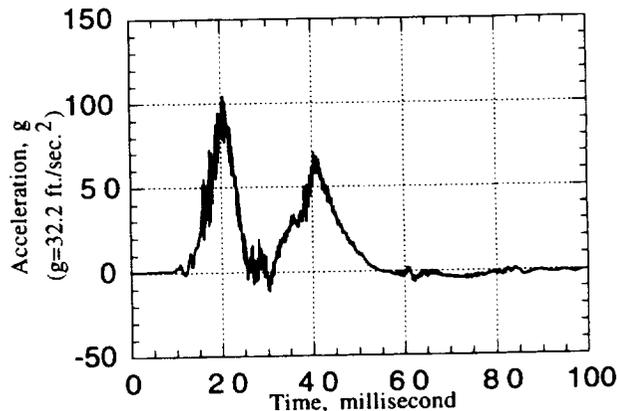
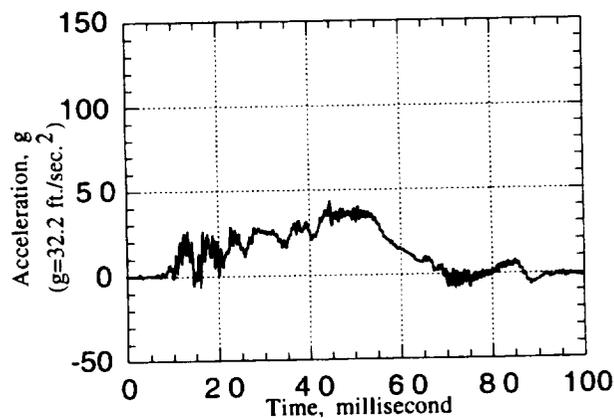
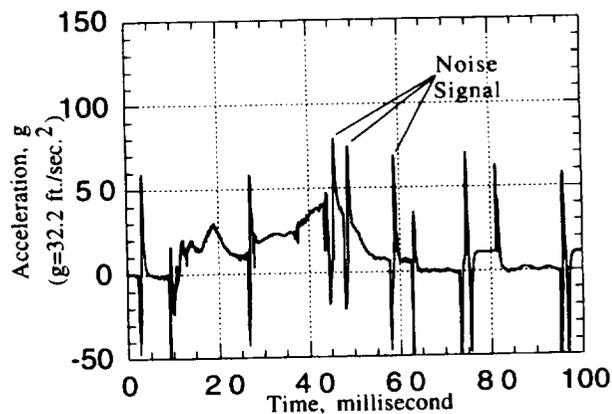
Figure 9. Typical vertical pelvis accelerations.

(a) Vertical pelvis acceleration for No. 1 occupant in standard seat.

(b) Vertical pelvis acceleration for No. 2 occupant in energy absorbing seat.

(c) Vertical pelvis acceleration for No. 5 occupant in a developmental energy absorbing seat.

Typical accelerations and lumbar loads for the occupants are shown in Figures 9, 10, and 11. The vertical pelvis accelerations for occupants 1, 2, and 5 are given in Figure 9(a), 9(b) and 9(c) respectively. Occupant 1 was seated in a standard aircraft seat and occupants 2 and 5 were seated in energy absorbing (EA) seats. The maximum vertical accelerations for the energy absorbing seats are less than half that of the standard seat. The maximum acceleration for the standard seat occupant was 90 g. Occupants 2 and 5 each had a maximum acceleration of 40 g. The acceleration data from the developmental seat were disrupted by an intermittent noise signal, but the data trace characteristics are clear.

The trends in the pelvis vertical and longitudinal acceleration data are representative of the chest and head acceleration data. In general, the occupants in the EA seats had lower maximum accelerations. Only two channels of occupant lateral accelerations were recorded (See Table I). Because of the no-roll, no-yaw conditions of the test and limits on the number of channels available, the lateral accelerations were not recorded and will not be discussed.

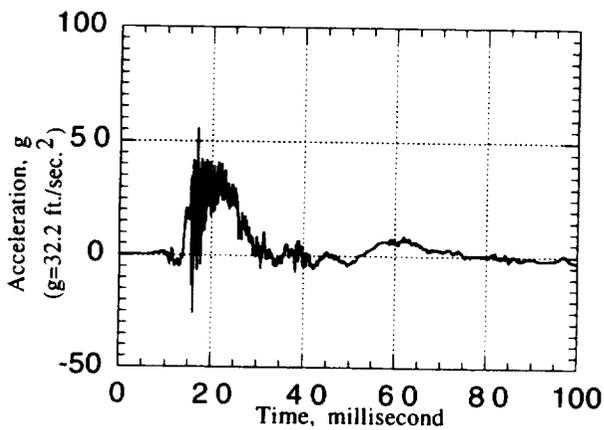
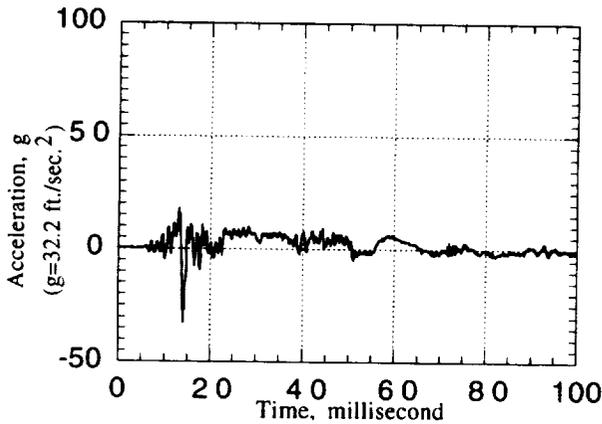
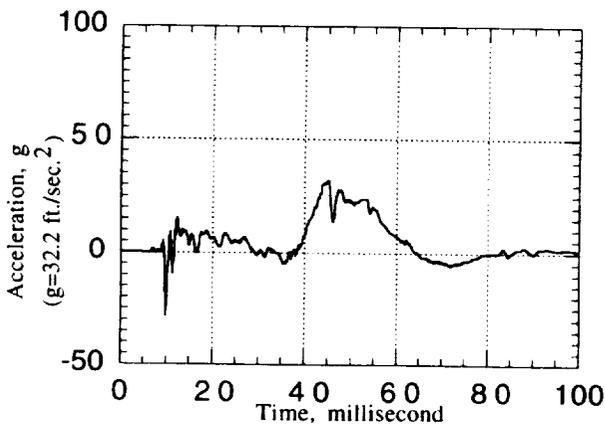
Figure 10. Typical longitudinal pelvis accelerations.

(a) Longitudinal pelvis acceleration for No. 1 occupant in standard seat.

(b) Longitudinal pelvis acceleration for No. 2 occupant in an energy absorbing seat.

(c) Longitudinal pelvis acceleration for No. 5 occupant in developmental energy absorbing seat.

The longitudinal pelvis accelerations for the same three occupants are given in Figure 10. The maximum longitudinal accelerations for occupants 1, 2, and 5 are 35 g, 15 g, and 33 g respectively. Again, the high frequency, low energy data are considered insignificant when compared with the overall response.

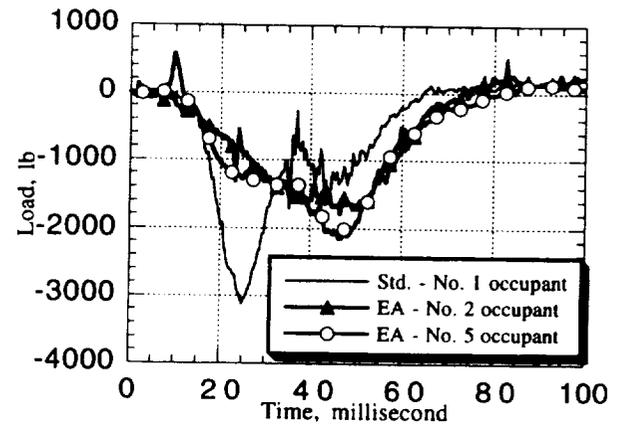
Figure 11. Typical vertical lumbar loads for standard seats and energy absorbing (EA) seats.

A comparison of the vertical lumbar loads for occupants 1, 2 and 5 is shown in Figure 11. These results indicate that an EA seat can significantly reduce the lumbar loads. However, all seven occupants exceeded the -1500 lb. spinal limit generally accepted as the on-set for injury to the spine and specified as the fail/pass limit for seat testing (Part

23 regulations). Occupant 1 had a maximum load of over -3000 lb., and for 10 milliseconds the load exceeded -2000 lb. Occupant 2 had a maximum load of approximately -1600 lb., and sustained -1600 lb. for approximately 12.5 milliseconds. Occupant 5 had a maximum load of approximately -2100 lb., and the load exceeded -1500 lb. for 15 milliseconds.

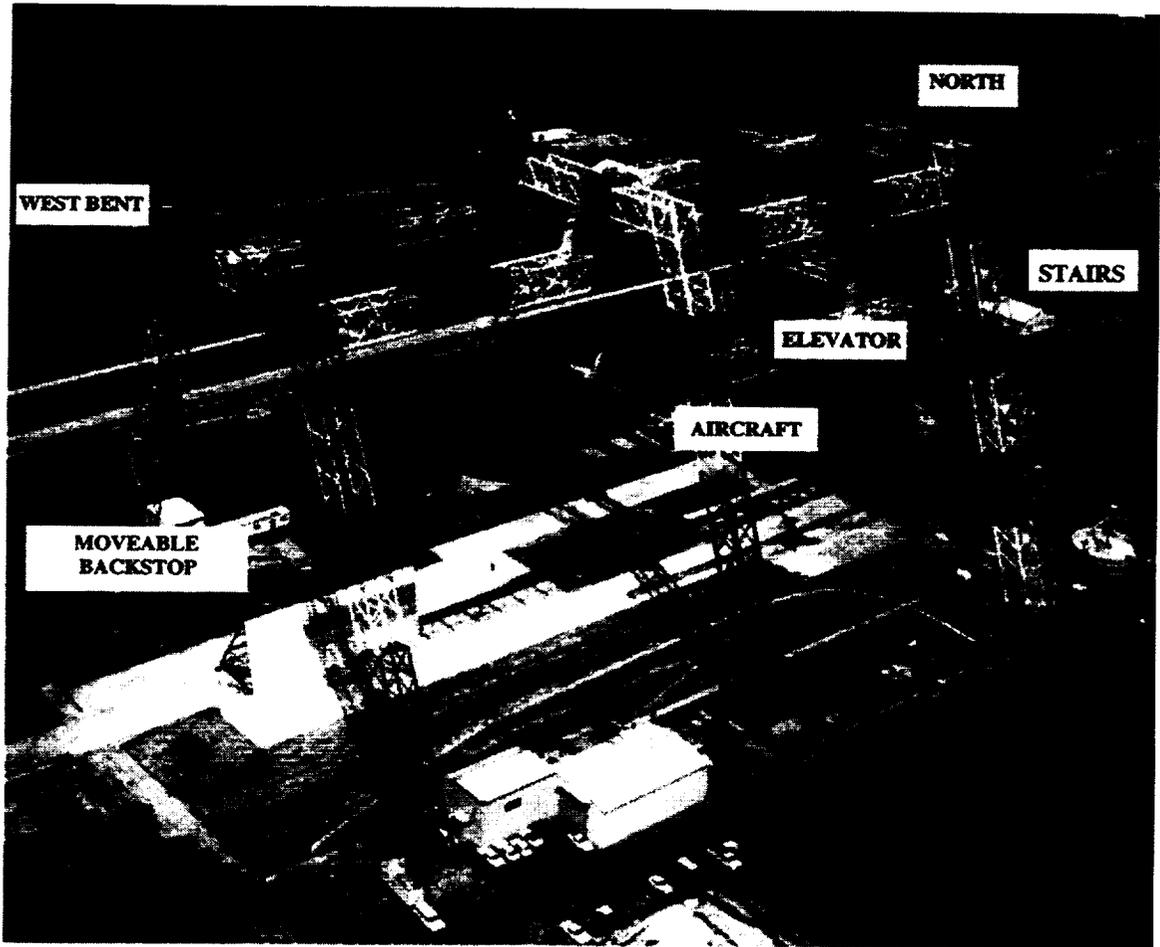
Figure 1. NASA Langley Research Center Impact Dynamics Research Facility.

The NASA Langley Research Center Impact Dynamics Research Facility (IDRF) was used to test the airplane studied in this investigation and is shown in Figure 1. The facility is 240 feet high, 400 feet long, and 265 feet wide at the base. An 8-inch-thick reinforced concrete impact surface is centered under the facility gantry and is approximately 396 feet long and 29 feet wide. The movable backboard is used for photographic clarity and camera referencing.

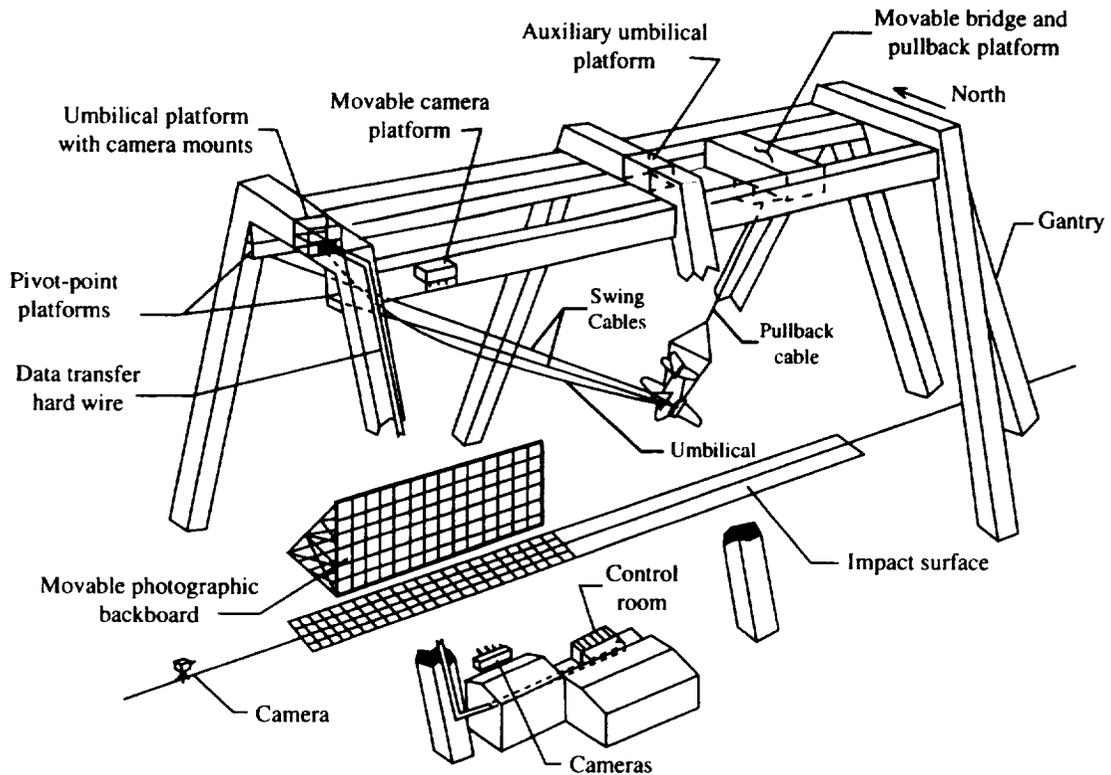
Figure 2. Diagram of Impact Dynamics Research Facility.

For a test at the IDRF, the test vehicle is suspended from two swing cables, pulled back, and released to allow the test vehicle to swing into the impact surface (Figure 2). Free flight conditions are established when the swing cables are pyrotechnically separated from the vehicle just prior to the impact. Knowing the attitude, cable forces, and flight path velocity desired for the test, calculations are made to determine the necessary swing and pull-back cable size and lengths, and the release height of the test vehicle. Details of these calculations are available in Reference 1.

Onboard transducers are wired to an onboard junction box for data acquisition. An umbilical cable connects the onboard junction box to a junction box in the superstructure of the gantry (Figure 2) which is connected to a junction box in the control room. Through the umbilical, an external power supply is used to power voltage regulator cards that provide precision excitation for the onboard instrumentation. The output signals from the onboard instruments are transmitted through the umbilical back to the control room where the signals are recorded by a digital data acquisition system. Up to 96 channels of data can be collected at a typical rate of 4000 samples per second (References 1 and 2).
