Practitioner Case History

Field Experience

Distribution: Engineer: <u>DLH</u> Engr. Ingr.: <u>JAB</u>		Northwest Airlines ENGINEERING AUTHORIZATION National Airlines, Inc. Engineering Dept.		E.A. Number 32-197865	Rev B
Name of Component/Title Left Hand Elevator, Upper Skin		Orig. Issue Date 02 Feb 04	Last Rev. Date 02 Mar 04		
NWA Ship & Serial No. - 58486 -		Type A320	Hours 34,678	Cycles 15,143	Mfg. ATA Code 55-20-01
Mfg. PIN D552 80001 004 51		Classification <input checked="" type="checkbox"/> Major <input type="checkbox"/> Recurrence <input type="checkbox"/> Vice		Prepared By / Date Dan Hitchcock / 02 Feb 04	
Approval No. 0121 (CG 1421)		Approval Date 02 Feb 04		Approved By / Date Brian Holasek / 02 Feb 04	
NWA Stock No. 32-5520-4-0001		NWA DSR SFAR 36		Aircraft Zone 33C	
Weight & Balance Change Weight: <u>NA</u> <u>NA</u> <u>NA</u>		Approval of AIRCRAFT DEPT <u>NA</u>		Rev Info See Sheet 3

Description of Problem:
 During accomplishment of Airbus Service Bulletin A320-55-1024 [Ref (A)] through inspection at MUP and per Refs (C), (D), & (F) multiple locations with evidence of water ingestion were found on the upper surface of the LH Elevator. The elevator skin panels are made

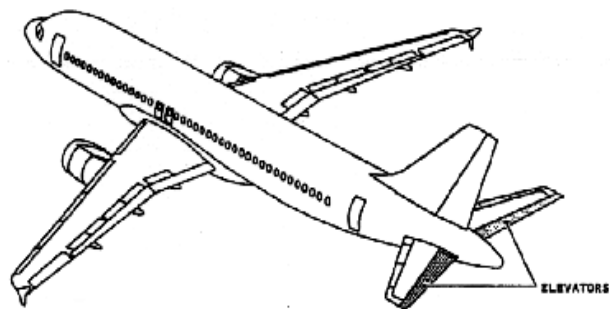
● - Damage
- Damage Number
(see Table I)

1. Gain access as required.
2. Repair each damage in group of damage as follows:
 - a) Damage #1 & #2: Perform a combined cosmetic repair according to A320 SRM 55-21-11 (C1) Figure 204 (sheet 2) and Figure 205 (sheet 4).

- f) Damage #7 - #14, plus damage from removing the metallic strip at this location: Perform a structural repair according to A320 SRM 55-21-11 Figure 214 with the following deviations: (See Figure 2 for similar repair)

- iii) The repair plies have to extend to the front spar and trailing edge ends.
 NOTE: The fasteners in the front spar area need to be removed as can be seen in Figure 2.
