# Rudder structural investigations

Relevant to rudders CFRP rudder PN A55471500 series

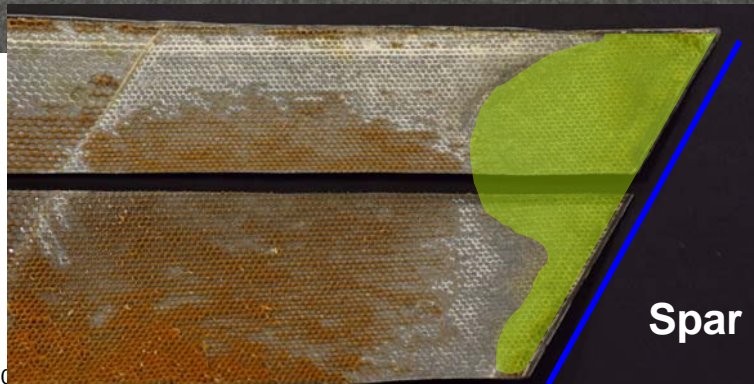
- December 2005
- Lower rib was removed for maintenance
- Inner skin to core disbond was detected

## Hydraulic fluid contamination at inner face

Inner skin flipped after removal

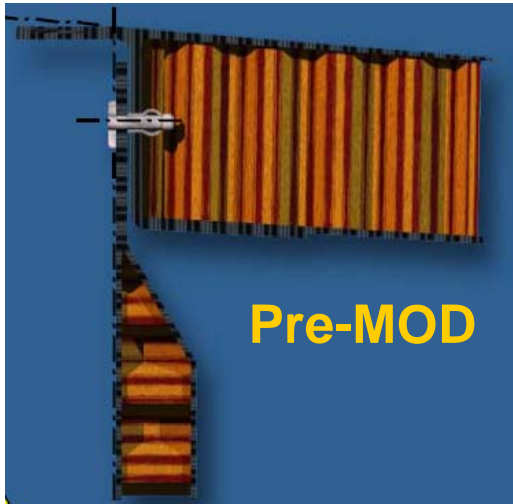
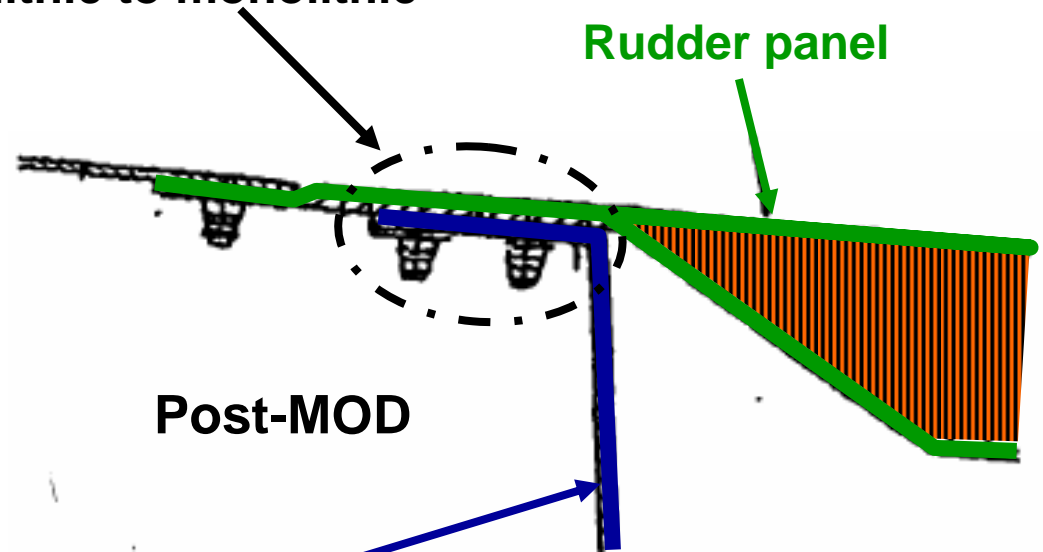
## Fluid path specific to Z-profile design rudder series

- Other design rudders are not affected

Connection  
monolithic to monolithic

Rudder panel

Monolithic spar

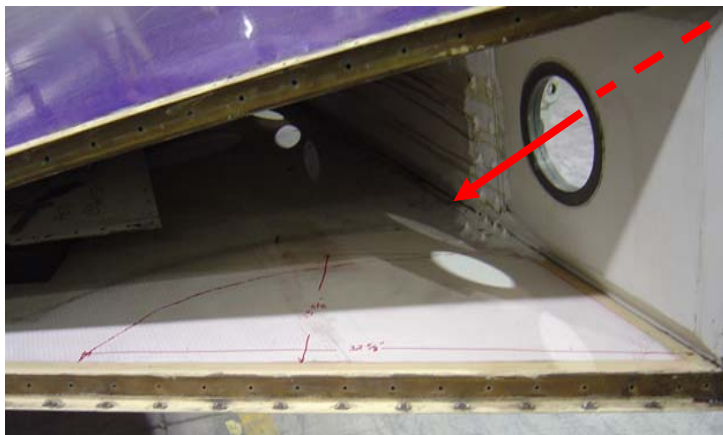
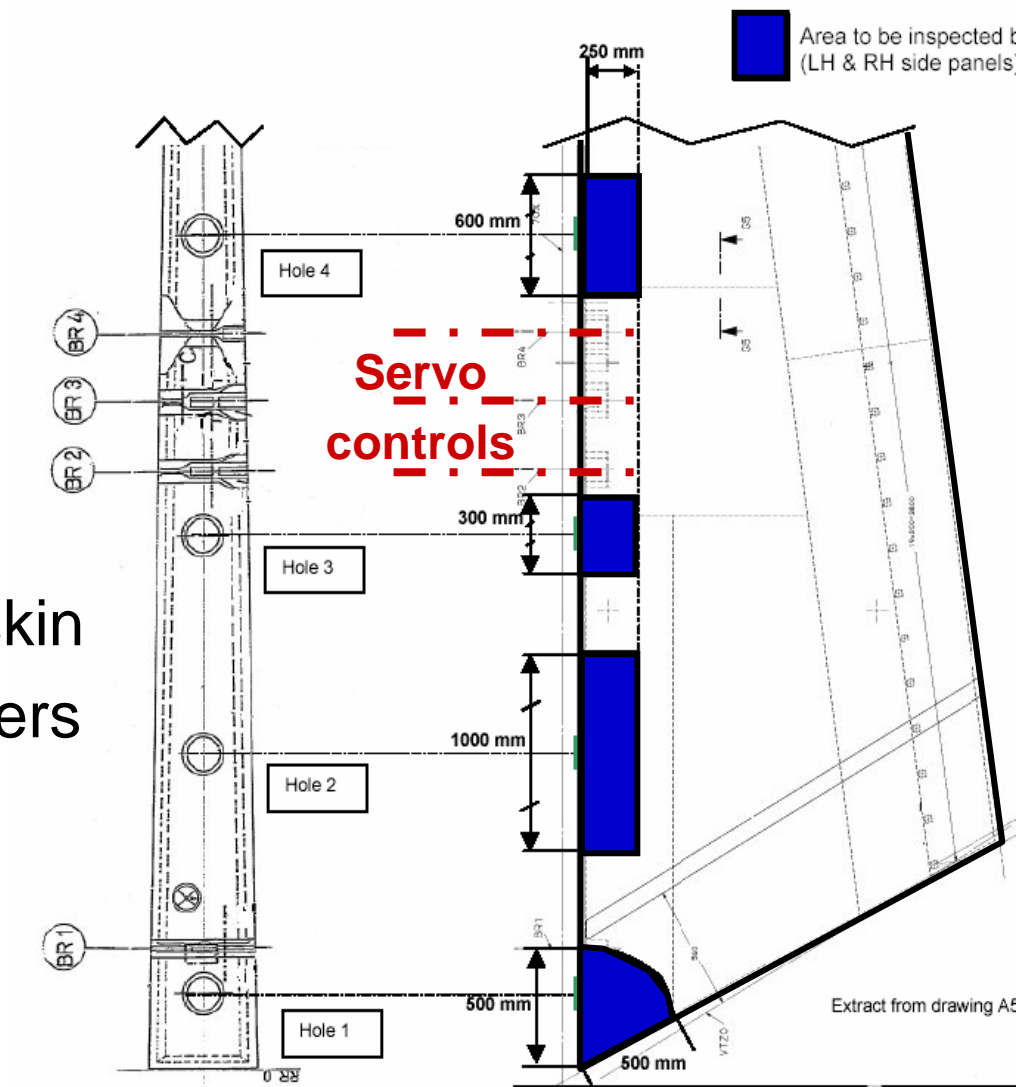
## Tap test & ELCH

- Tap test of accessible inner skin
- ELCH of some selected rudders
- All rudders found airworthy

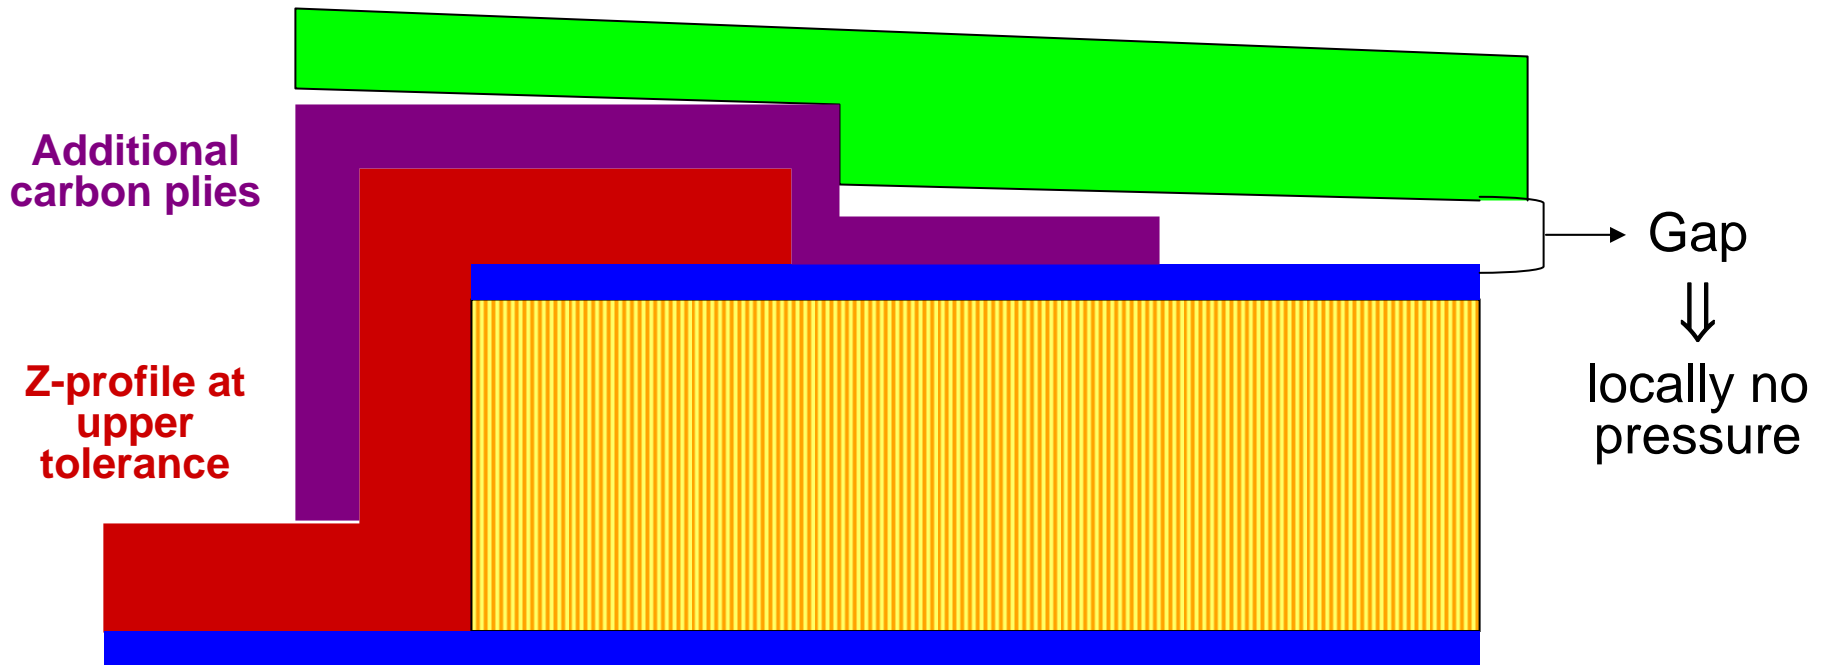
## Possible lack of compensation during curing

- Initiation of a disbond at the edges of the Z-profile is the most likely scenario for the disbond occurrence
- This scenario is also valid for the event of structural failure in flight
- Rudder disbond occurred before hydraulic contamination
- Remains of the rudder that failed in flight do not exhibit a similar hydraulic fluid contamination
  - ▶ Rudder did not fail because it was contaminated with hydraulic fluid
