Boeing Composite Airframe Damage Tolerance and Service Experience

Allen J. Fawcett (ATF/DER) and Gary D. Oakes (ATF)
Boeing Commercial Airplanes
787 Program

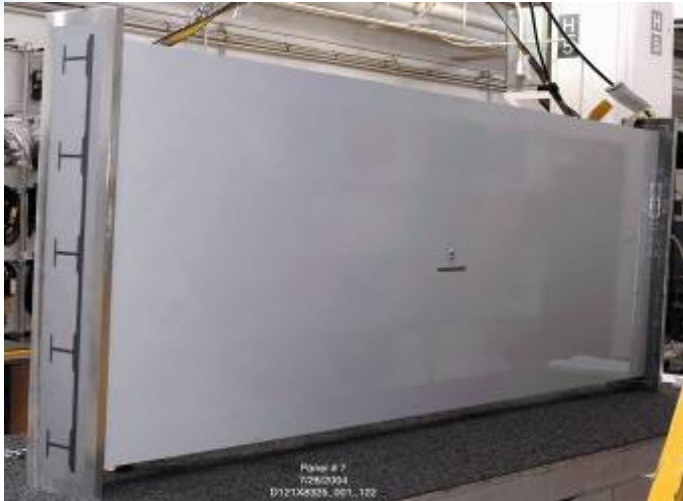
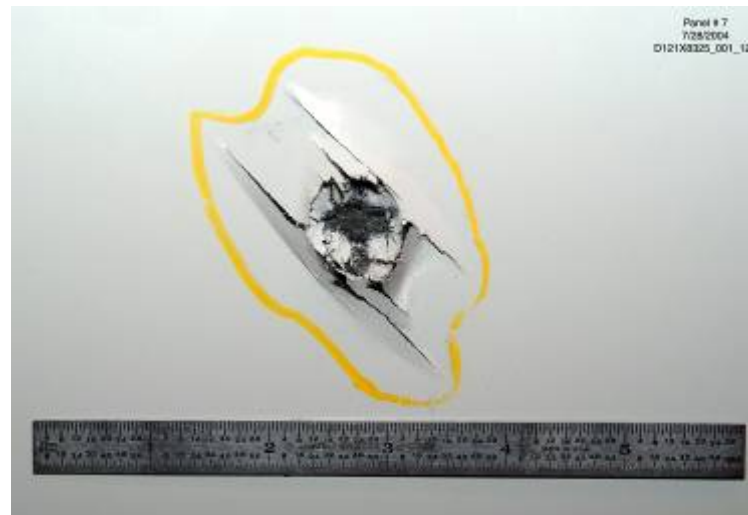
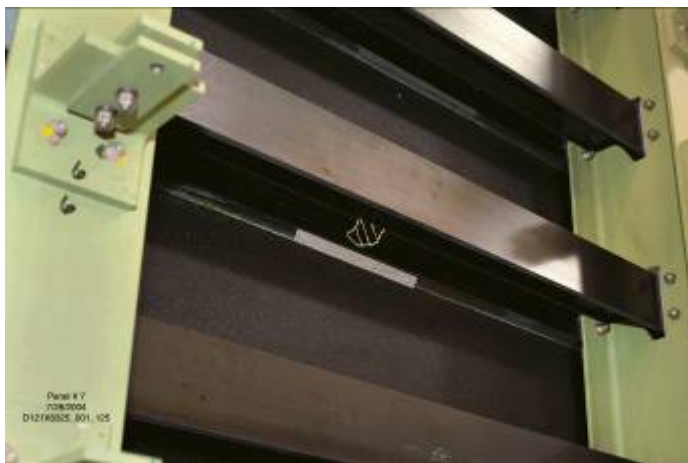
Wing Skin Visible Impact Damage

OML Impact, 1" Diameter impactor
Impact Energy: Greater than 8000 in-lbs

Residual Limit Load
No Growth for a missed inspection interval

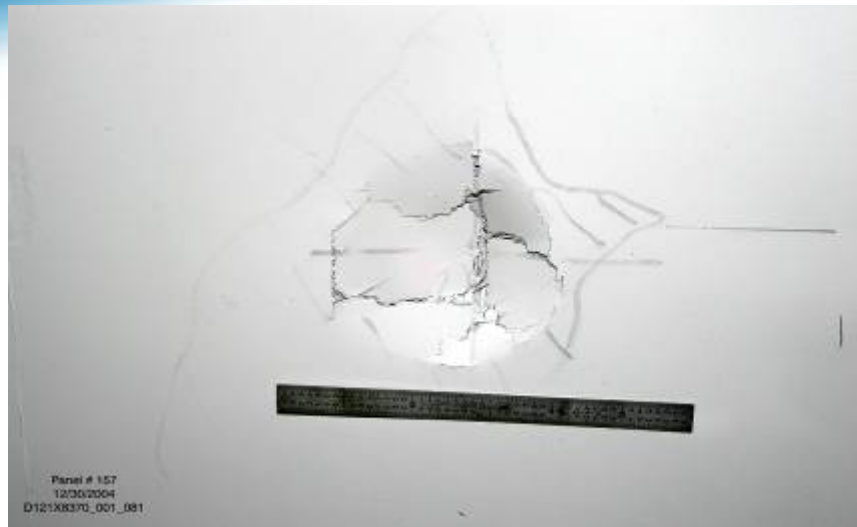
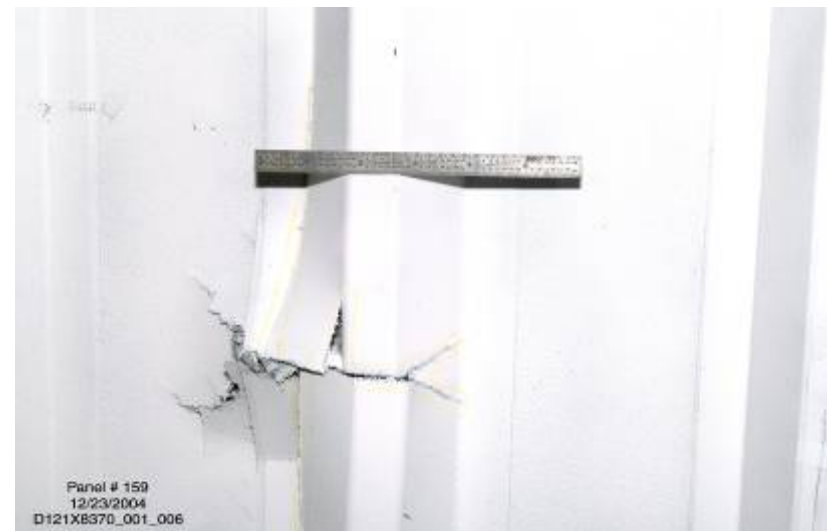
Fuselage Skin Visible Impact Damage

OML VID Impact

Inside damage associated with OML VID

Residual Limit Load

No Growth for a missed inspection interval

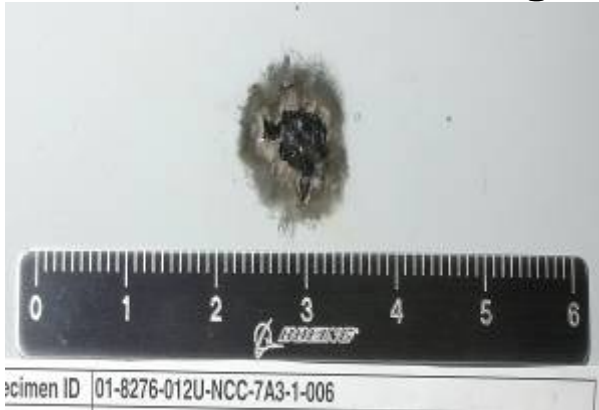
787 composite panel; nominal strike causes superficial damage only. This damage would be expected to be within ADL and the airplane would be dispatched with deferred structural repair

- CFRP structures must meet same lightning strike regulatory requirements as Aluminum structures
- Additionally 787 structures are designed, by requirement, to resist economic levels of lightning strike

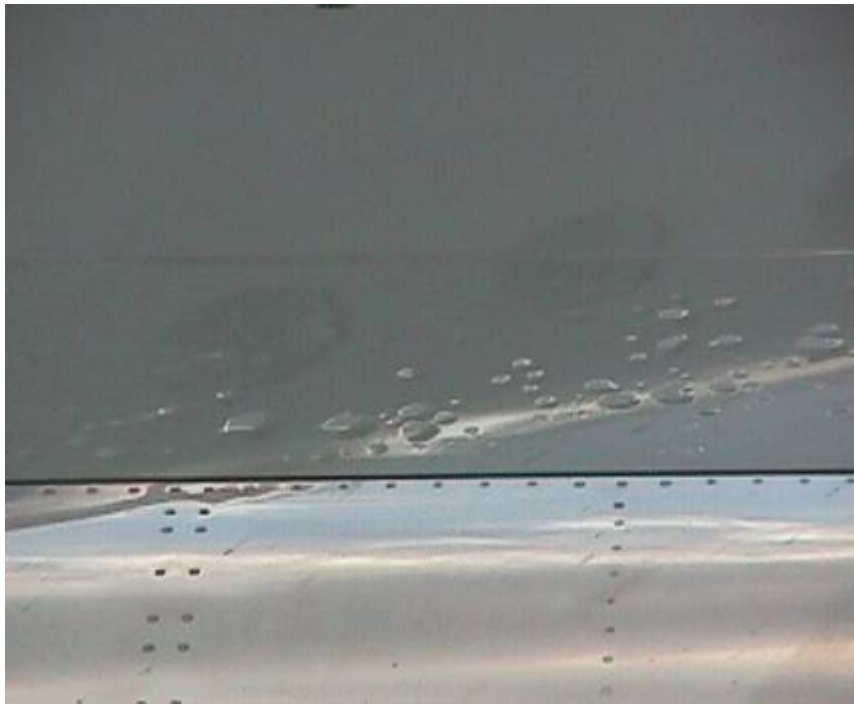
777 In-Service Experience Sydney Hailstorm

2.5" to 3.0" hail dented the fixed 5 ply honeycomb structure shown here but did no damage to the CFRP main torque box

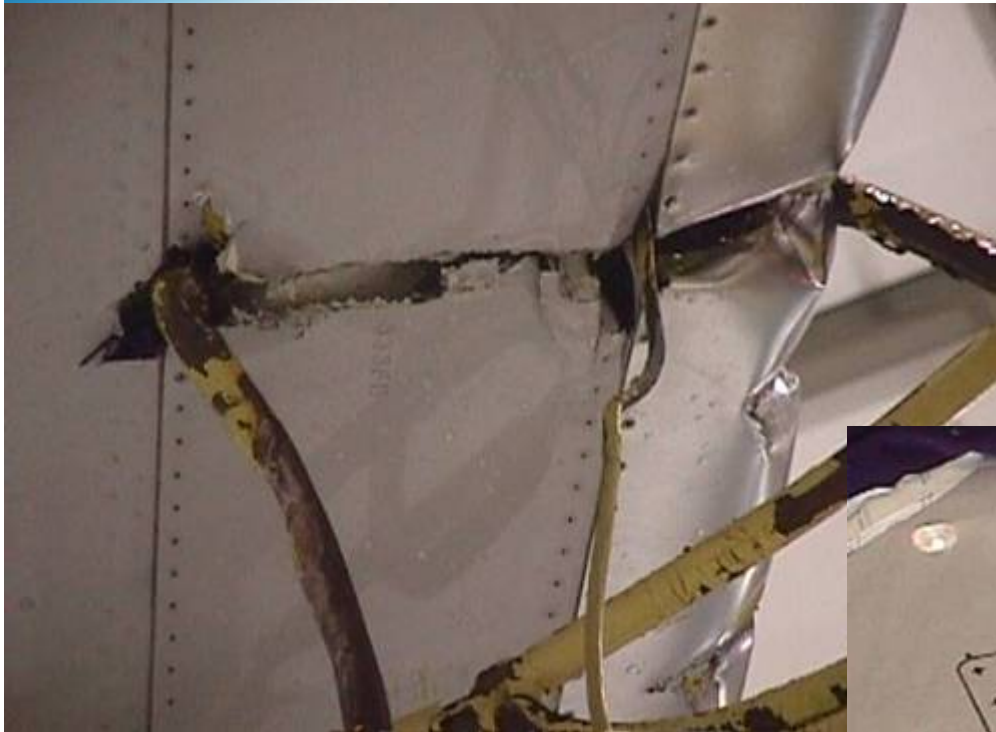
Skin/Spar Damage—Ground Handling Equipment Impact

Conventional Bolted Repair

- **5 reported service-induced damage incidents associated with the main torque boxes**
 - ❖ **FOD damage due to engine run-up**
 - Area of skin/stringer disbond repaired with blind fasteners
 - ❖ **Tip damage due to impact while taxiing**
 - No damage to CFRP primary structural components
 - ❖ **Hailstorm damage**
 - No damage to main torque box structure
 - ❖ **Damage due to impact with maintenance stand**
 - Damage to front spar, main torque box skins, aux spar and leading edges
 - Bolted titanium sheet metal repair on front spar, skin, other parts replaced
 - ❖ **Damage due to impact with service truck**
 - Damage to front spar and main torque box skin
 - Bolted titanium sheet metal repair on front spar and skin
