GLARE® and Bonded Repairs

Friday May 11th 2007

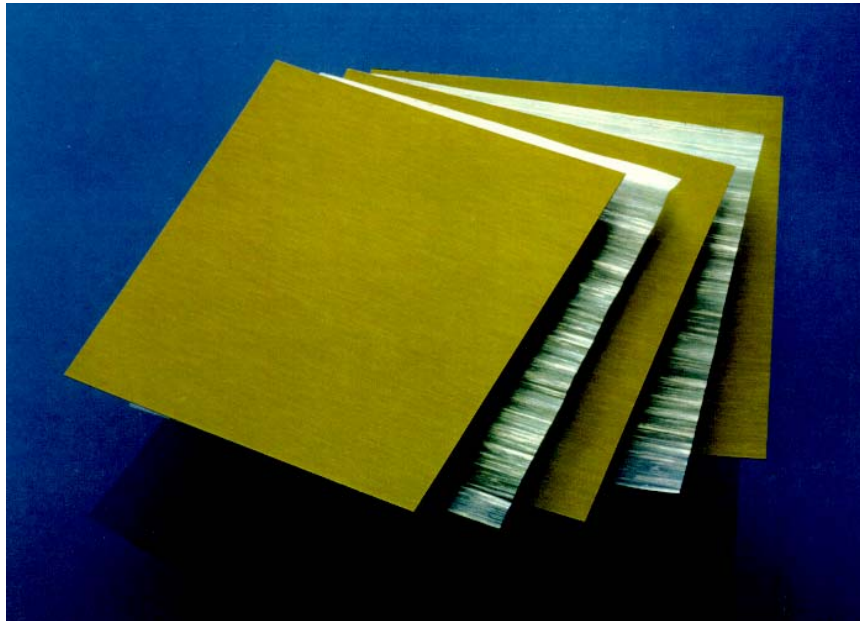
What is GLARE®?

- GLARE is a hybrid material built-up from alternating layers of aluminium and glass fibre reinforced metal adhesive

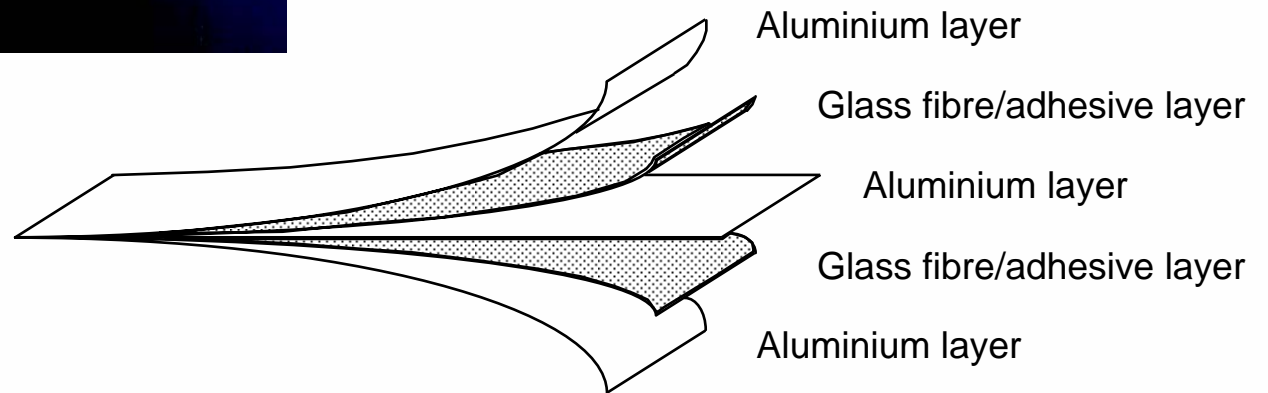
GLARE[®] build up.

- GLARE[®] build-up:
 - Aluminium layer thickness: 0.2 - 0.3 - 0.4 - 0.5 mm
 - Fibre/adhesive layer build-up from multiple 0.125 mm UD layers
 - FM94 epoxy adhesive for structural metal bonding

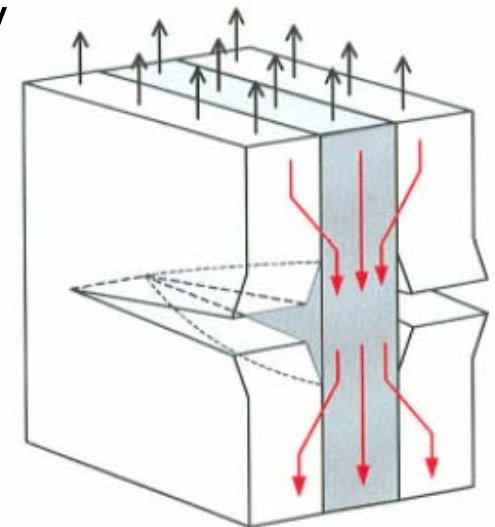
GLARE[®] damage behaviour

- FOD causes a dent (impact) or a scratch, similar to aluminium
- Inspectability of FOD similar to aluminium
- Penetration energy higher than for aluminium and composites
- Debonding sizes resulting from impact are small compared to the dent size
- Effect of FOD on compression properties similar to aluminium
- GLARE exhibits slow fatigue crack growth and high residual strength in the presence of FOD

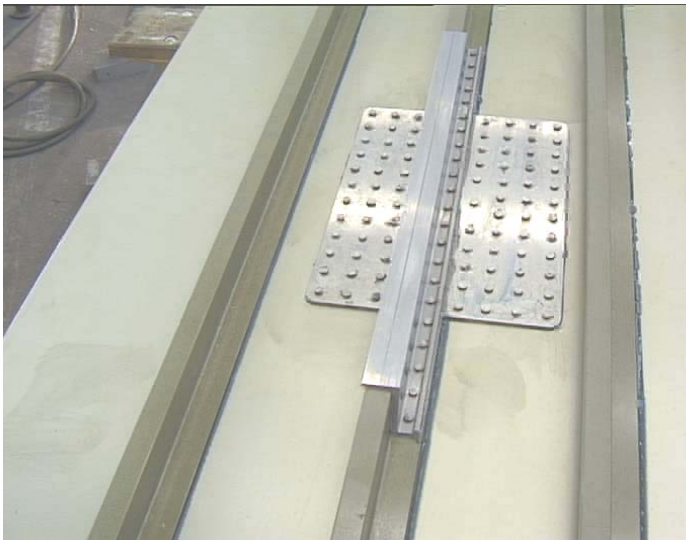
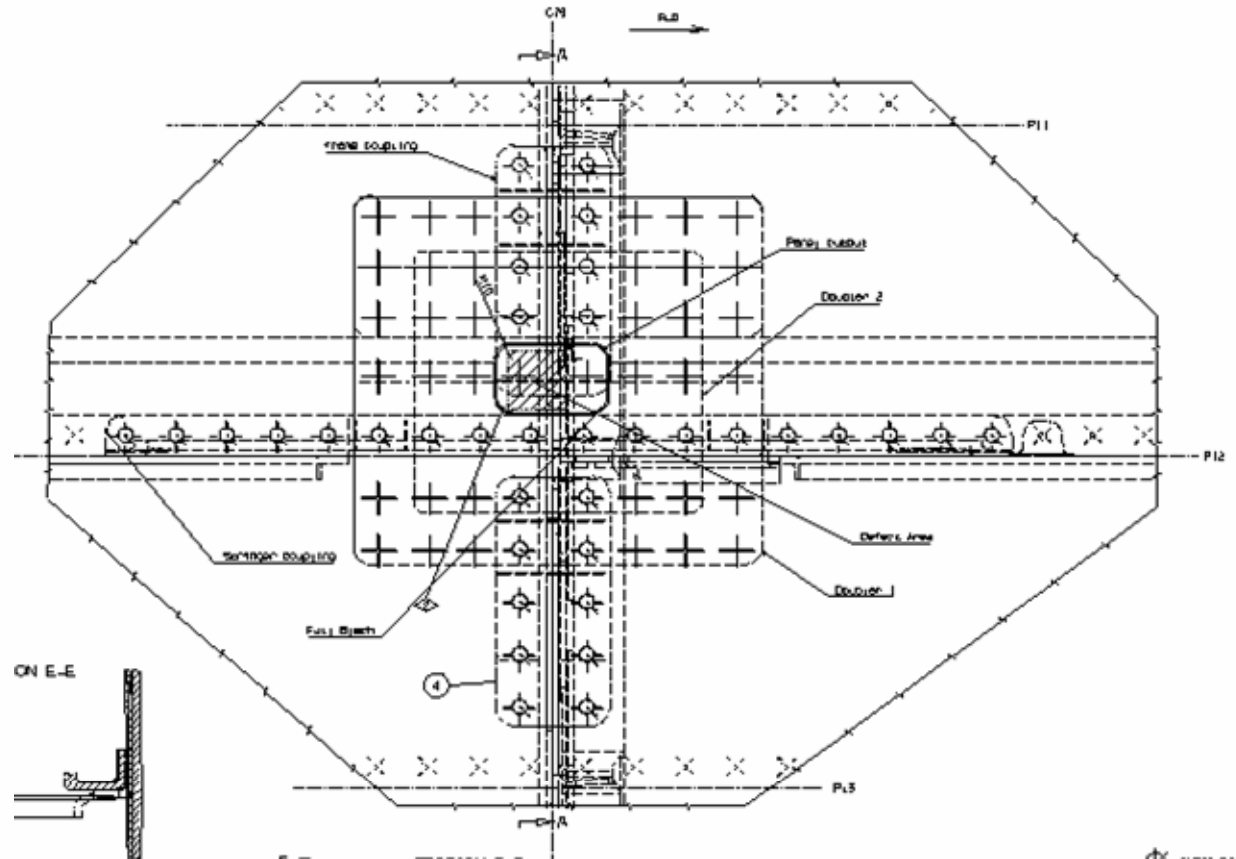
Present repairs, riveted. (cont'd)

- Typical repairs

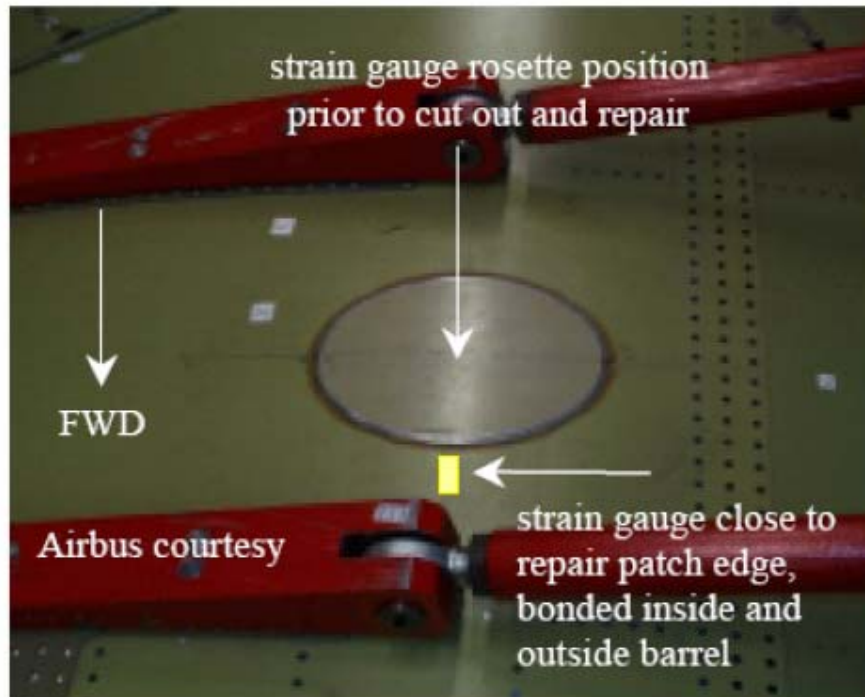
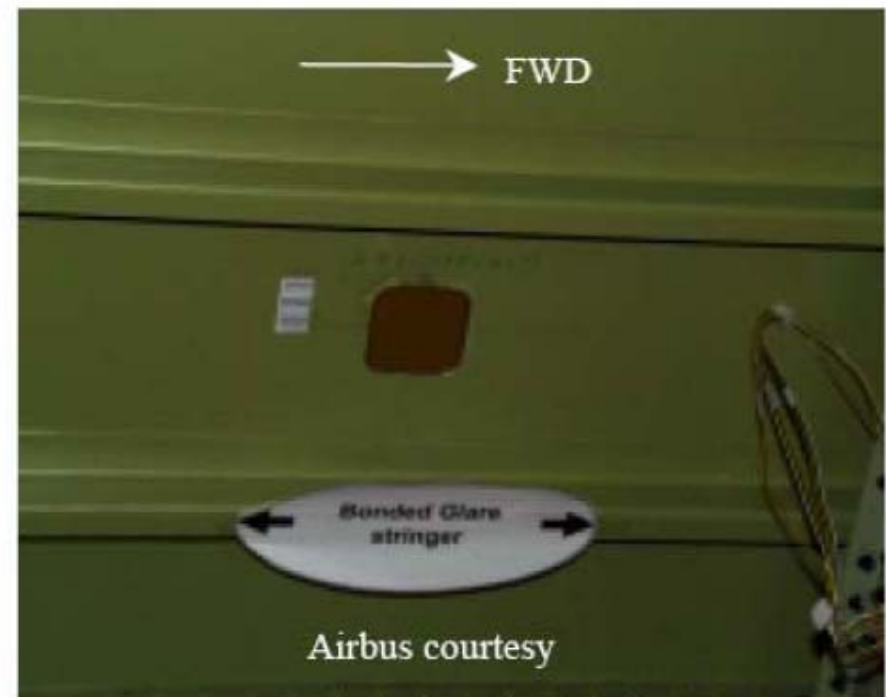
Future repairs, bonded.

- Advantages:
 - Fatigue insensitive
 - Corrosion
 - Lower design weight, reduced skin thickness

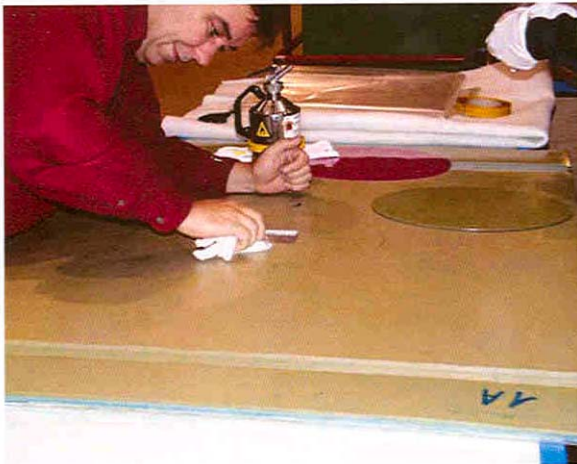
Cleaning of bonding surface

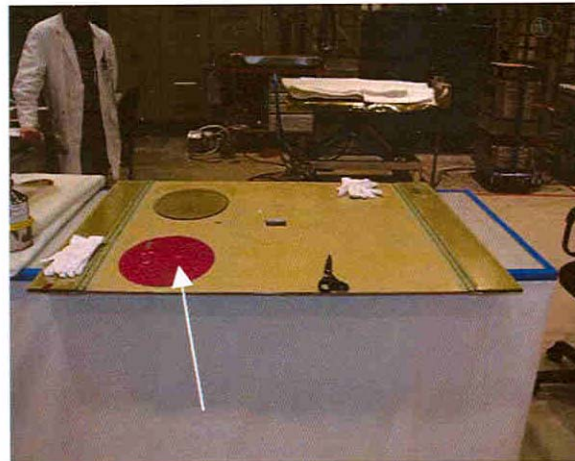
Bonding film cut to shape

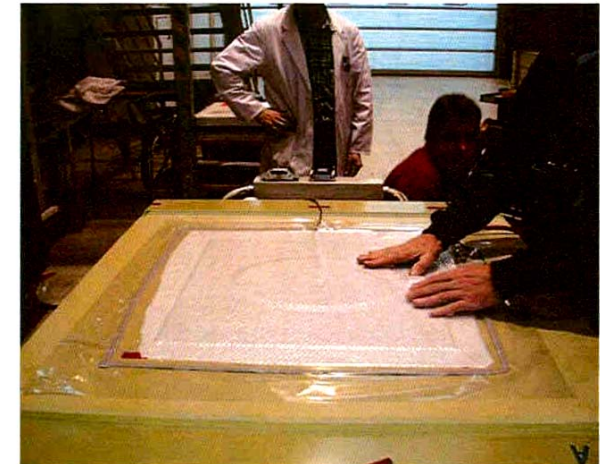
Application of vacuum foil, thereafter start of curing with Heatcom[®] device, low vacuum pressure

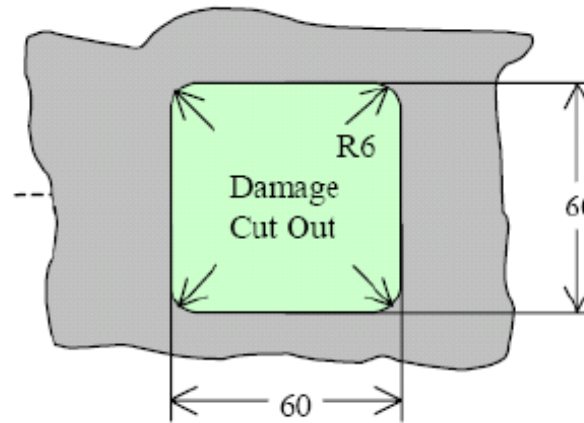
Megaliner barrel bonded repairs

- GL4A-5/4-.4 patch / GL4A-5/4-.4 SSC skin
- Two CA fatigue tests
- Three outdoor exposure + CA fatigue tests

- The tests are still ongoing:
 - No problem to bond a repair (GLARE-)patch to GLARE®
 - Fine tuning of repair patch
 - Feasibility of standard GLARE patch.
 - Outdoor exposure program to be completed. Preliminary results (after 2 years outdoor exposure): no effect of outdoor exposure (Me/Me bonding is not affected)

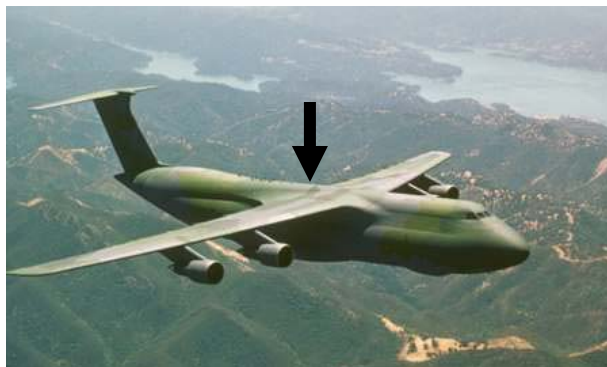
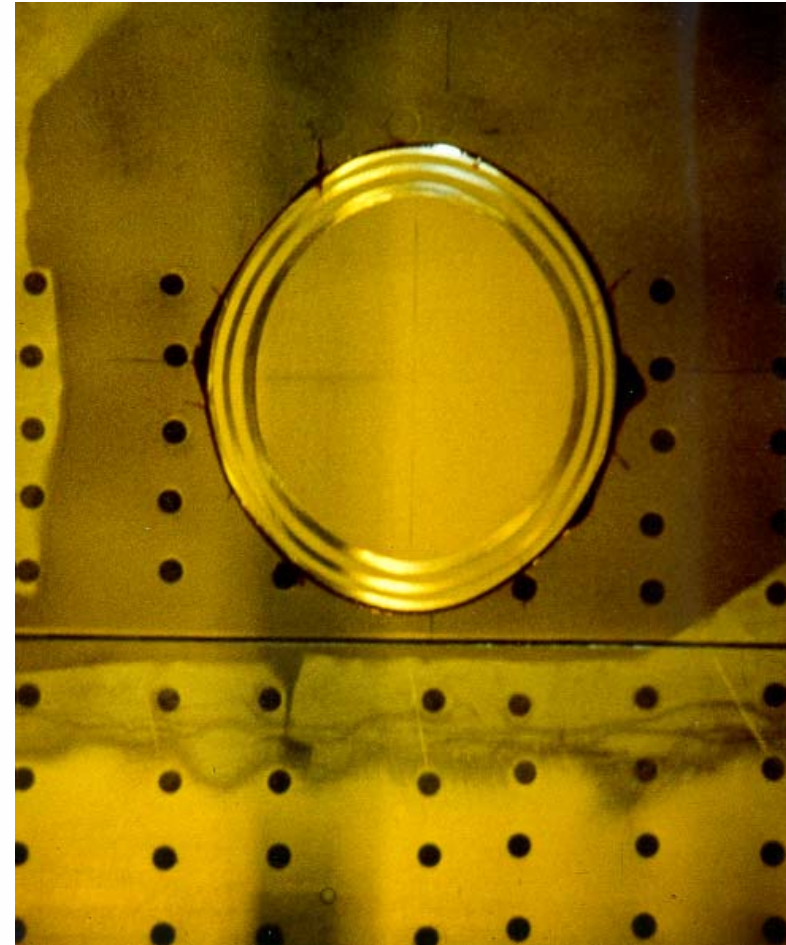
GLARE[®] repairs patches (cont'd)

- Status:
 - No skin crack extension
 - No debonding
 - No damage to GLARE patch

US Air Force/Lockheed Martin C-5A Galaxy: Bonded Patch Repairs

- Material: Two GLARE 2-3/2-0.2 repairs installed October 1995
- Design: Patch bonded over a fuselage longitudinal butt-joint with AF 163-2M
- Due to the poor fatigue performance of the aluminium 7079-T6 skin, significant fatigue damage did occur. When riveted aluminium patches were used, new cracks typically nucleate in the skin at the corners of the patches, leading to ever larger repairs.
- Status:
 - No skin crack extension
 - No debonding
 - No damage to GLARE patch

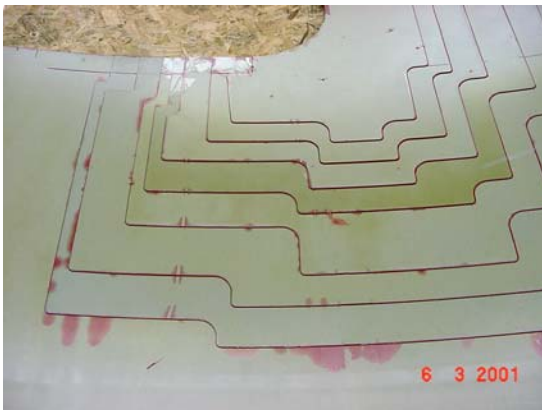
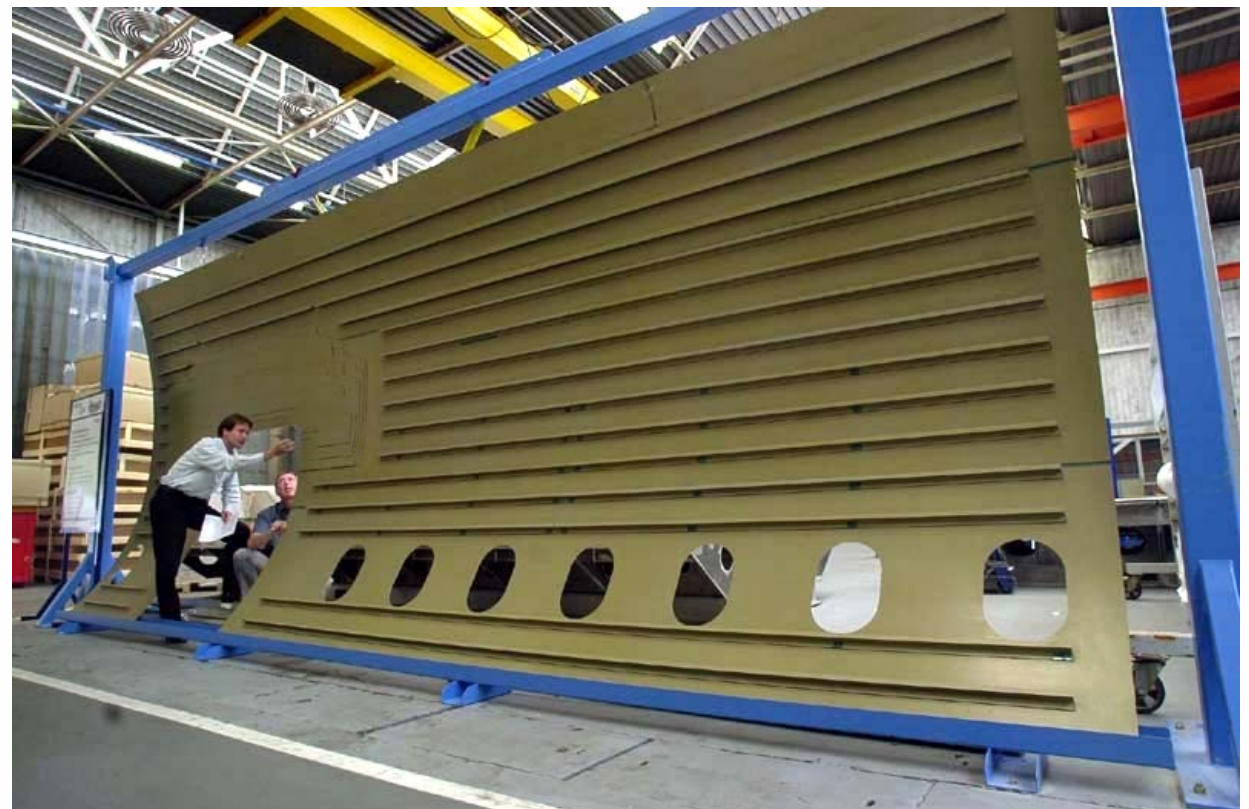
General developments (cont'd)

- Larger panels:
 - Easier Assembly
 - Less joints

Dimensions: 3.5 x 11 meters (10x33ft)

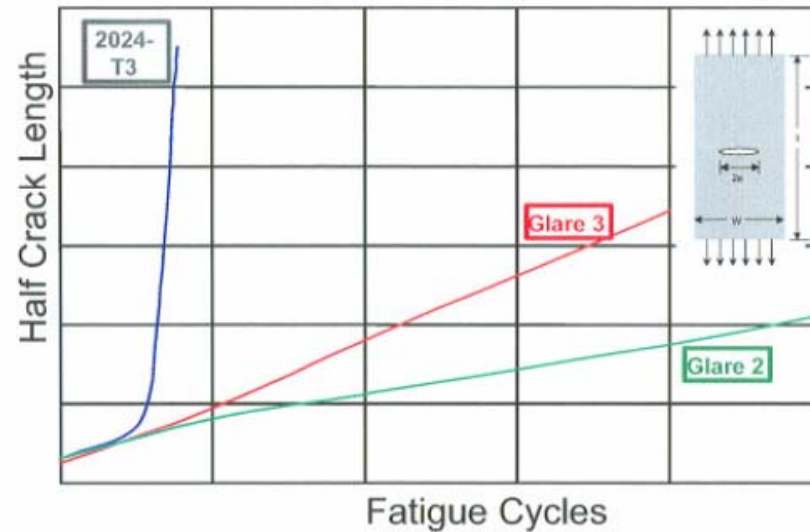
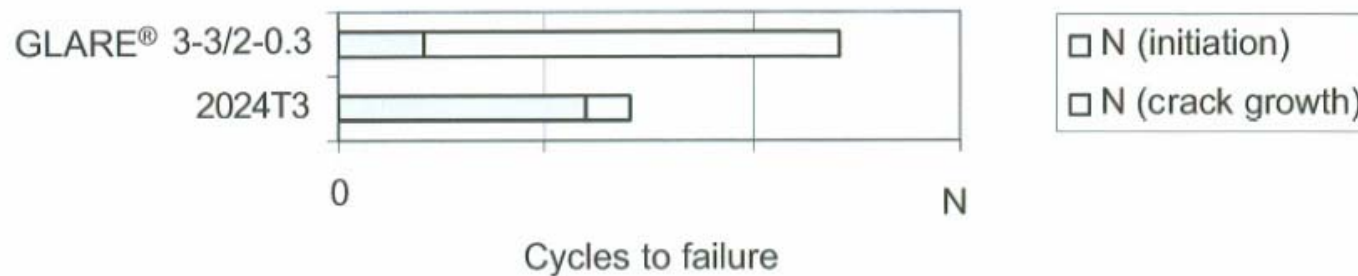
Crack Propagation is no Sizing Parameter

General differences of GLARE® compared with Aluminium:

- Fatigue life is longer
- Crack initiation is earlier
- Contribution of crack propagation period on total fatigue life is larger

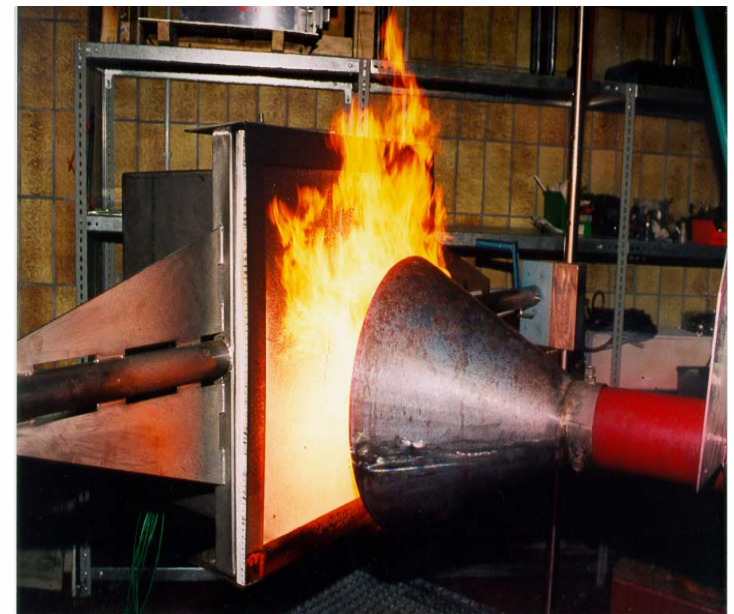
Fire resistance

- GLARE shows excellent fire resistance behaviour
 - fire wall tests: 15 minutes minimum at 1100°C
 - No flame penetration
 - Exposed aluminium layer melts
 - Epoxy around glass fibres carbonizes and protect remaining aluminium layers.
 - Backside temperature reduced by more than half due to isolating effect of delaminated glass fibre layers
