Experience in Manufacturing Nomex Composites Sandwich Structures

FAA Workshop on Adhesive Bonded Structures

A330 Trent 700 Nacelle
Fan Cowl Door

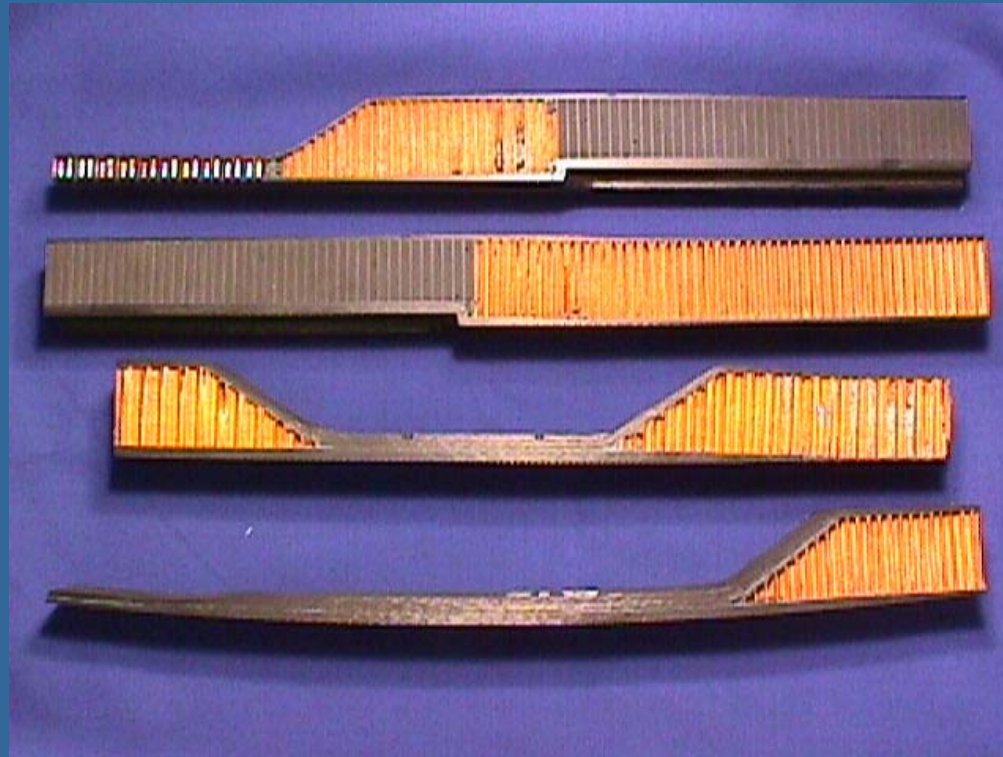
Typical A330 Trent 700 Fan Cowl Door Sandwich Structure Configuration

Typical sandwich structure configuration

External Skin	Three Plies of Carbon Prepreg (Precured)
Film Adhesive	FM300M .03 psf
Core	HRH10- 1/8-4.0
Film Adhesive	FM300M .03 psf
Internal Skin	Two Plies of Carbon Prepreg (Secondary Stage Cured)

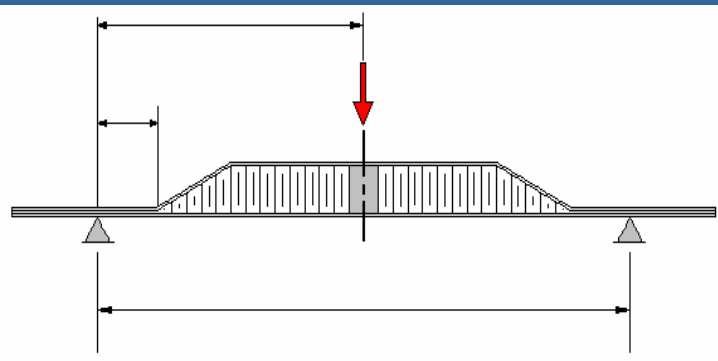
Coupon Level Tests

- Flatwise Tensile Test
- 3-Pts Bending Tests
- Climbing Drum Peel Tests
- Single Overlap Shear Tests

The material certification test results have been analysed following the guidelines of MIL-HDBK-17 and multi-batch testing has been carried out to investigate key mechanical properties.

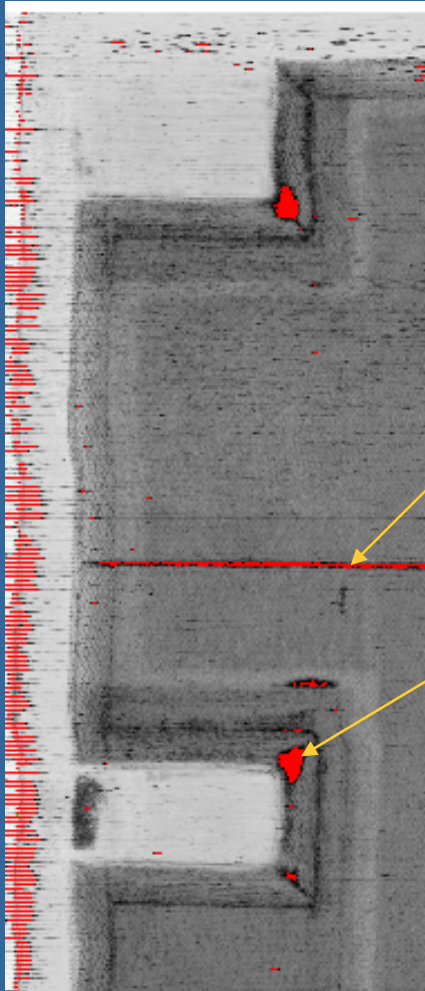
Typical Results of a C-Scan Quality Control

Line of Foaming Adhesive Joining Two Core Panels

Manufacturing Defect Due to Improper Positioning of Tooling
