Alenia Experiences on Composite Structures Repairs

Benedetto Gambino

Amsterdam, 10 May 2007

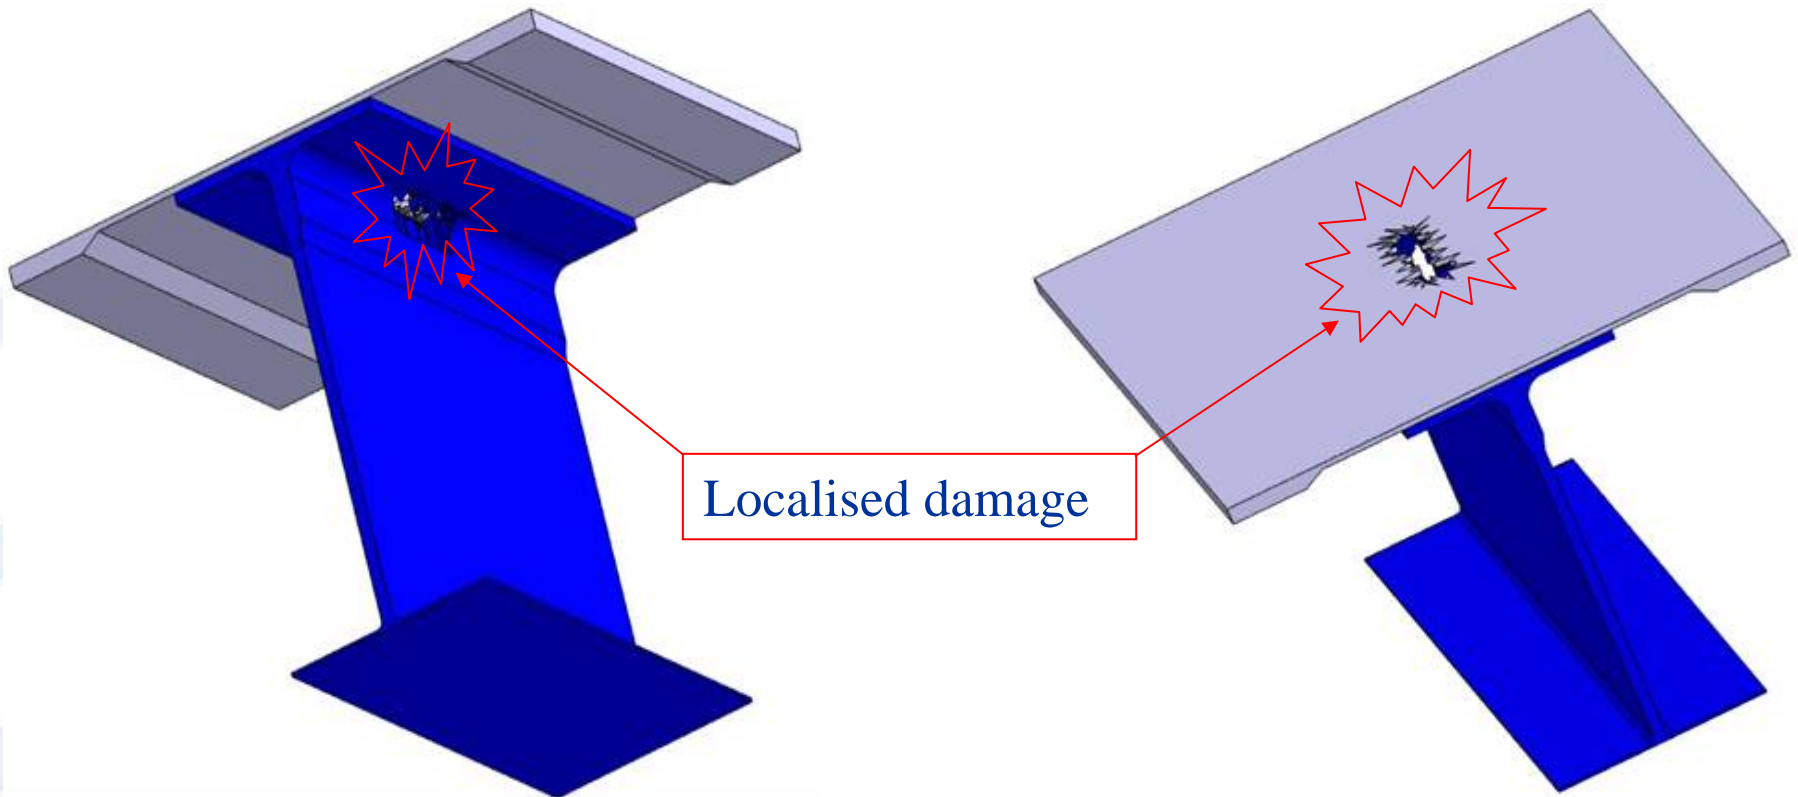
Repair Concepts (STEP 1)

Skin and Rib damage example

The damage is considered on laminated zone of skin and corner zone of rib's flange

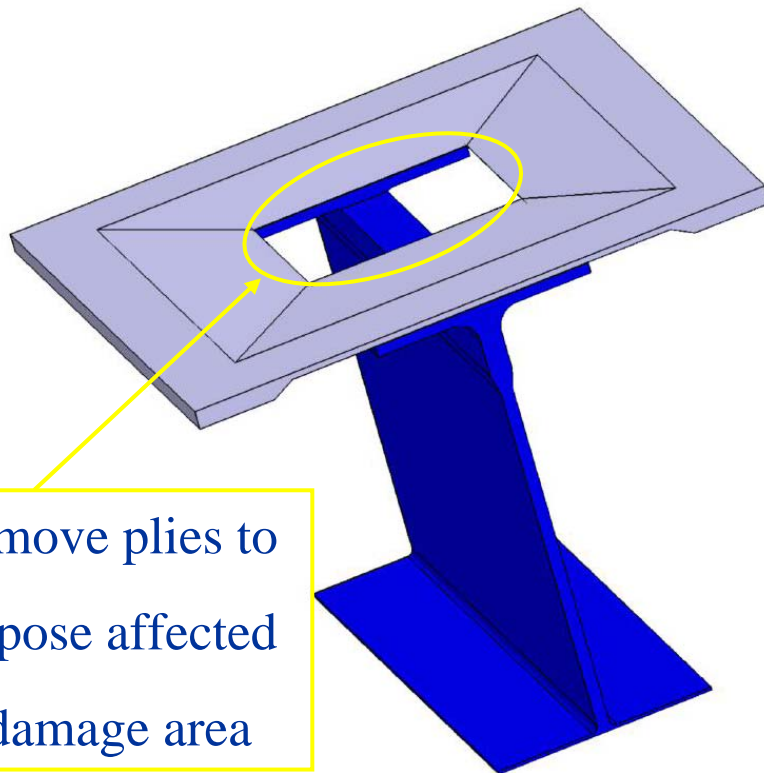
Repair Concepts (STEP 2)

Remove crushed zone

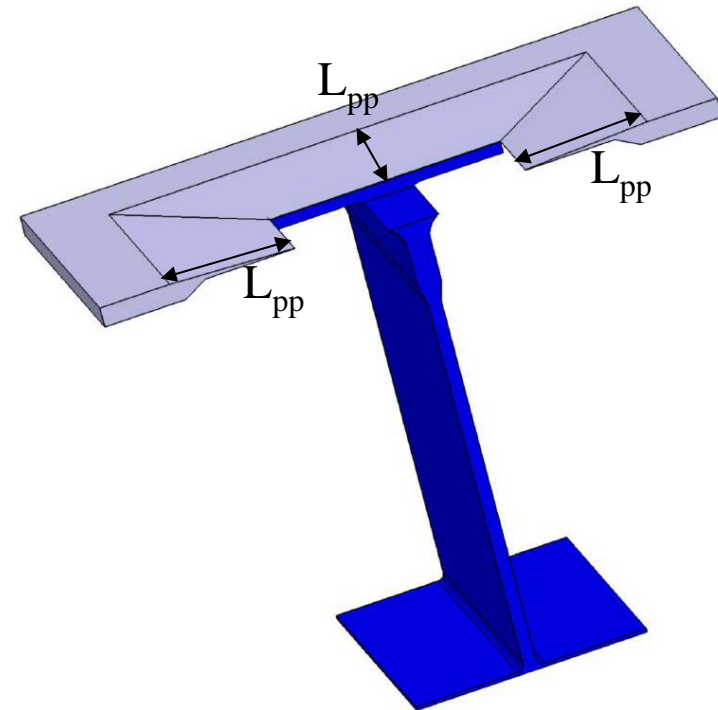
Remove plies to expose affected damage area

$$L_{pp} = \text{Peel Ply Length} = n.\text{plies (thickness)} \times 12\text{mm}$$

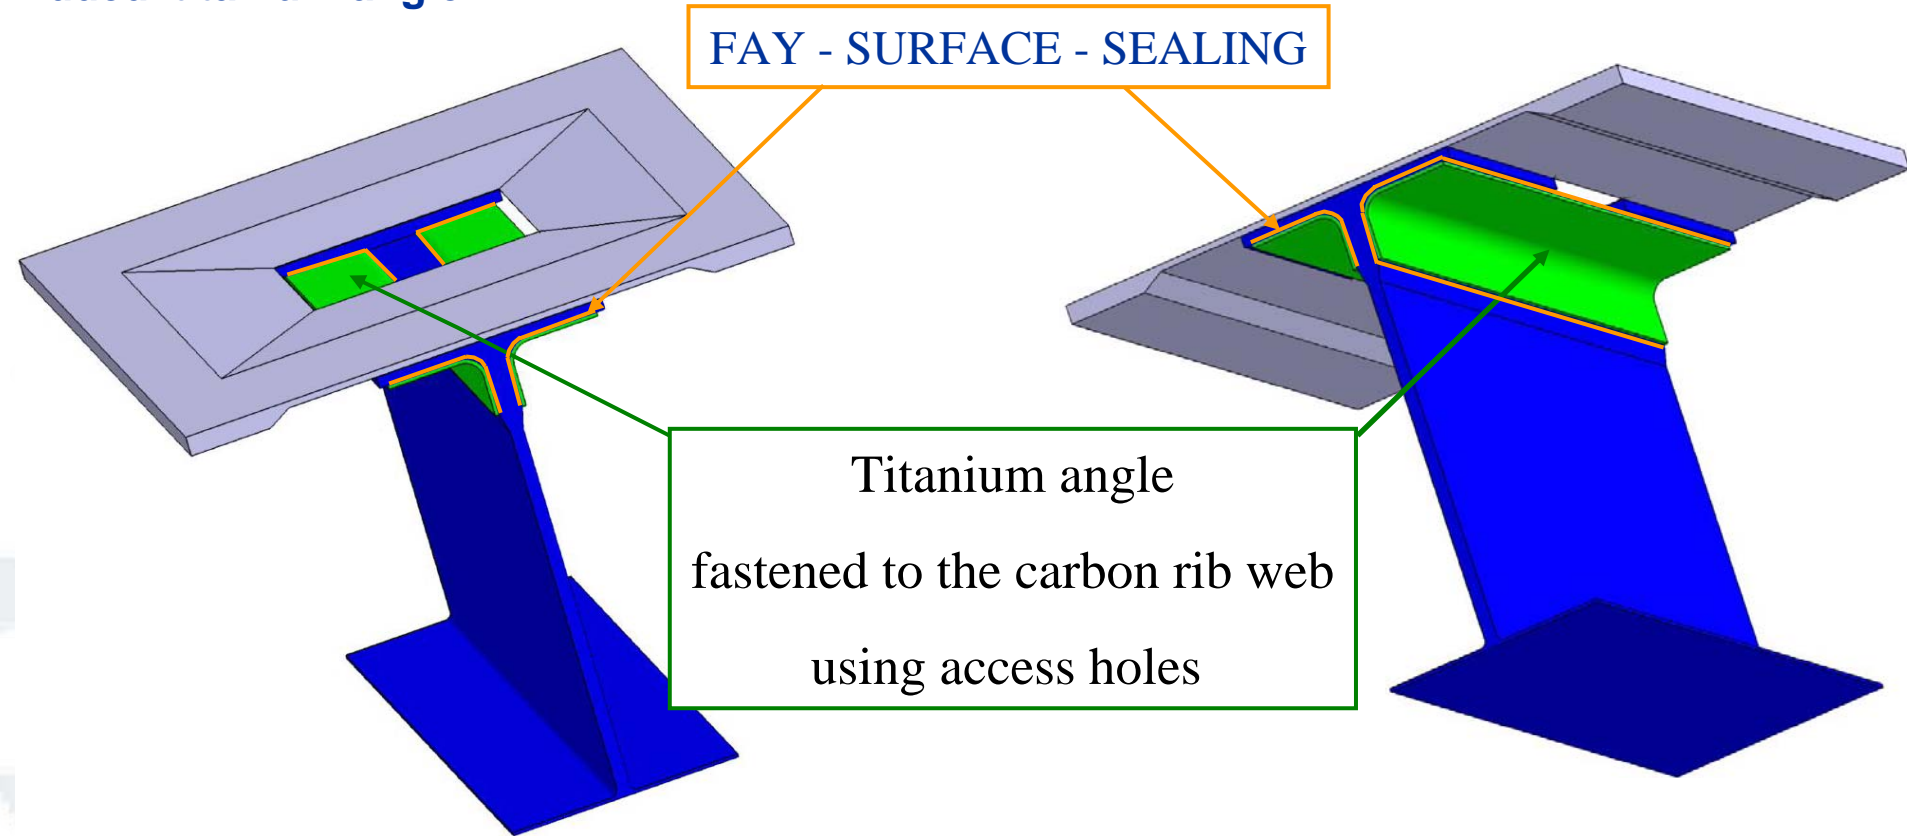
Repair Concepts (STEP 3)

Added titanium angle

FAY - SURFACE - SEALING

Titanium angle
fastened to the carbon rib web
using access holes

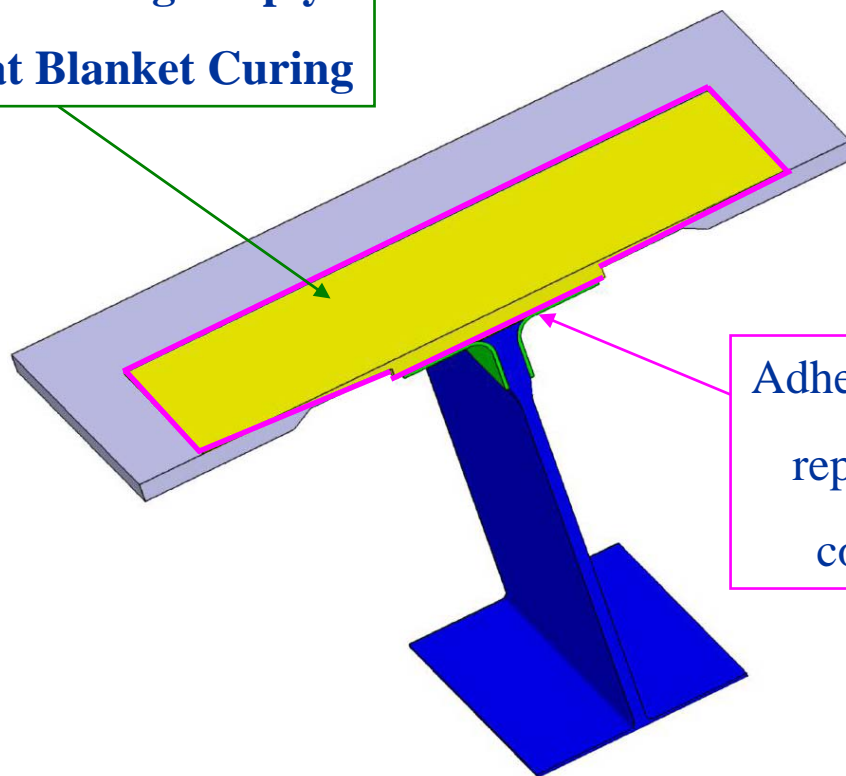
Repair Concepts (STEP 4)

**Replace plies on a ply for ply (prepreg)
+ 2 extra plies (prepreg) + 1 Fiberglass ply
Local Vacuum Bag and Heat Blanket Curing**

Adhesive ply between
repair plies and all
contact surfaces

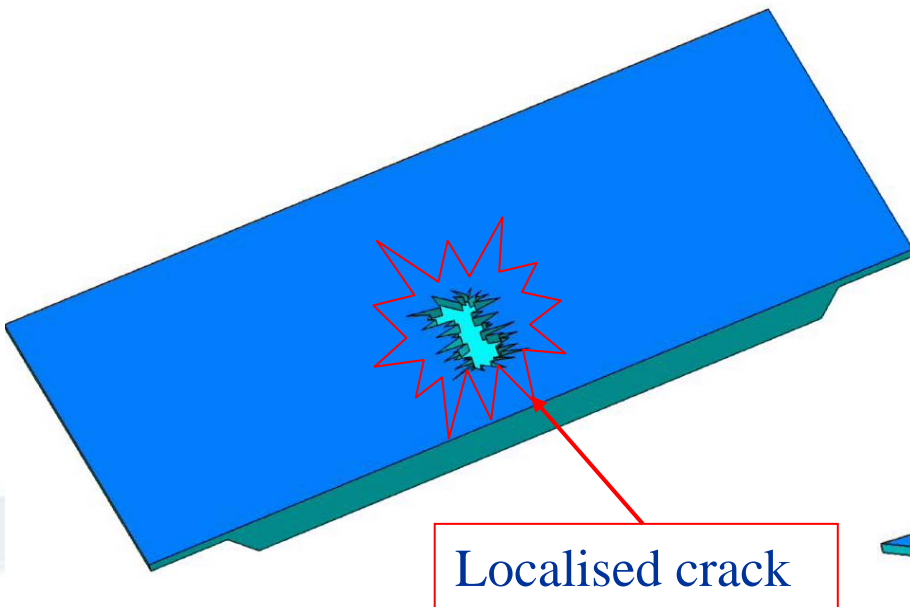
Repair Concepts (STEP 1 & 2)

Sandwich panel Damage example

Remove affected
plies to expose core.
Remove a core plug to
remove damaged core.

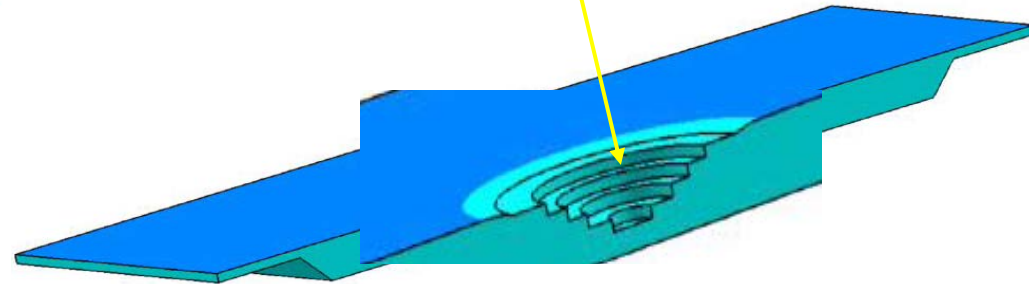
The damage considered is: crushed core and delaminated plies

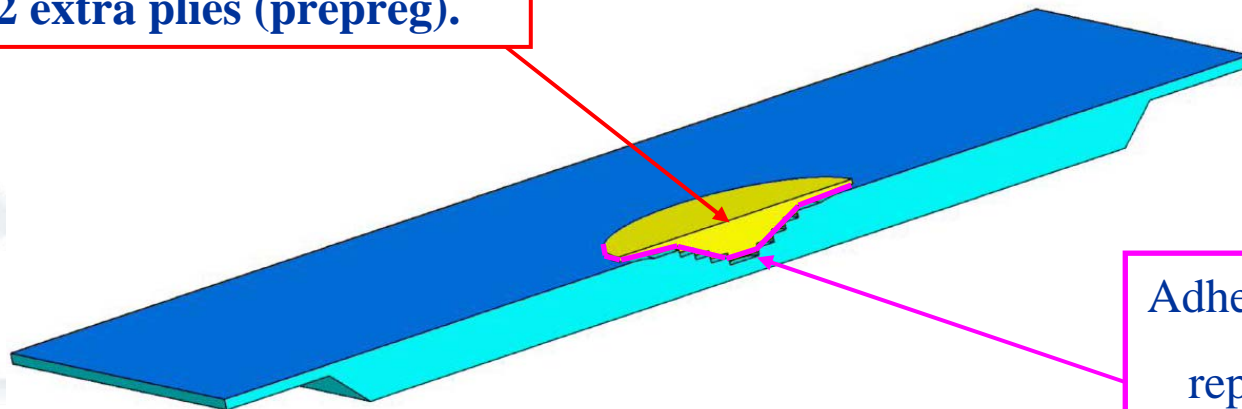
Repair Concepts (STEP 3)

**Bond in a new core plug.
Replace plies on a ply for ply
+ 2 extra plies (prepreg).**

**Adhesive ply between
repair plies and all
contact surfaces**

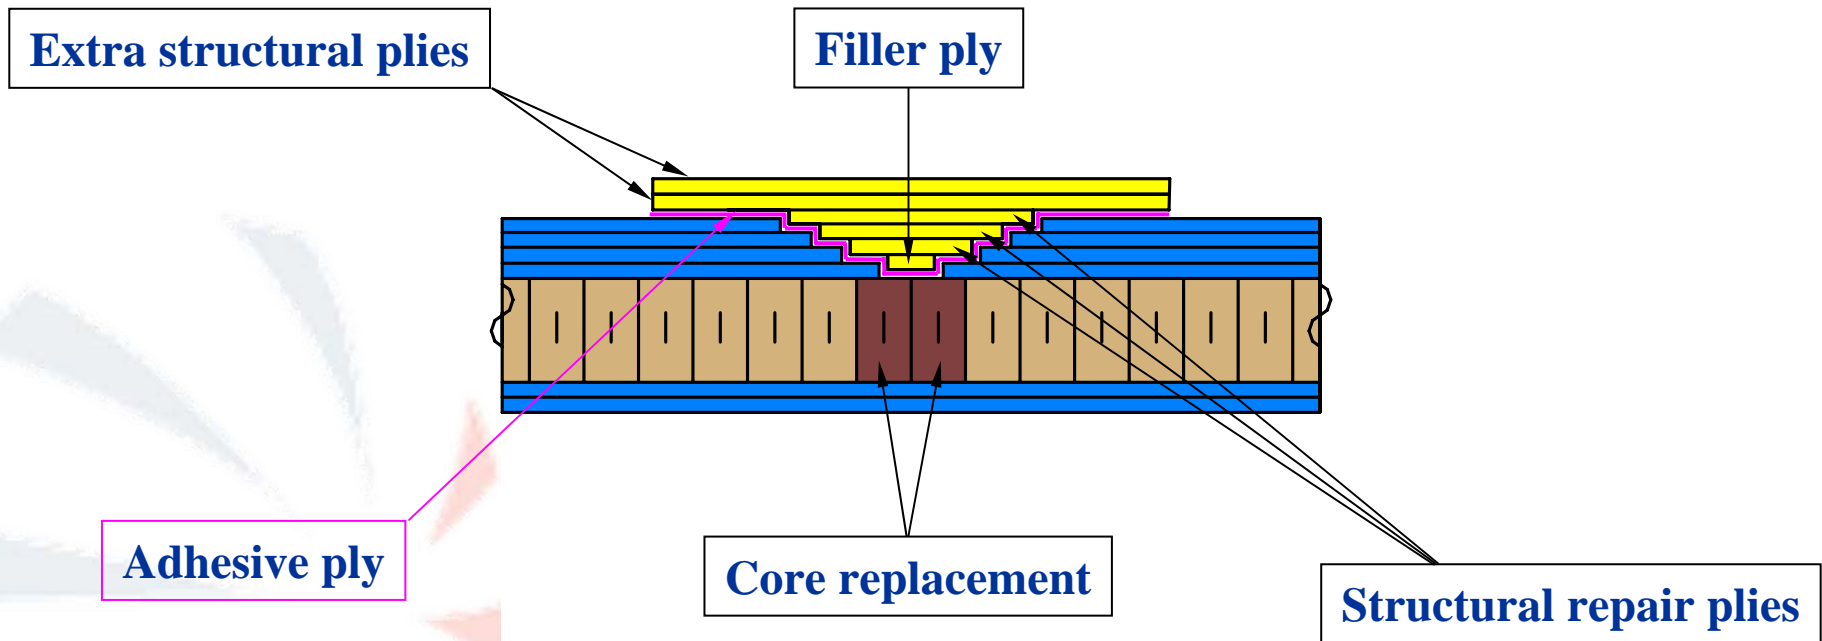
Repair of Sandwich Panel (detail)

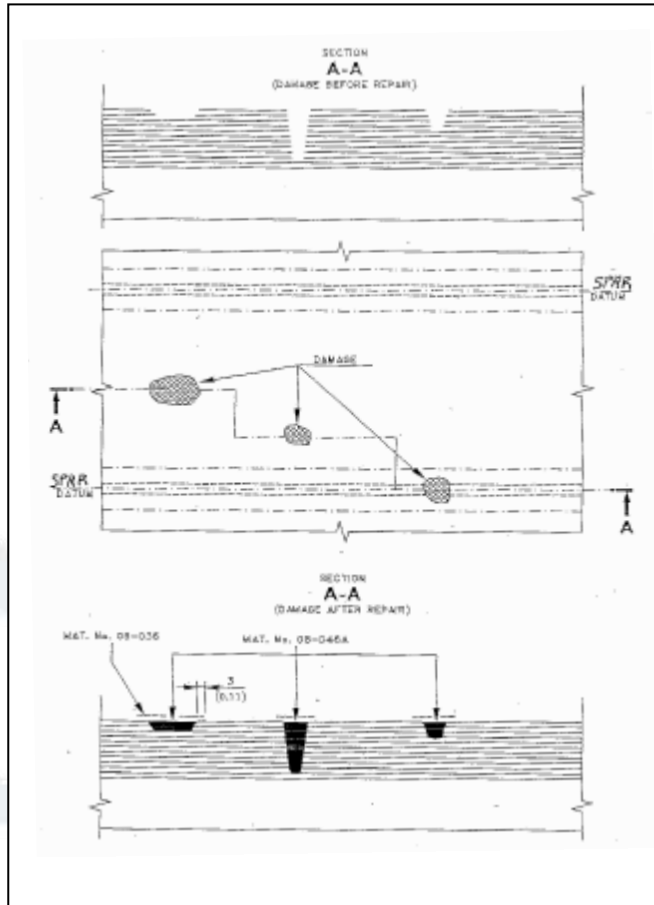
**Repair for Light damage
By Resin Filling**

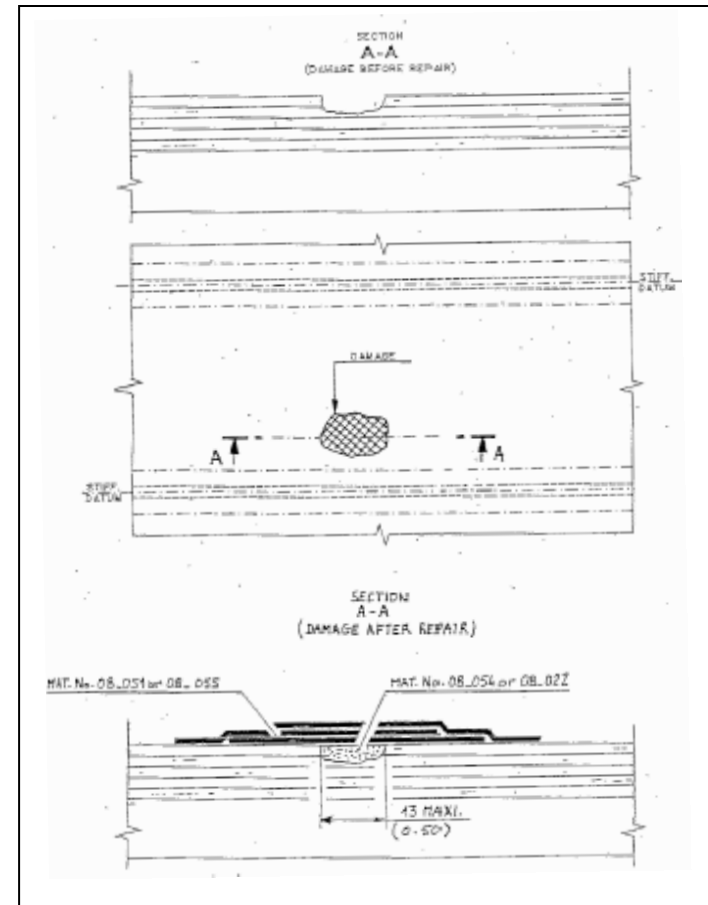
**Repair for Light damage
By Resin Filling and Extra Plies**

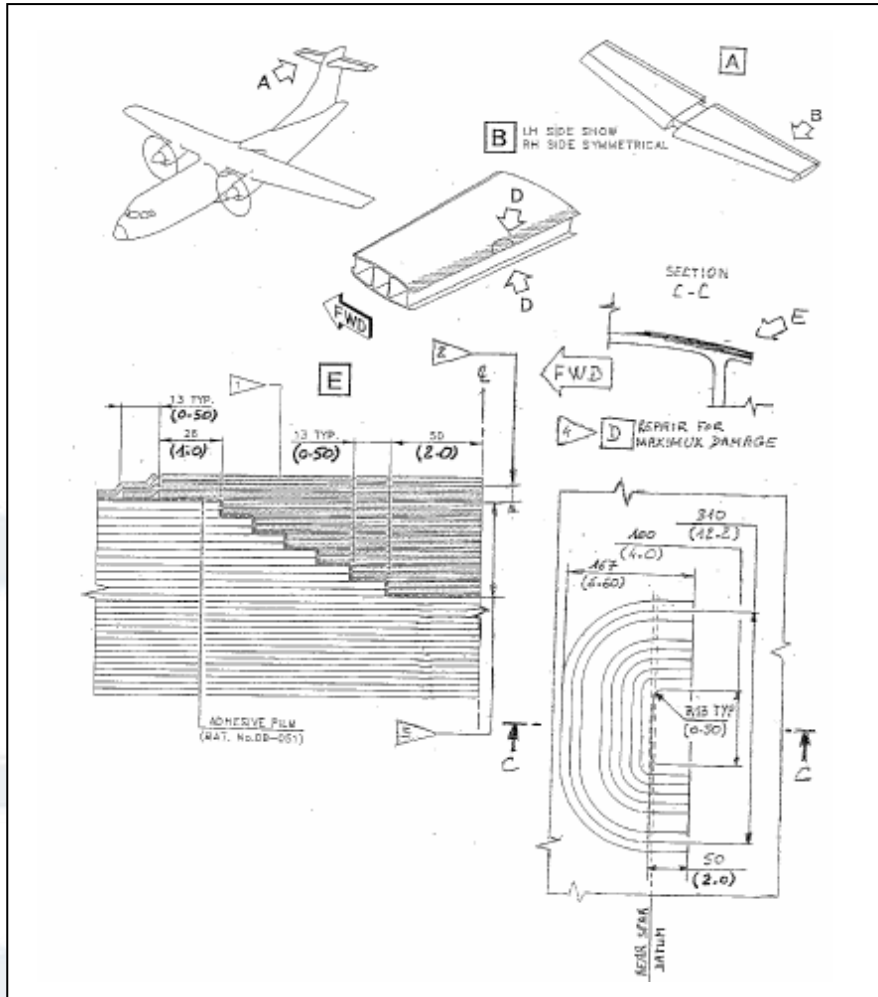
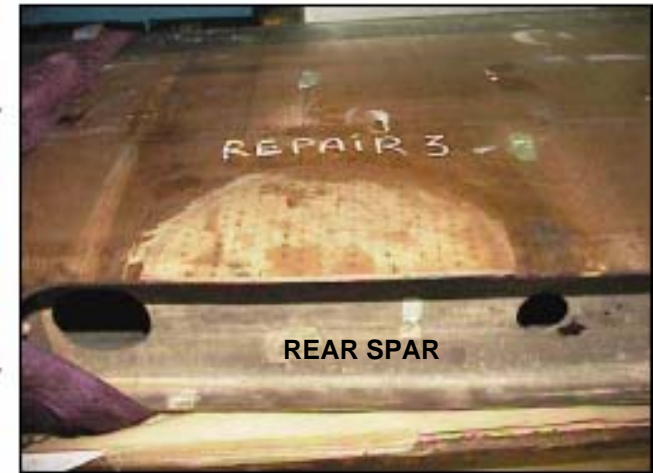
HOT BOND REPAIR FOR NON-PERFORATING DAMAGE ON PANEL EDGE CLOSE TO REAR SPAR

- 1 PUT A FIBER GLASS PLY COVERING THE PATCH IF COPPER MESH WAS PRESENT ON DAMAGED AREA.
USE ALUMINUM FLAME SPRAY TO RECREATE THE ELECTRICAL PATH.
- 2 2 EXTRA PLIES.
- 3 12 REPAIRED PLIES.
- 4 THIS REPAIR IS VALID ON UPPER AND LOWER PANEL EDGES.

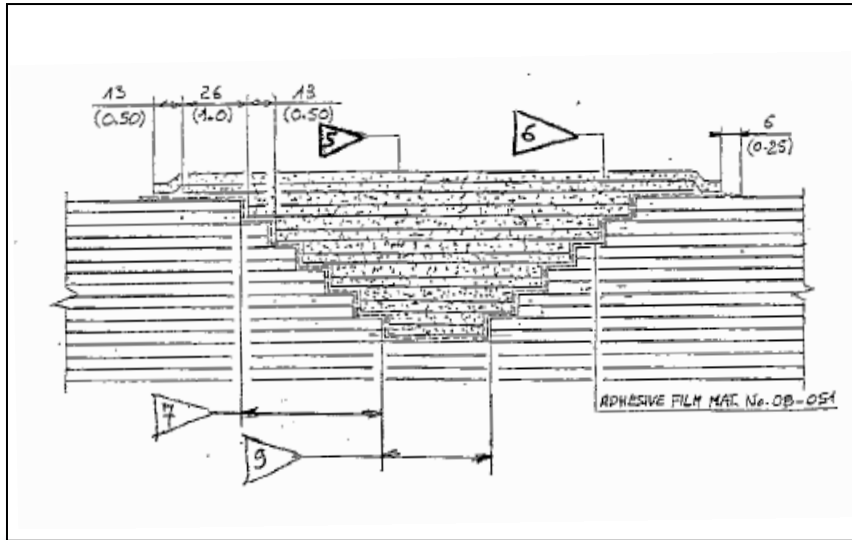
HOT BOND REPAIR FOR NON-PERFORATING DAMAGE ON PANEL EDGE CLOSE TO REAR SPAR (cont'd)

1TH PRINCIPLE: STEP CUTTING

- 5 DETERMINE NUMBER OF PLYS, ORIENTATION AND MATERIAL FROM SPECIFIC COMPONENT STRUCTURE IDENTIFICATION
- 6 THE ORIENTATION OF THE OUTERMOST EXTRA REPAIR PLY HAS TO BE THE SAME AS THE OUTERMOST PLY OF THE ORIGINAL LAMINATE. ANY OTHER EXTRA REPAIR PLY HAS TO BE ORIENTED $+45^\circ$ TO THE EXTRA REPAIR PLY IMMEDIATELY ABOVE IT
- 7 STEP CUTTING: 2 PLYS AT TIME

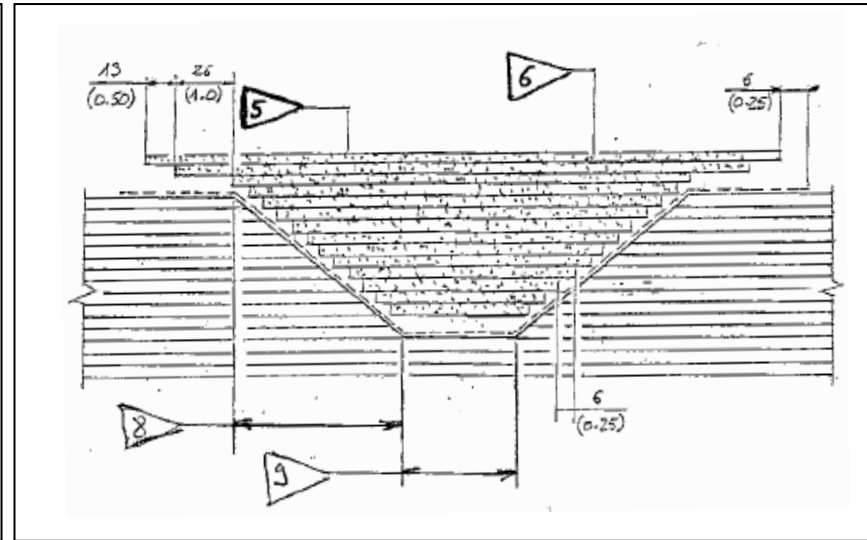
2TH PRINCIPLE: TAPER SANDING

- 8 SANDED RAMP: SLOPE 40:1
- 9 DAMAGE DIAMETER

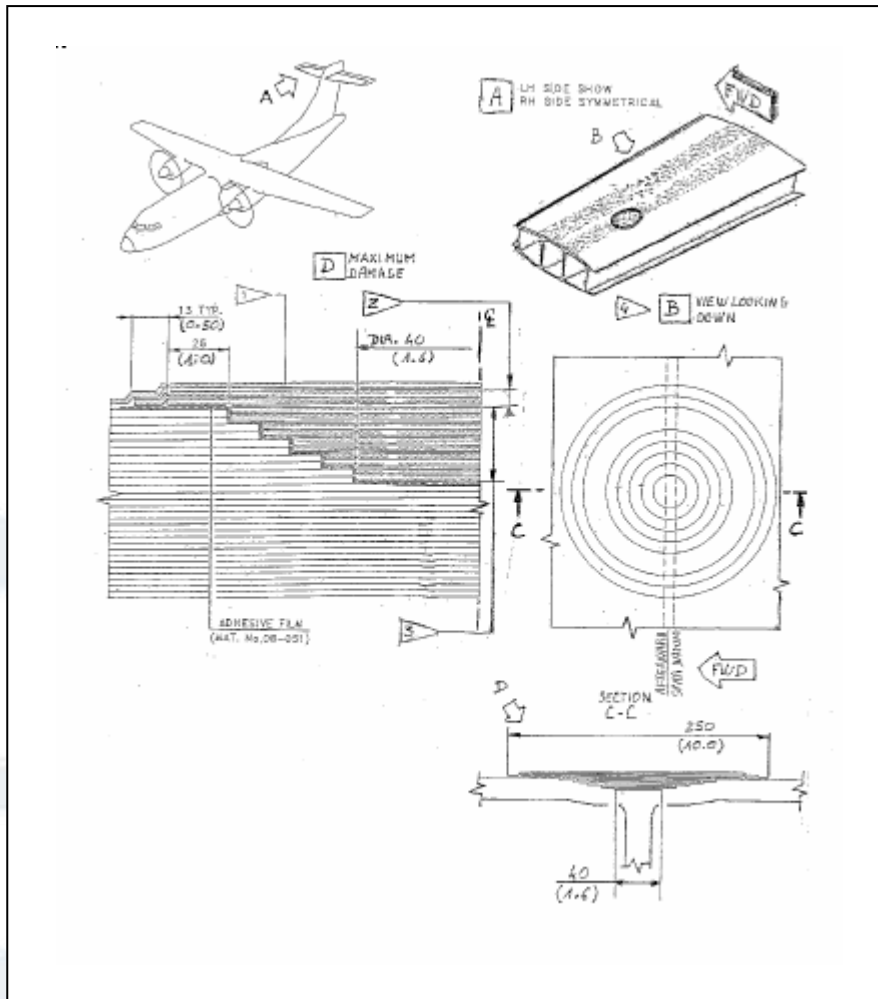
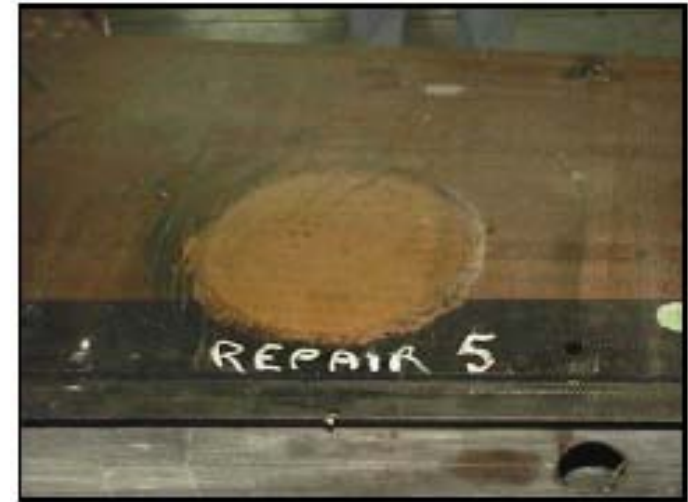
HOT BOND REPAIR FOR NON-PERFORATING DAMAGE ON THE SKIN AT THE SPAR LOCATION

- 1** PUT A FIBER GLASS PLY COVERING THE PATCH IF COPPER MESH WAS PRESENT ON DAMAGED AREA. USE ALUMINUM FLAME SPRAY TO RECREATE THE ELECTRICAL PATH.
- 2** 2 EXTRA PLIES.
- 3** 10 REPAIRED PLIES.
- 4** THIS REPAIR IS VALID ON UPPER AND LOWER PANEL EDGES.

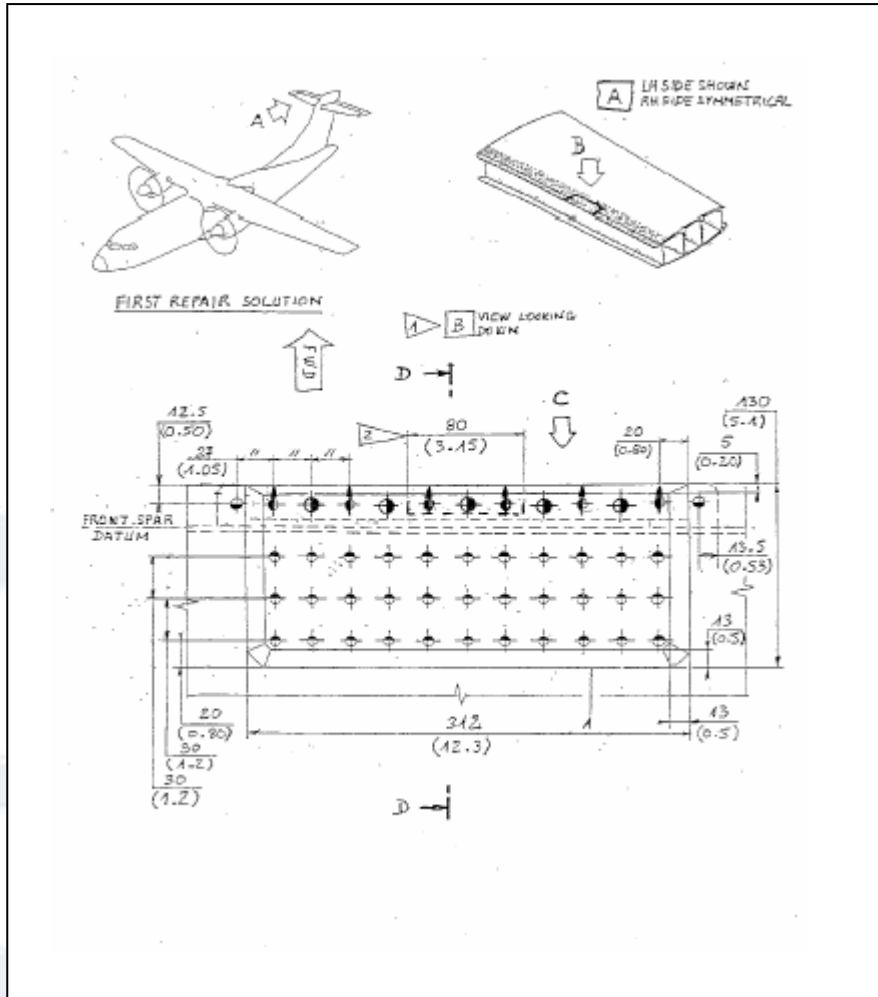
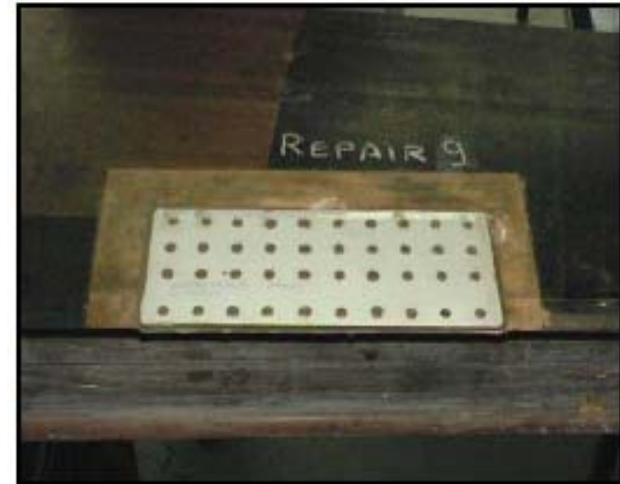
METAL PATCH REPAIR FOR PERFORATING DAMAGE ON FRONT SPAR CAP LOCATION

- 1 THIS REPAIR IS VALID ON UPPER AND LOWER PANEL.
- 2 MAXIMUM DAMAGE ALLOWED 80 x 17 mm (3.15") x (0.70")

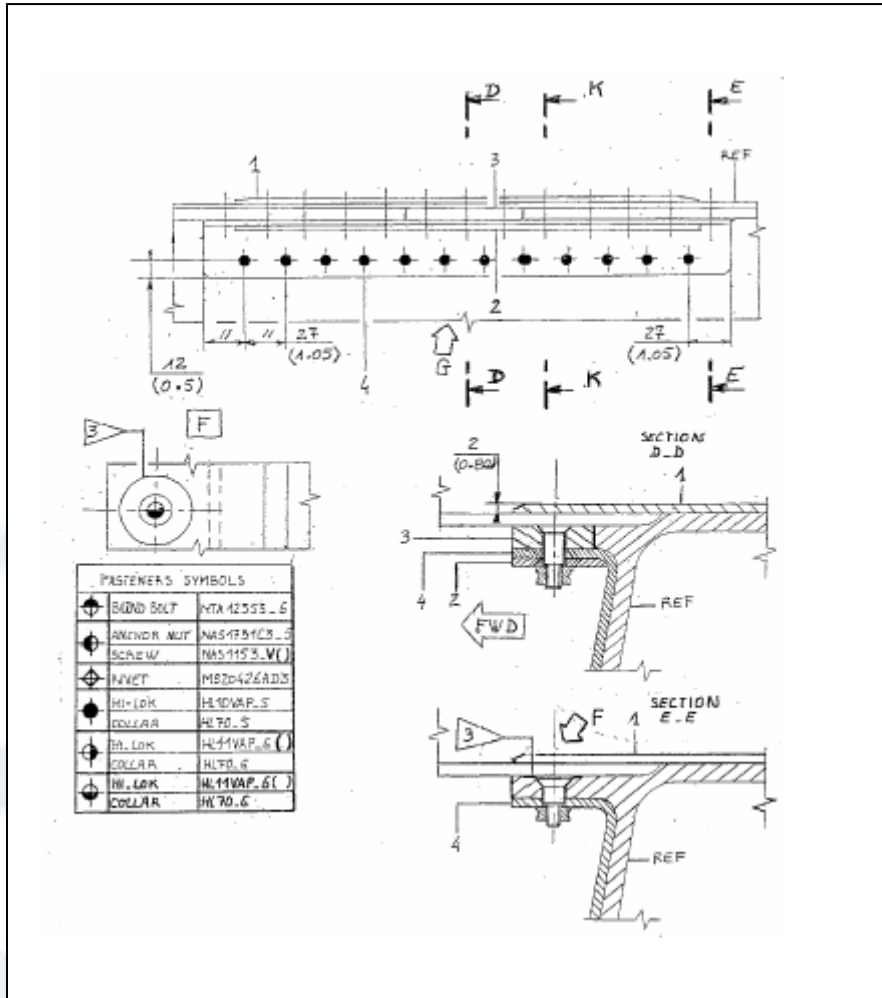
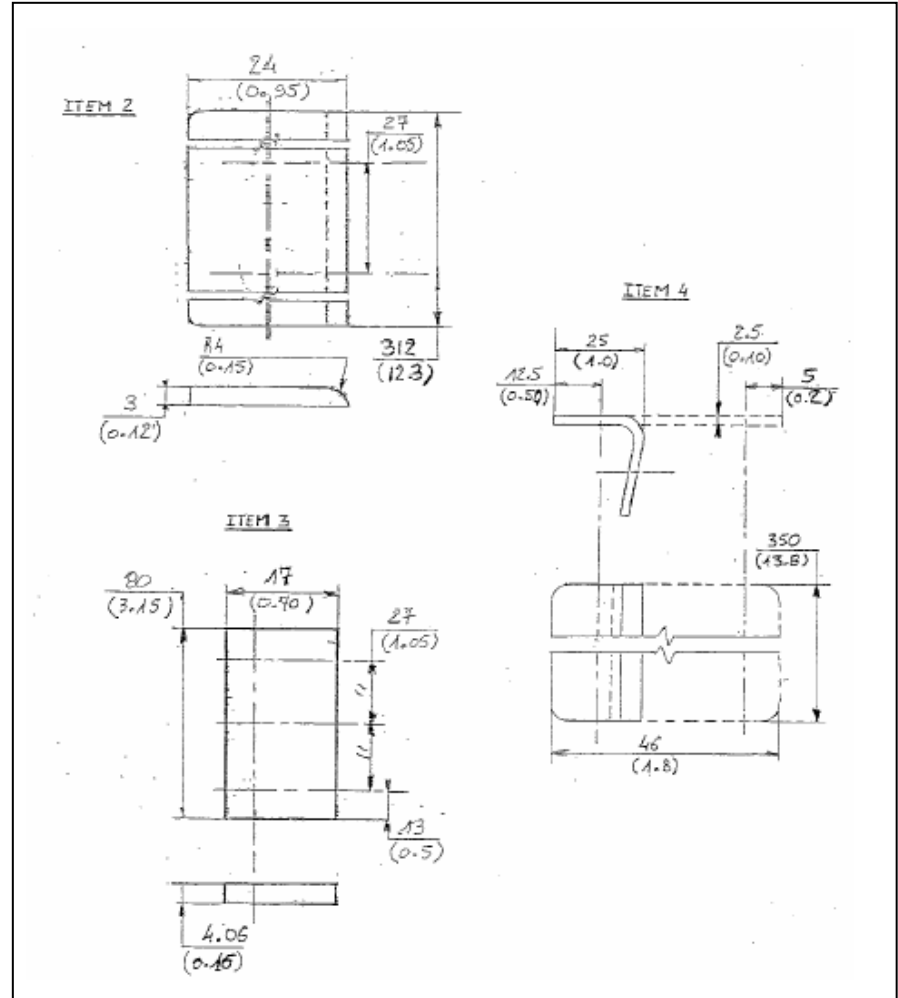
METAL PATCH REPAIR FOR PERFORATING DAMAGE ON FRONT SPAR CAP LOCATION (cont'd)

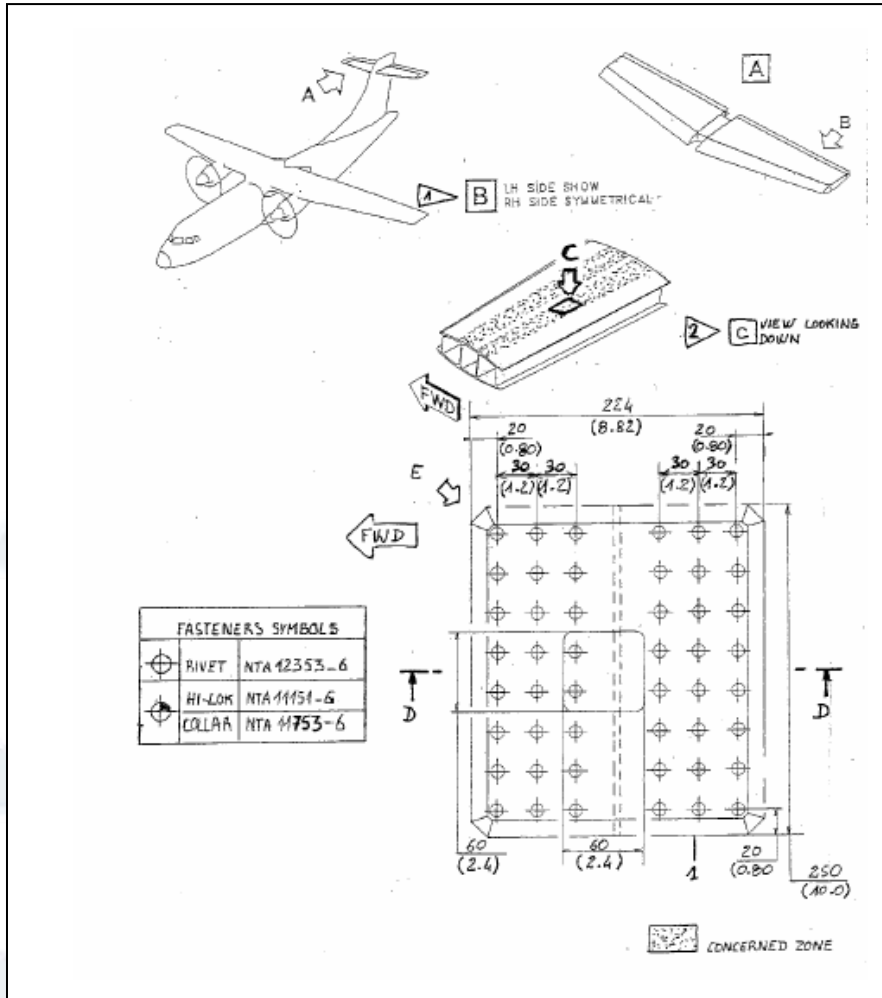
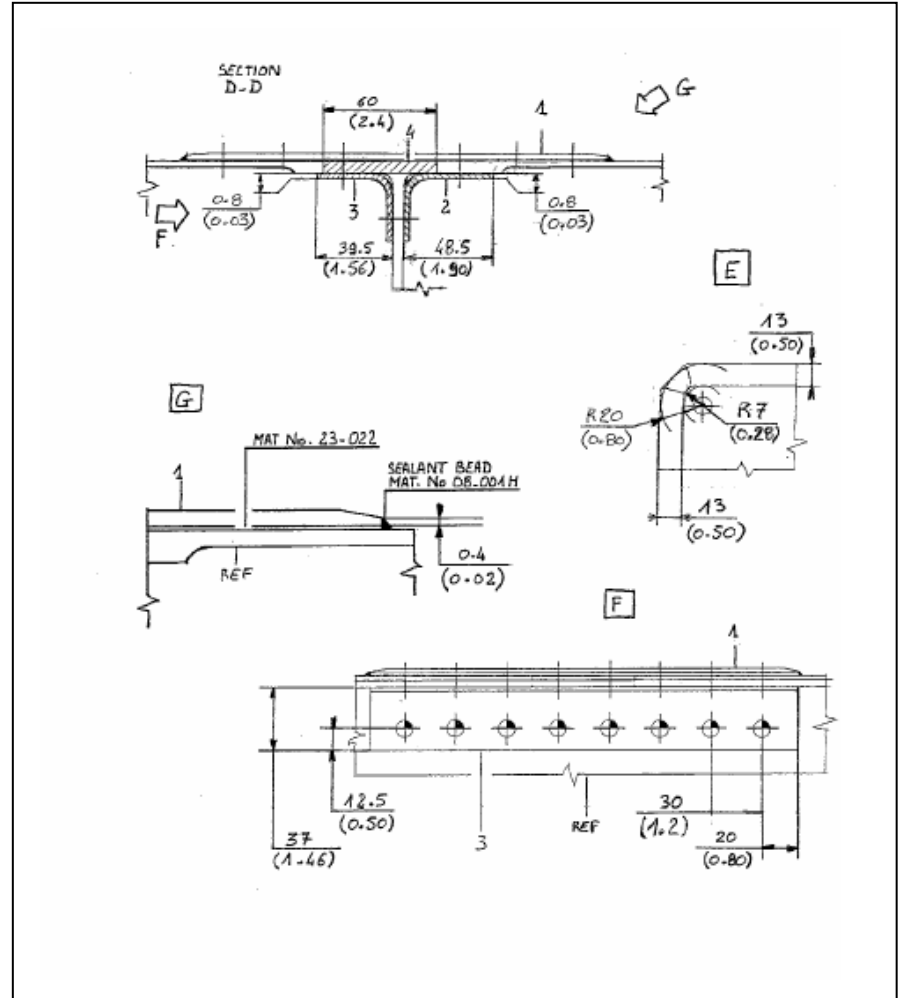
METAL PATCH REPAIR FOR PERFORATING DAMAGE ON THE SKIN AT THE SPAR CAP LOCATION

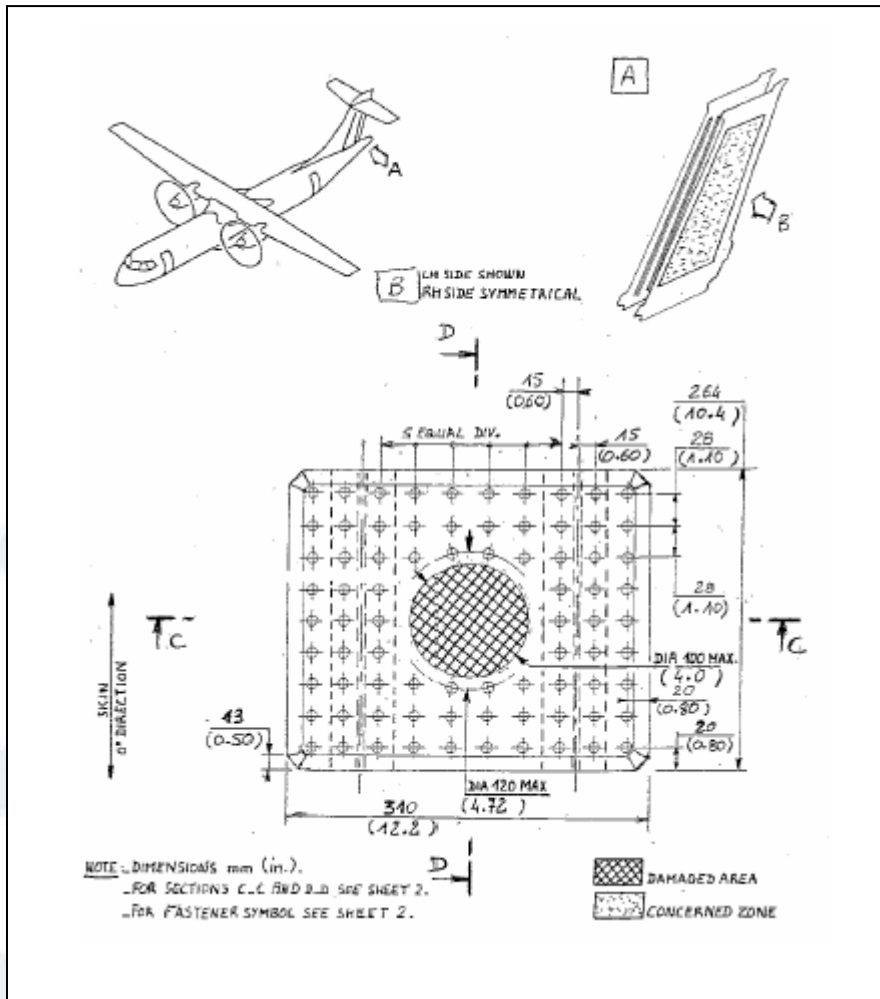
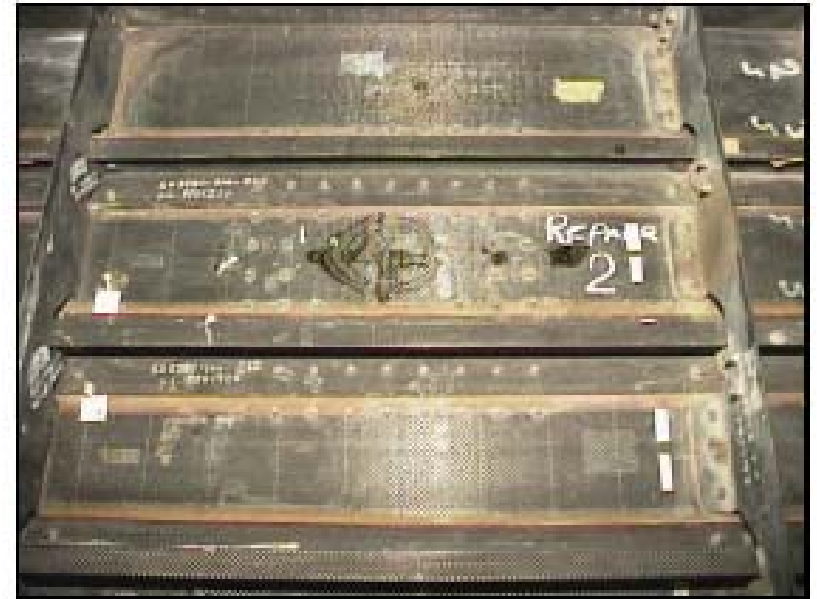
METAL PATCH REPAIR FOR NON-PERFORATING DAMAGE ON SKIN BETWEEN TWO STRINGERS

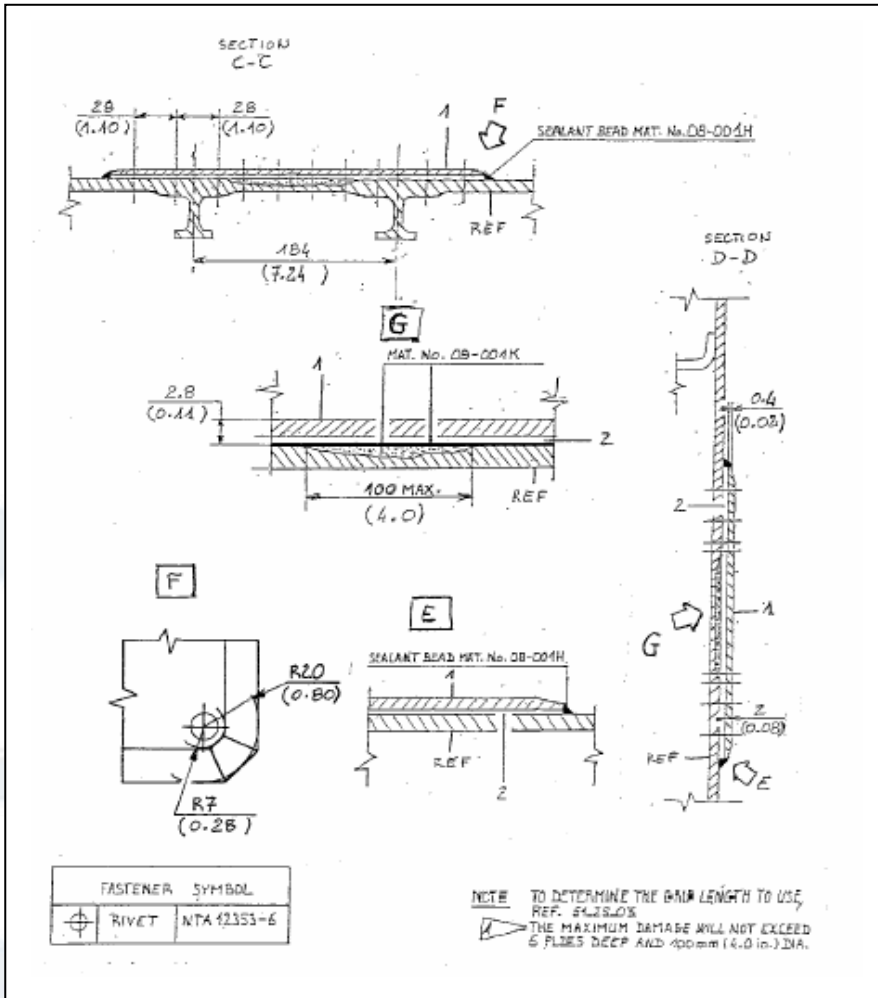
METAL PATCH REPAIR FOR NON-PERFORATING DAMAGE ON SKIN BETWEEN TWO STRINGERS (cont'd)

THE MAXIMUM DAMAGE WILL NOT EXCEED 6 PLYS DEEP AND 100 mm (4.0") DIA.

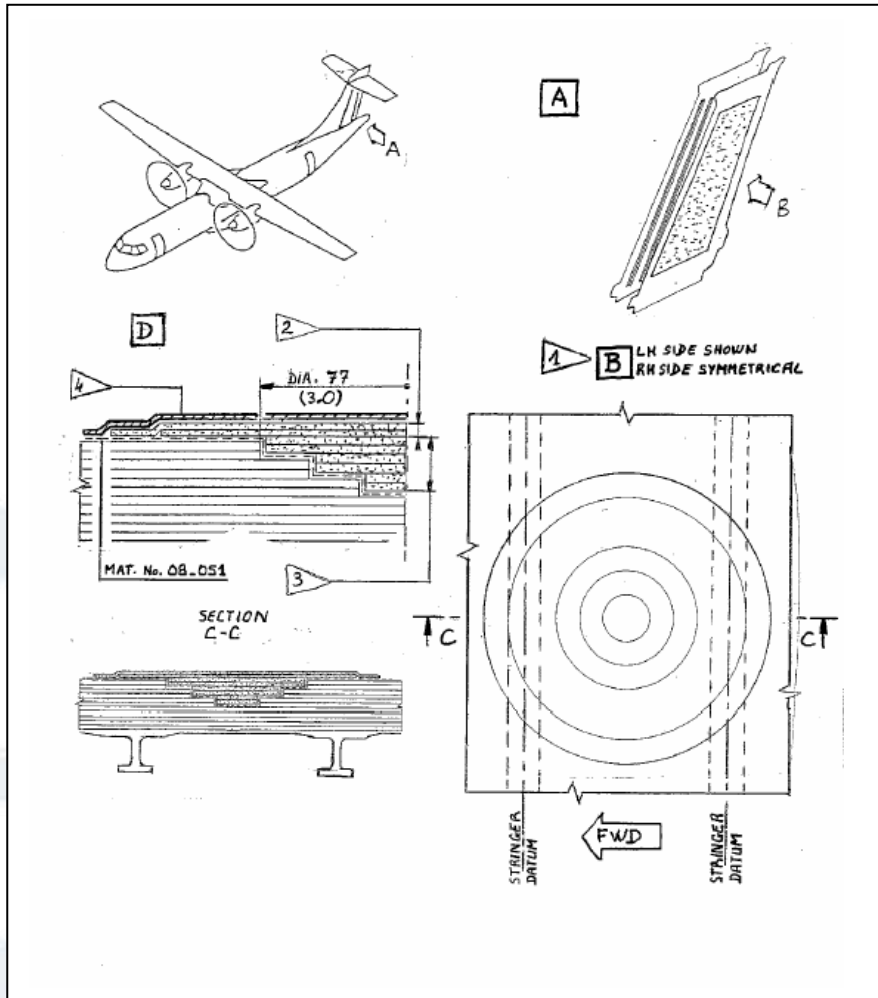
HOT BOND REPAIR FOR NON-PERFORATING DAMAGE ON SKIN BETWEEN TWO STRINGERS

- 1 THIS REPAIR IS VALID ON LHS AND RHS
- 2 2 EXTRA PLIES
- 3 6 RESTORED PLIES
- 4 PUT A FIBER GLASS PLY COVERING THE PATCH IF COPPER MESH WAS PRESENT ON DAMAGED AREA.

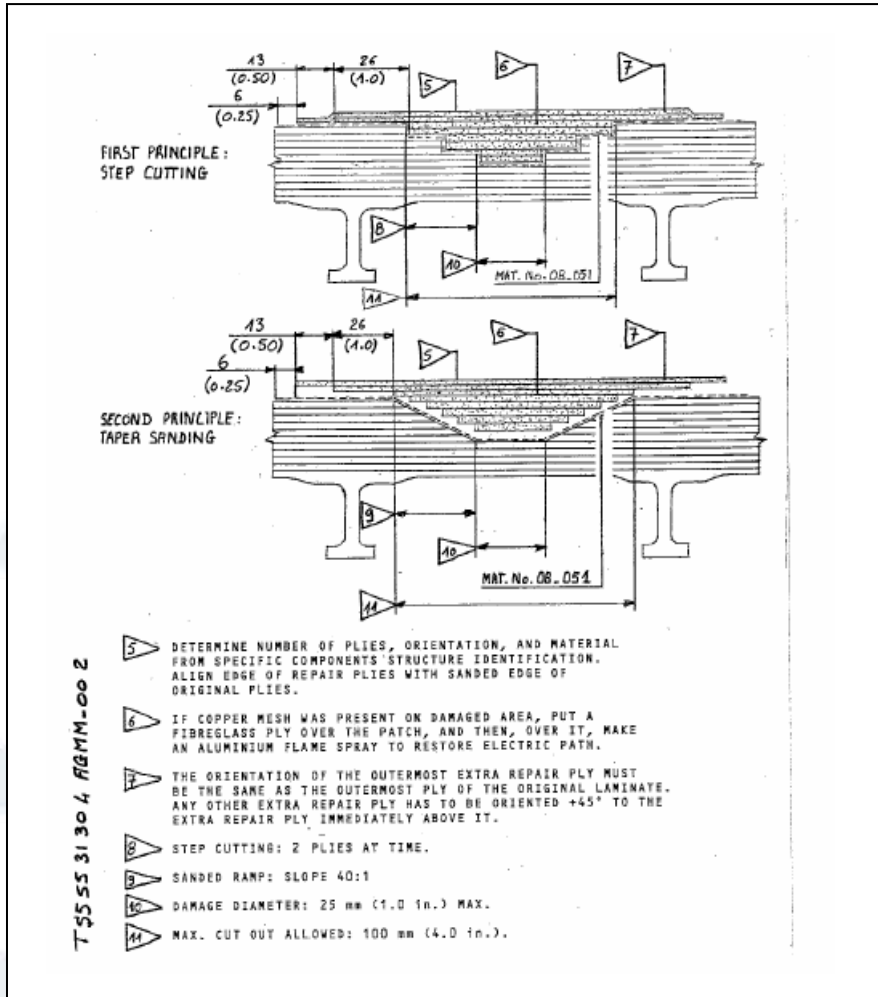
HOT BOND REPAIR FOR NON-PERFORATING DAMAGE ON SKIN BETWEEN TWO STRINGERS

- 5** DETERMINE NUMBER OF PLYS, ORIENTATION AND MATERIAL FROM SPECIFIC COMPONENT STRUCTURE IDENTIFICATION
- 6** PUT A FIBER GLASS PLY COVERING THE PATCH IF COPPER MESH WAS PRESENT ON DAMAGED AREA. USE ALUMINIUM FLAME SPRAY TO RECREATE THE ELECTRICAL PATH.
- 7** THE ORIENTATION OF THE OUTERMOST EXTRA REPAIR PLY HAS TO BE THE SAME AS THE OUTERMOST PLY OF THE ORIGINAL LAMINATE. ANY OTHER EXTRA REPAIR PLY HAS TO BE ORIENTED +45° TO THE EXTRA REPAIR PLY IMMEDIATELY ABOVE IT
- 8** STEP CUTTING: 2 PLYS AT TIME
- 9** SANDED RAMP: SLOPE 40:1
- 10** DAMAGE DIAMETER 25 mm (1.0") MAX
- 11** MAX. CUT OUT ALLOWED 100 mm (4.0 ")

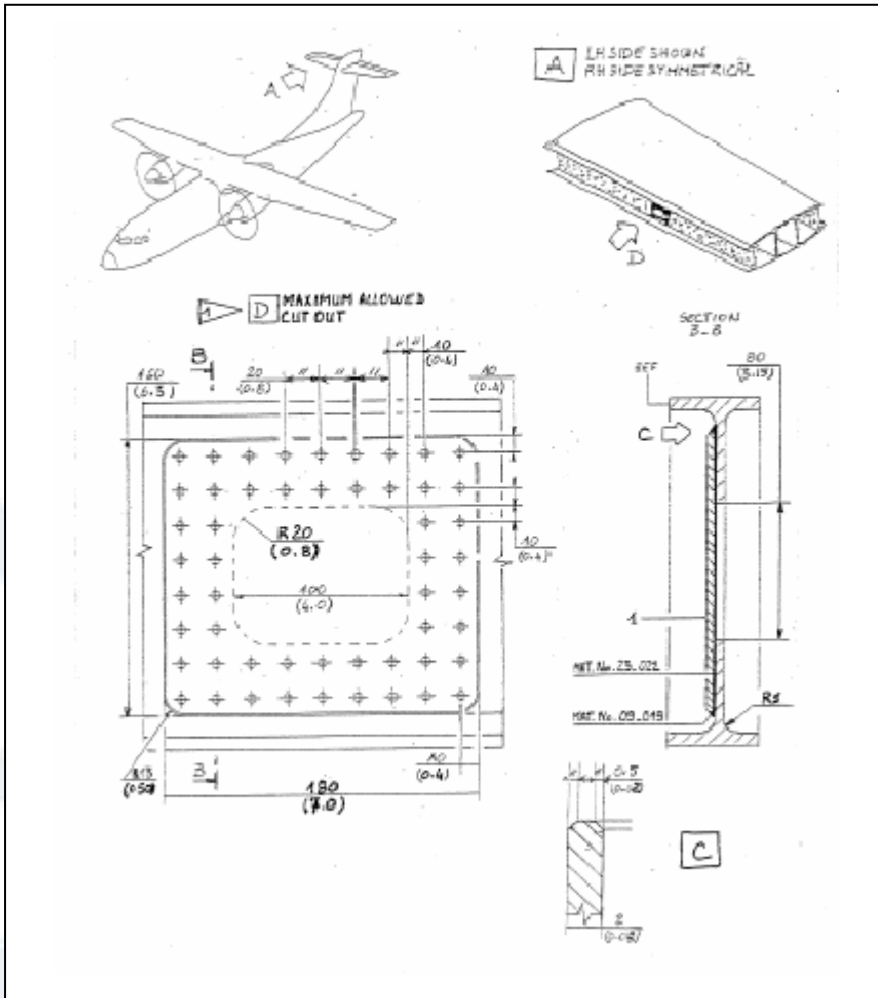
REPAIR ACCESS WINDOW PROCEDURE
