Alenia Experiences on Composite Structures Repairs

Benedetto Gambino

Amsterdam, 10 May 2007

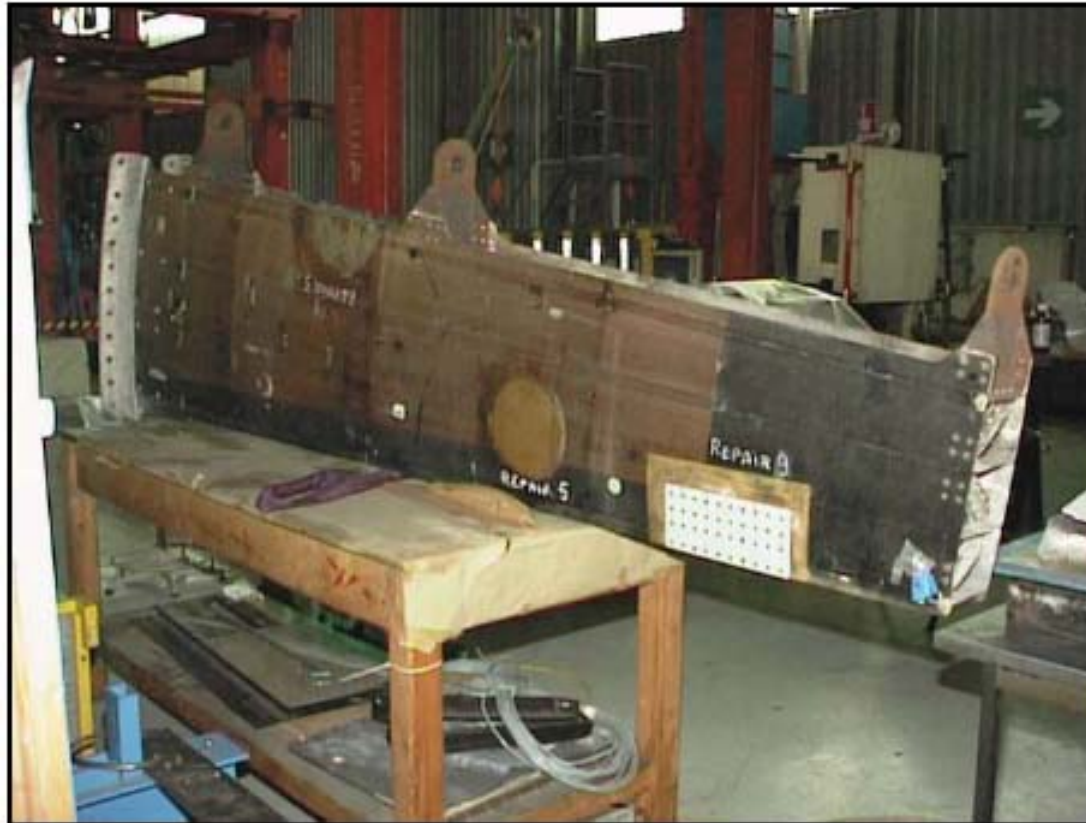
FULL SCALE FATIGUE TEST

TO SUSTAIN ALLOWABLE DAMAGE A FULL FATIGUE TEST HAS BEEN PERFORMED.

TEST RESULTS SHOW THAT THERE WAS NO ANOMALY AND/OR DAMAGE GROWTH OF SIMULATED DAMAGES.
