FAA R&D in Composite Sandwich Structures

Presented to: Damage Tolerance & Maintenance
Workshop

Date: 20 July 2006

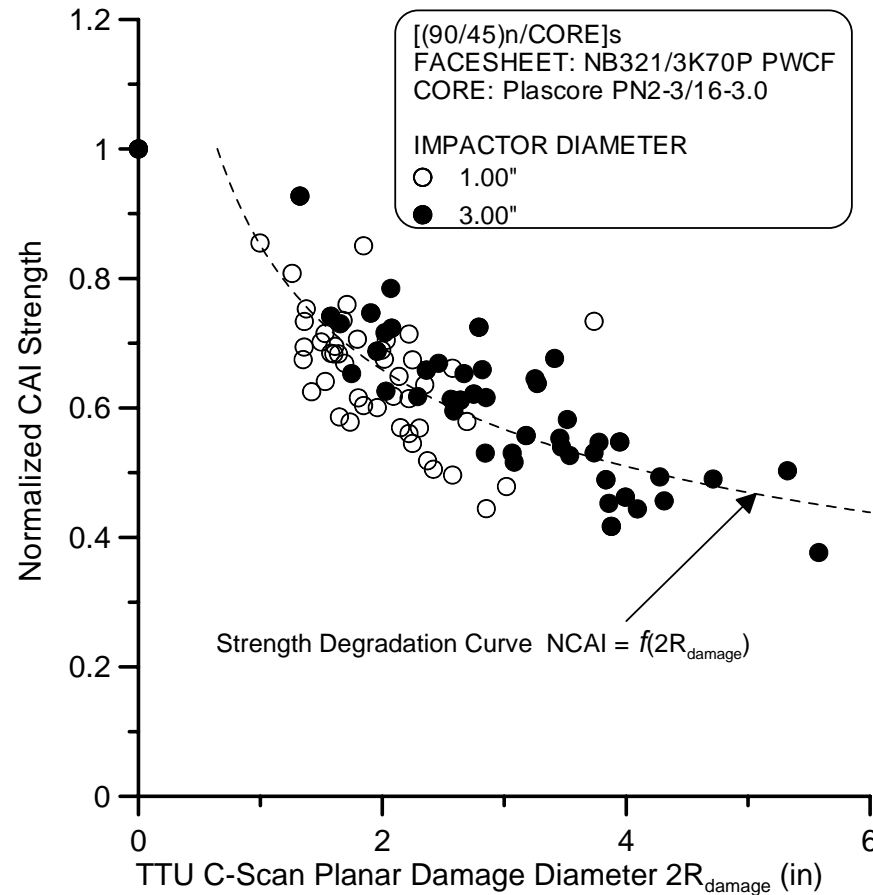
Compressive residual strength after impact

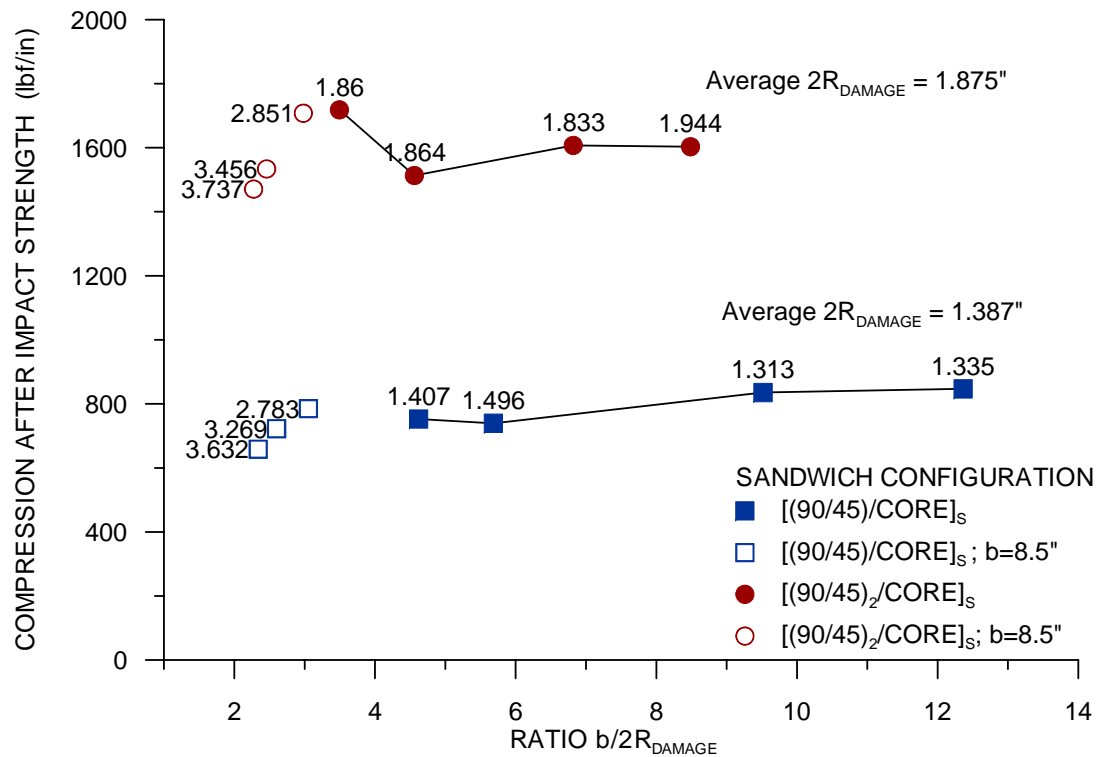
Effect of increasing width on compressive residual strength

- Damage resistance is reduced if one planar dimension is reduced; governed by global stiffness
- Damage tolerance does not seem to be affected by increasing the width if the damage state remains the same. Smaller specimen give slightly conservative but valid results if the damage size and failure mechanisms are monitored to ensure that the finite width effects are correctly accounted for.

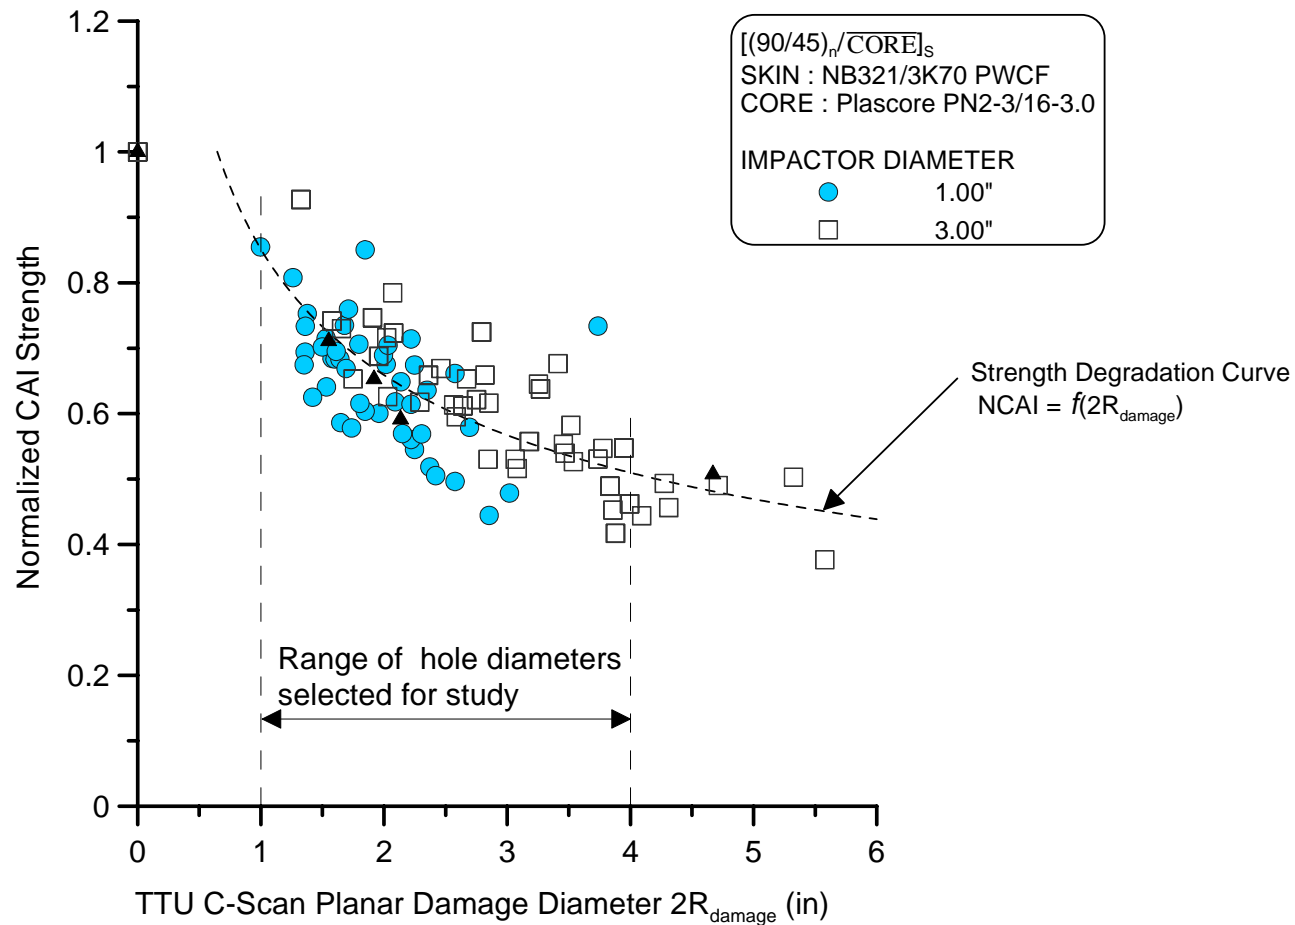
Impact data and open hole dimensions

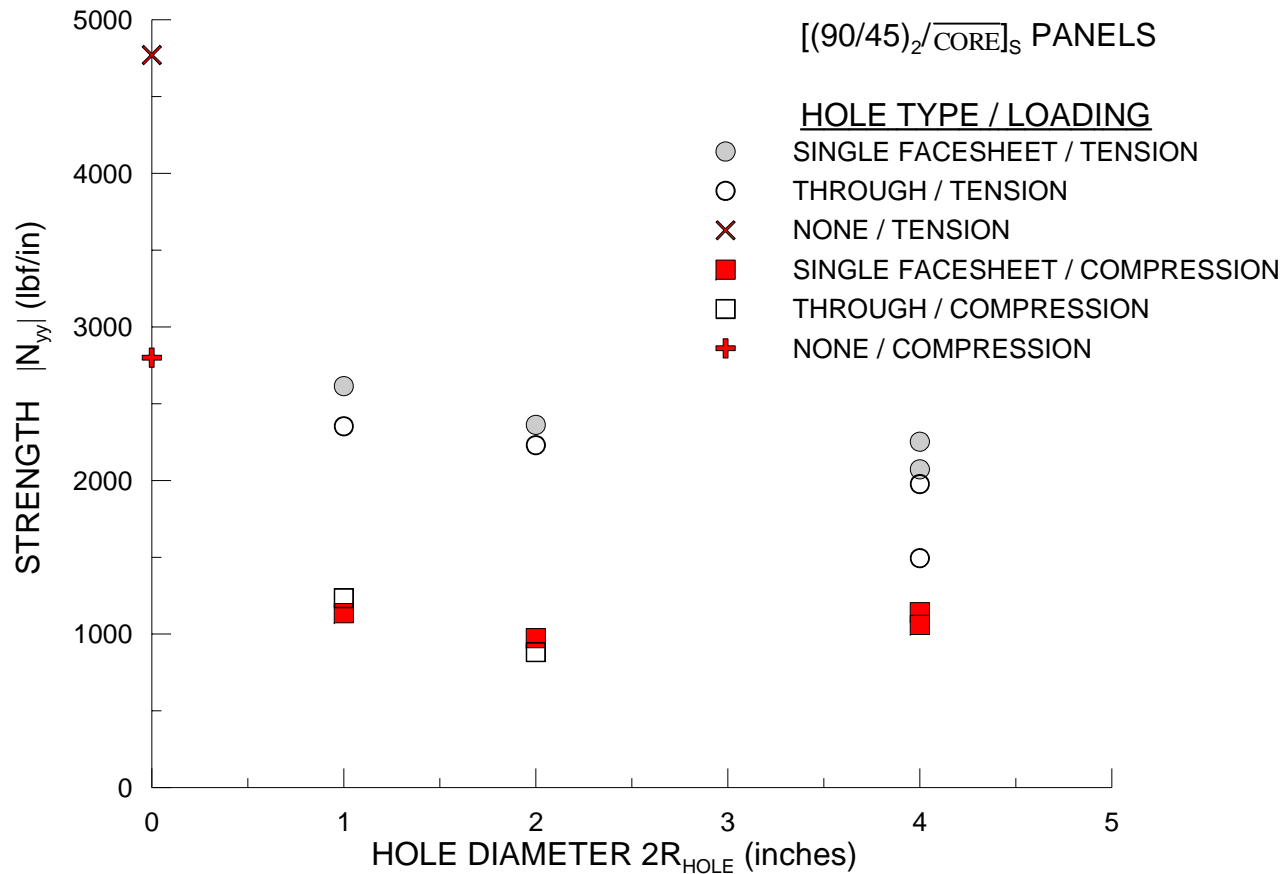
Open-hole strengths

- Open hole more critical than impact damage for equivalent damage size
- Through hole more severe than hole to one face-sheet
- Compression more critical than tension
- Increase in indentation depth approach open hole results
- In compression, face-sheet fracture failure mode was observed for small diameter holes in one face-sheet and for through holes of all sizes
- For 4 in. diameter holes in one face-sheet local instability mode was observed that blunted the stress concentration resulting in higher compressive strengths

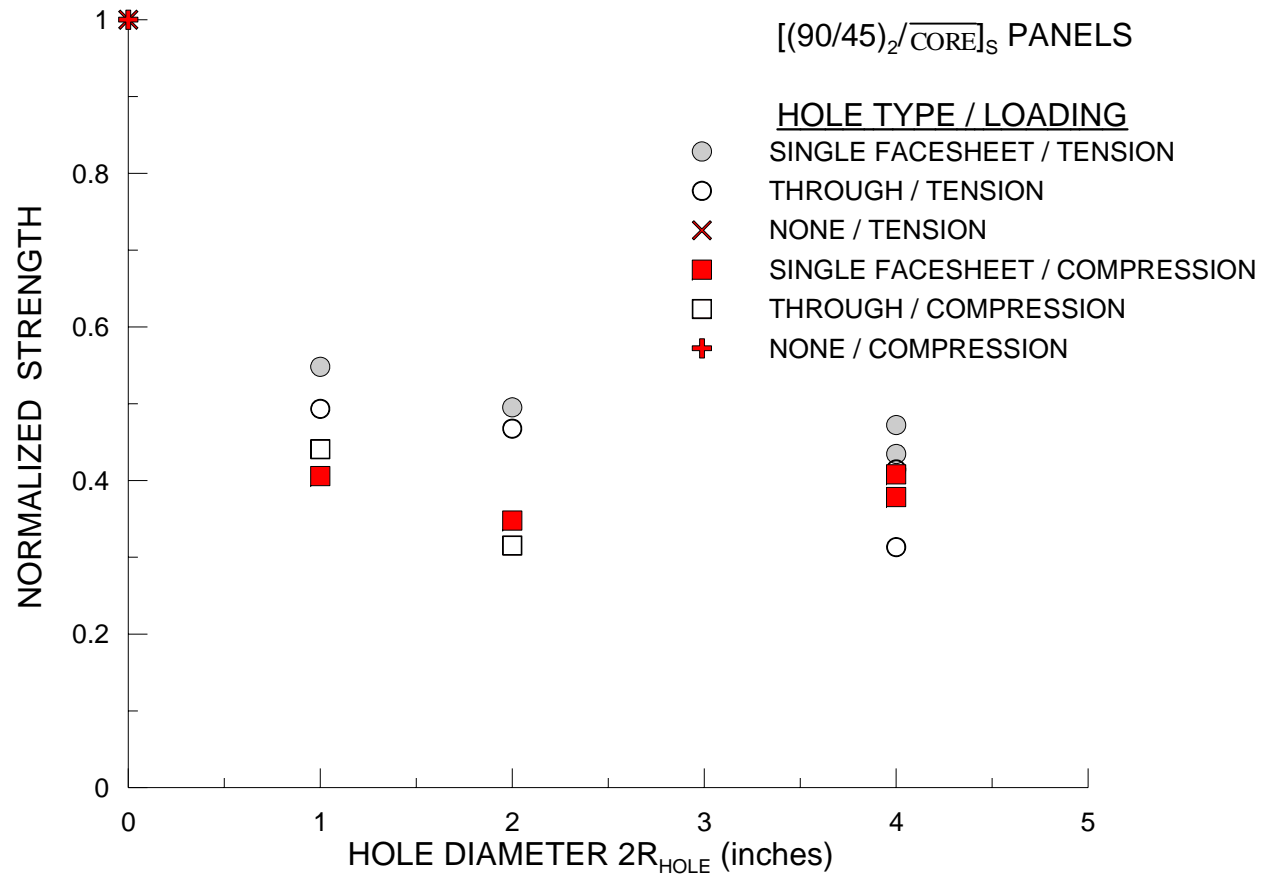
Open-hole strengths- normalized

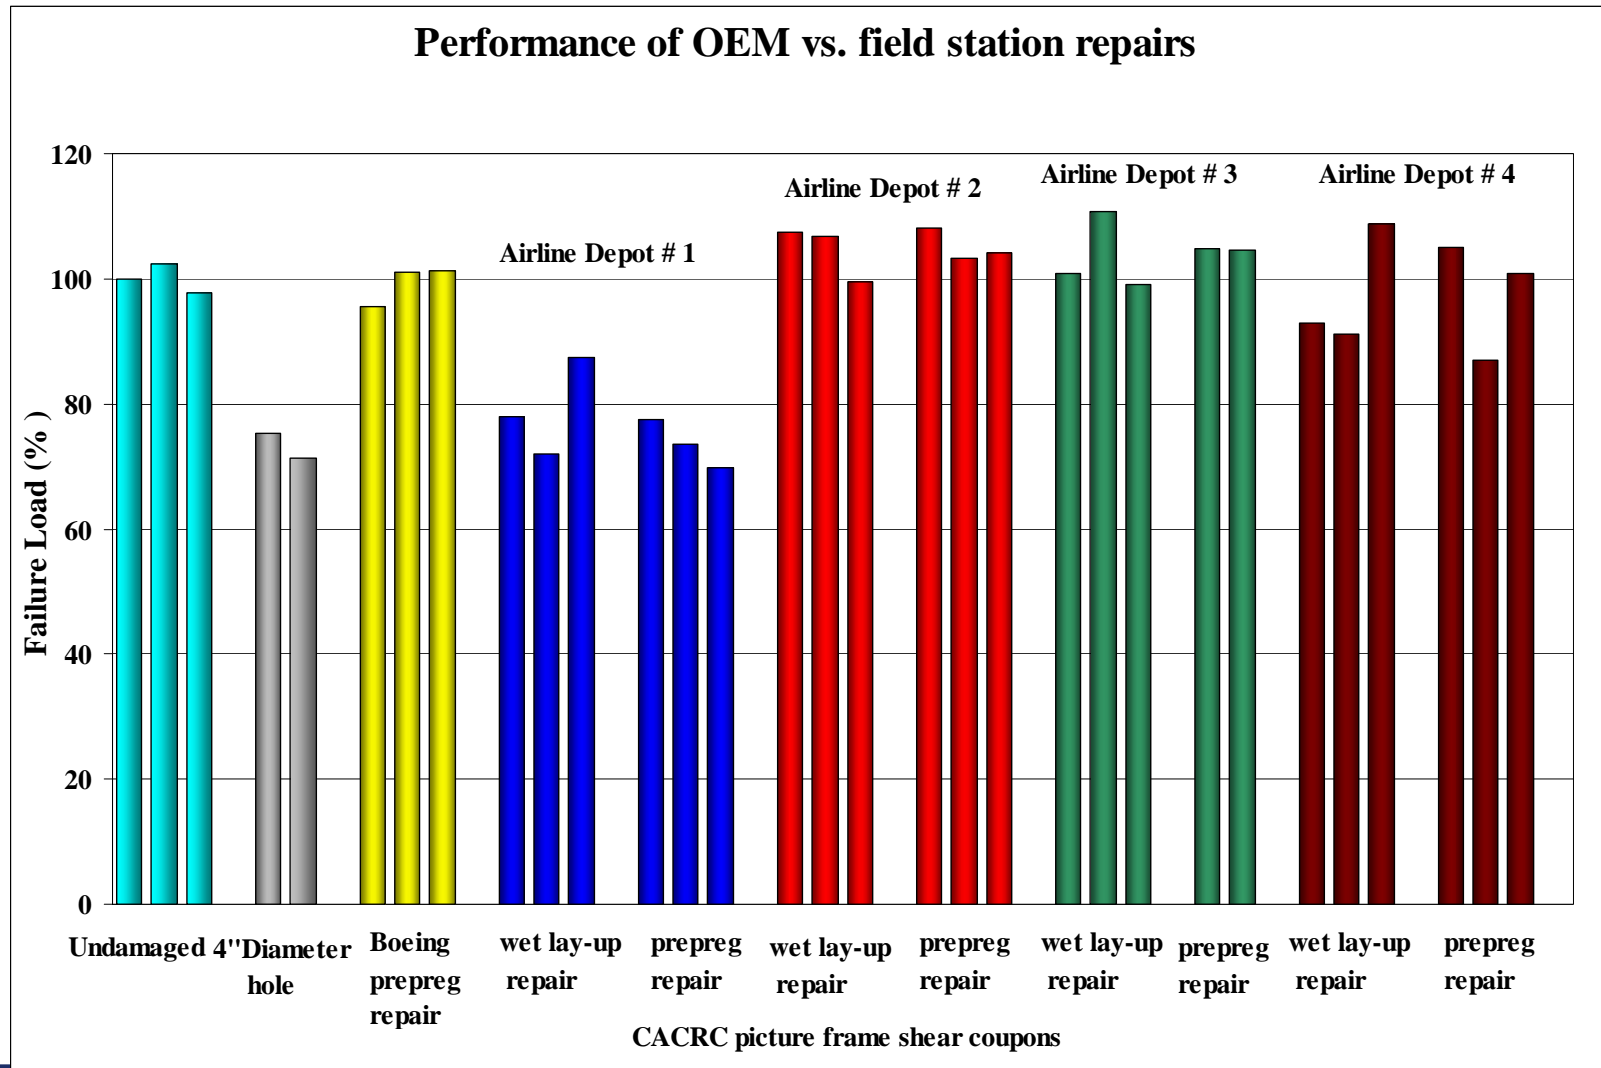
Repair test results

- All the repaired picture frame shear elements restored at least 90% of the average pristine strength except elements from one airline depot
- Heat blanket failure equals repair failure
- Field repair equivalent to prepreg repair
- Successful repairs require trained personnel
- The core cell size had a major effect on the performance of repaired sandwich structures regardless of the material system used: 1/8" core sandwich structures have higher strength than with the 3/8" core
- Comparable results can be achieved by either a 0.25" or a 0.5" scarf overlap
- Analysis has difficulty modeling core/face-sheet interfaces.

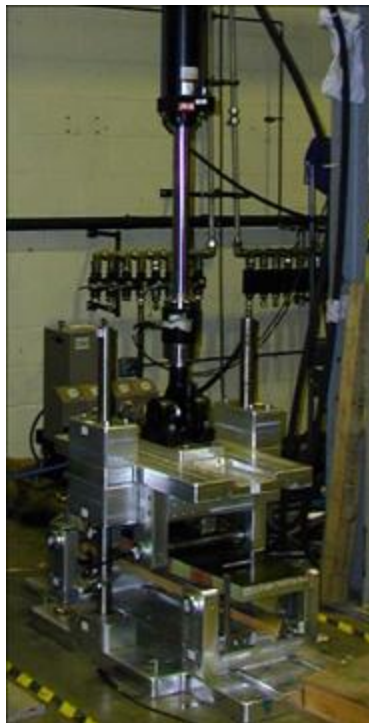
**Large (11.5"X46") and small (14"X3")
Four-Point Bending Beams**

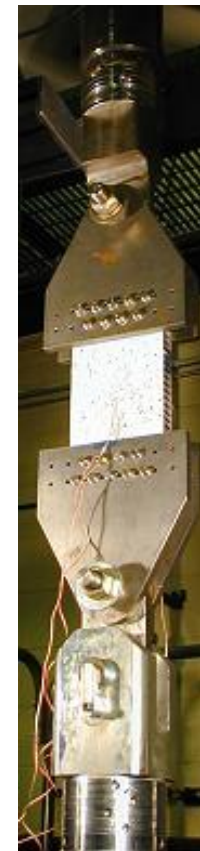
**Unidirectional Tension
Coupons**

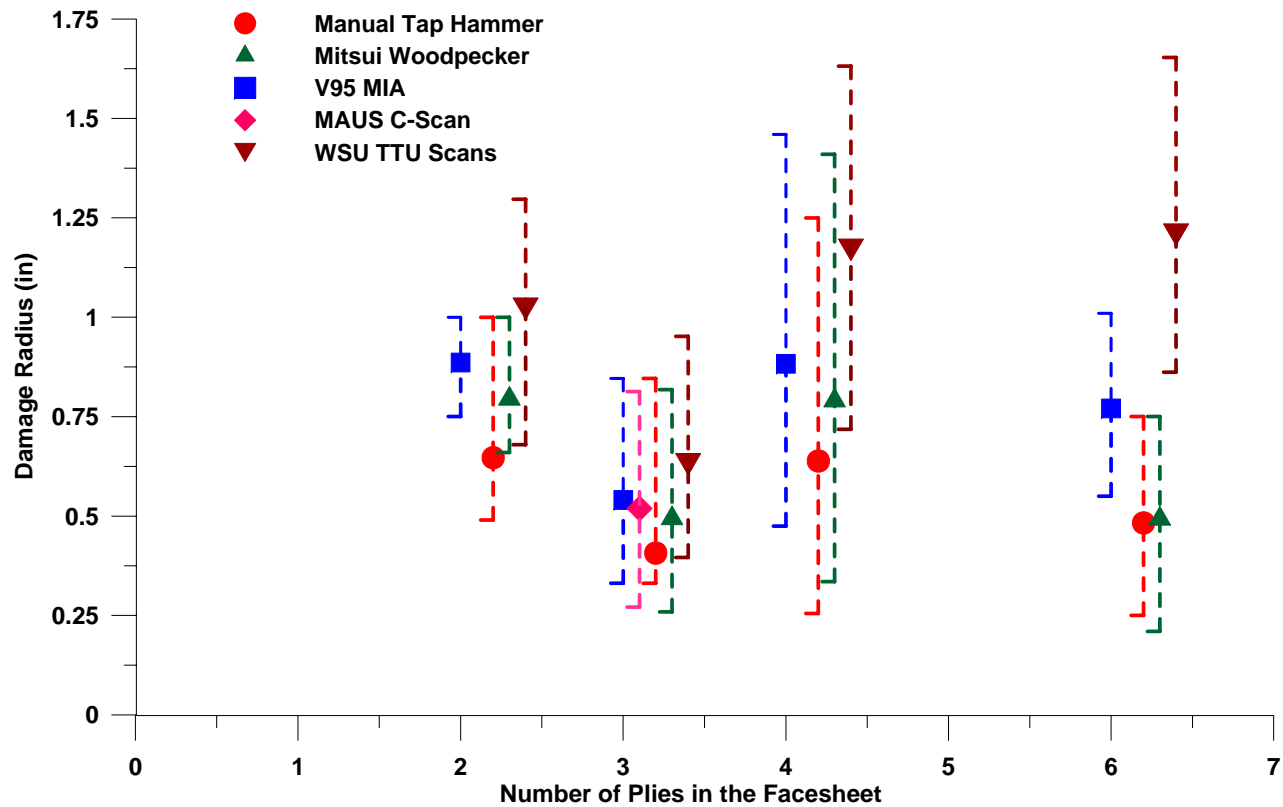
Performance of different NDI methods in detecting damage for sandwich panels with different facesheet thicknesses

- All the NDI field methods underestimated the damage size with the tap hammer being the least conservative
- Thickness seems to be a factor, however, the range here is only 2 to 6 plies
- The smaller the damage the better field techniques are
- Limitations of field NDI must be understood; this must be taken into account when deciding on the applicable damage size in the SRM
